Oatka Creek Site Inspection 2003

Genesee County Soil and Water Conservation District

2003 Inspection

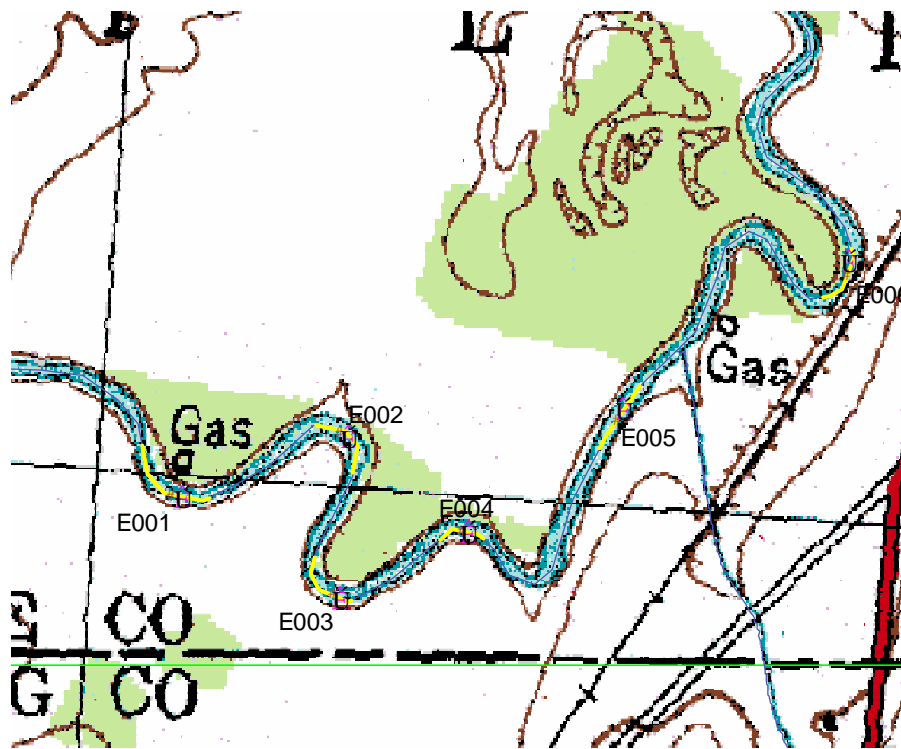
In this section, most erosion occurs where the bends are in the creek. Erosion is hypothesized to be a result of farming practices.

Erosion point E006 is in need of erosion control. Here, the railroad tracks are very close to the creek. As a result, it is assumed that this area will become a trouble spot in the near future.

Erosion point E007 has a great deal of erosion occurring on the left bank. Here, several log jams have also been identified. It is recommended that this area be examined further and that erosion prevention methods be implemented.

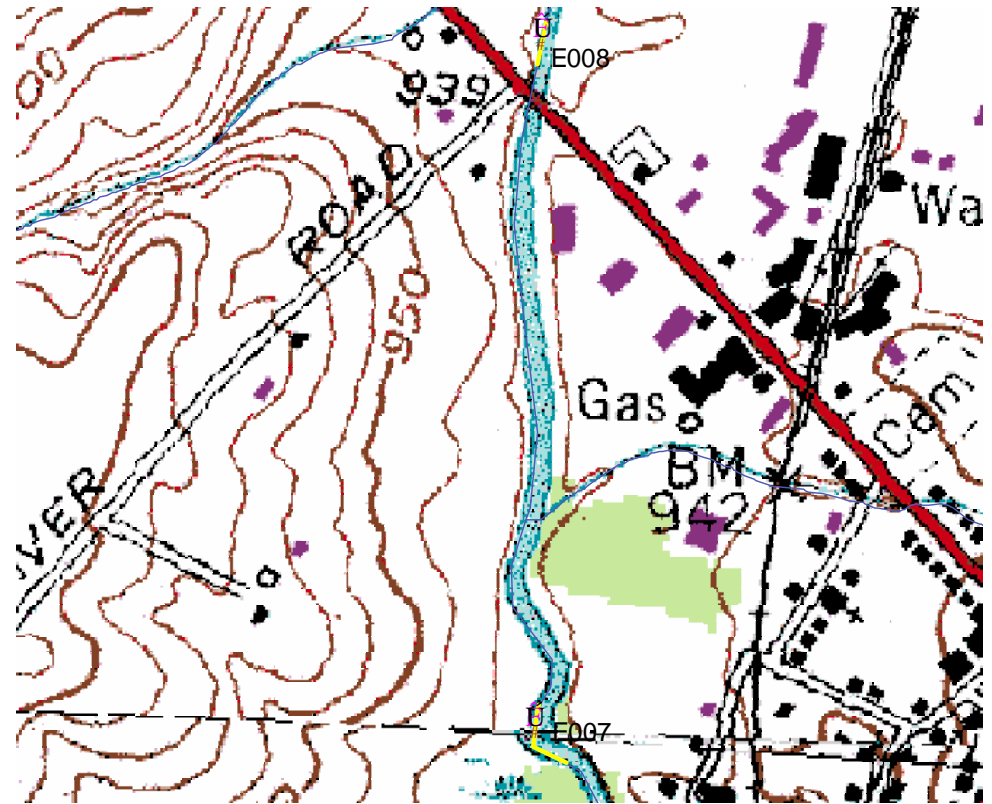
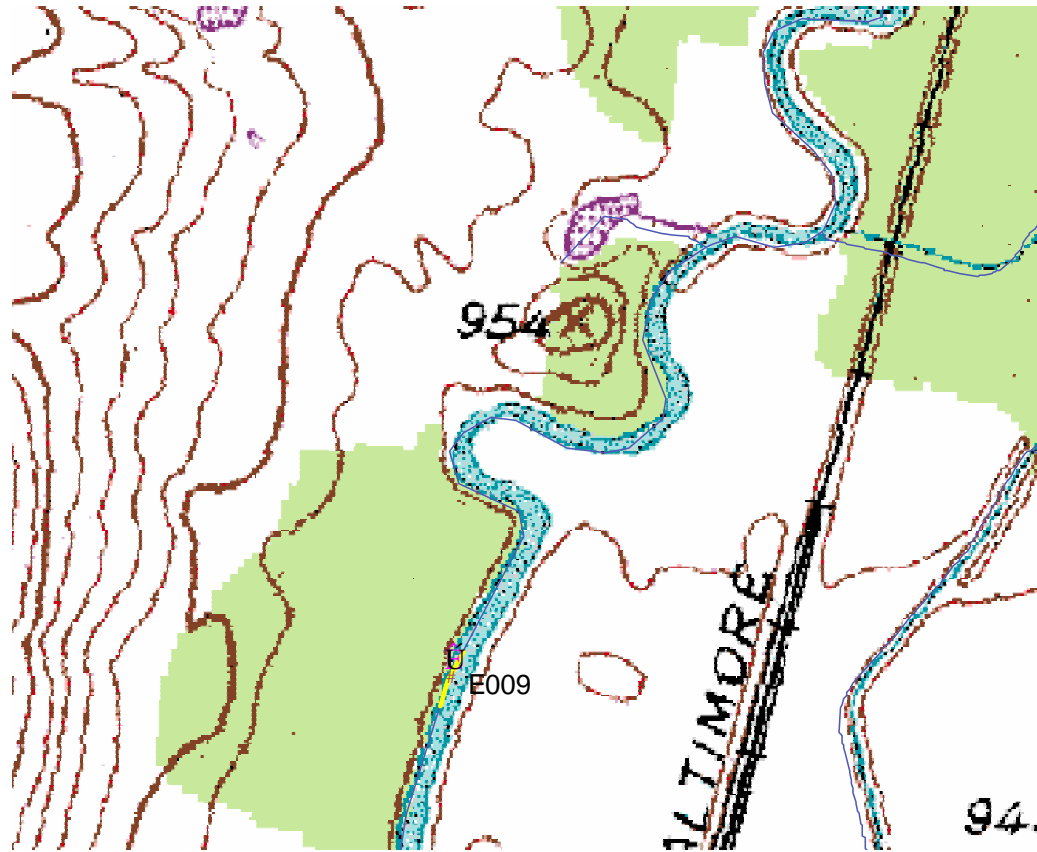
At erosion point E009, sediment has collected on the right side of the creek forcing water towards the left side. This has caused slight erosion of the left bank.

At all points displayed, there is sediment that has collected on one bank, forcing water over to the opposite bank. This in turn is causing increased erosion.

At erosion point E010, the creek is eroding the soil between itself and the road. Erosion Point E015 has arguably the most erosion in this section. About 250 feet of the left bank is undergoing massive erosion.

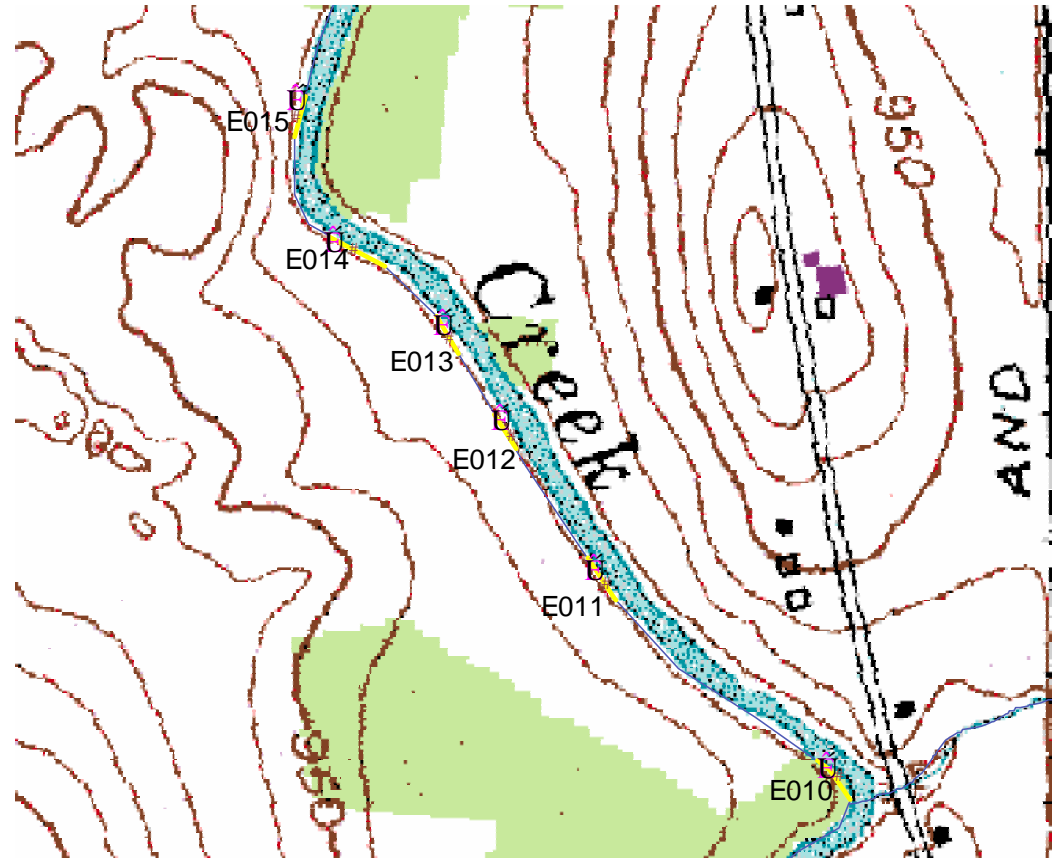
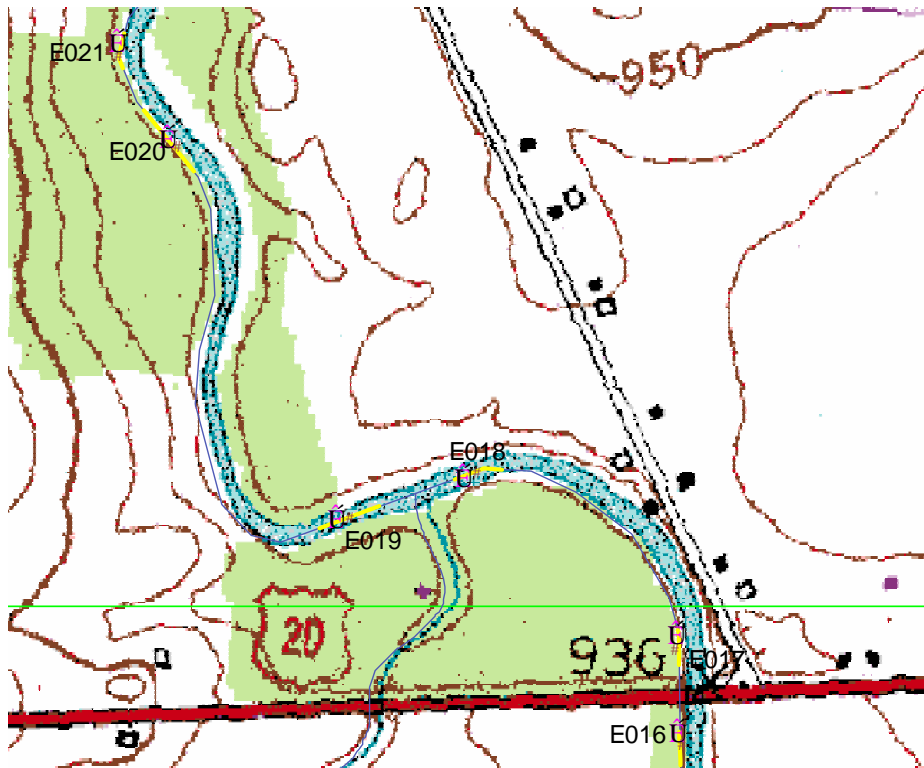
Erosion here is mostly occurring near the bridge. Sediment has collected at erosion points E016 and E017, forcing water to the opposite side of the collected sediment.

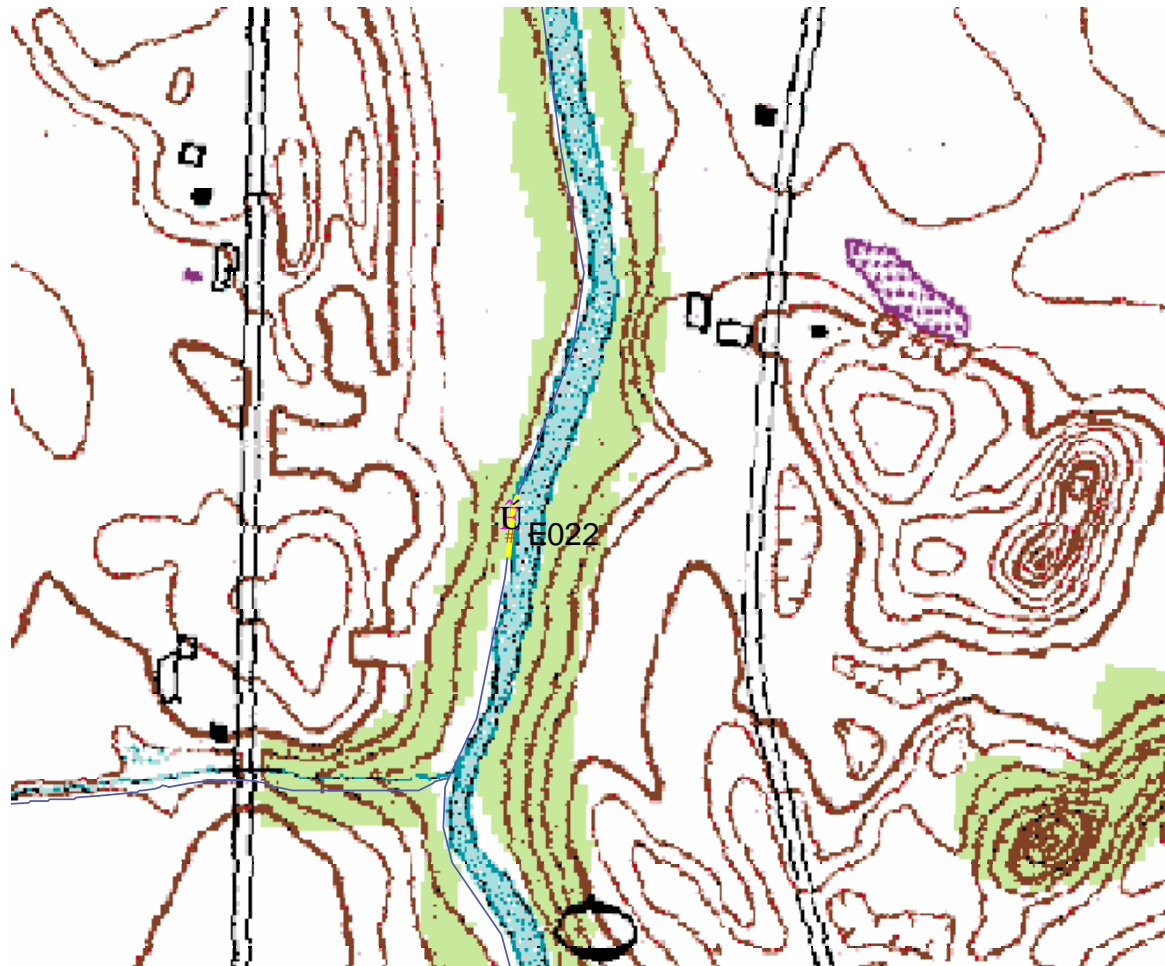
Along this portion of the creek, specifically E022, both the left and right bank are very steep. This is of course a result of erosion.

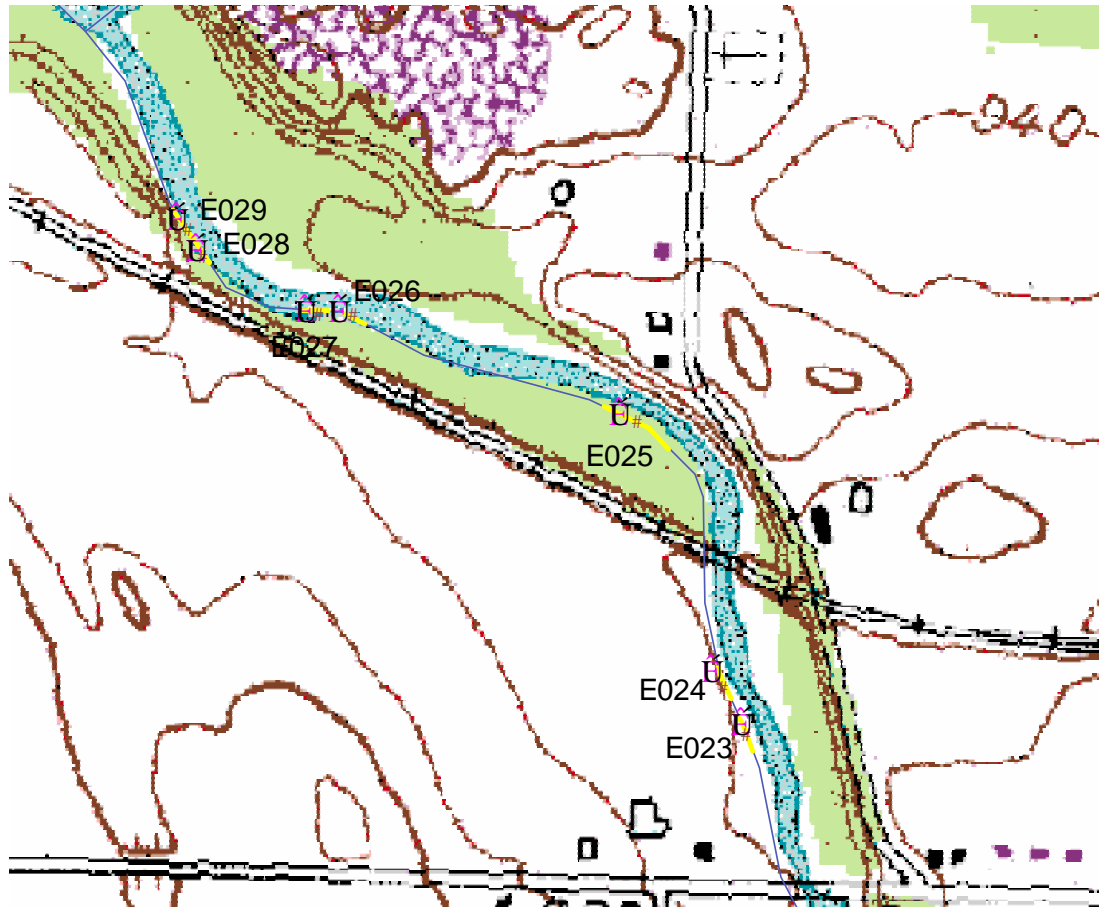
In this section there are no erosion points of immediate concern. Most erosion is a result of deposition along the banks which forces water towards the other bank.

At erosion points E030 and E031, erosion is occurring on the left bank. The right bank of E032 is undergoing erosion.

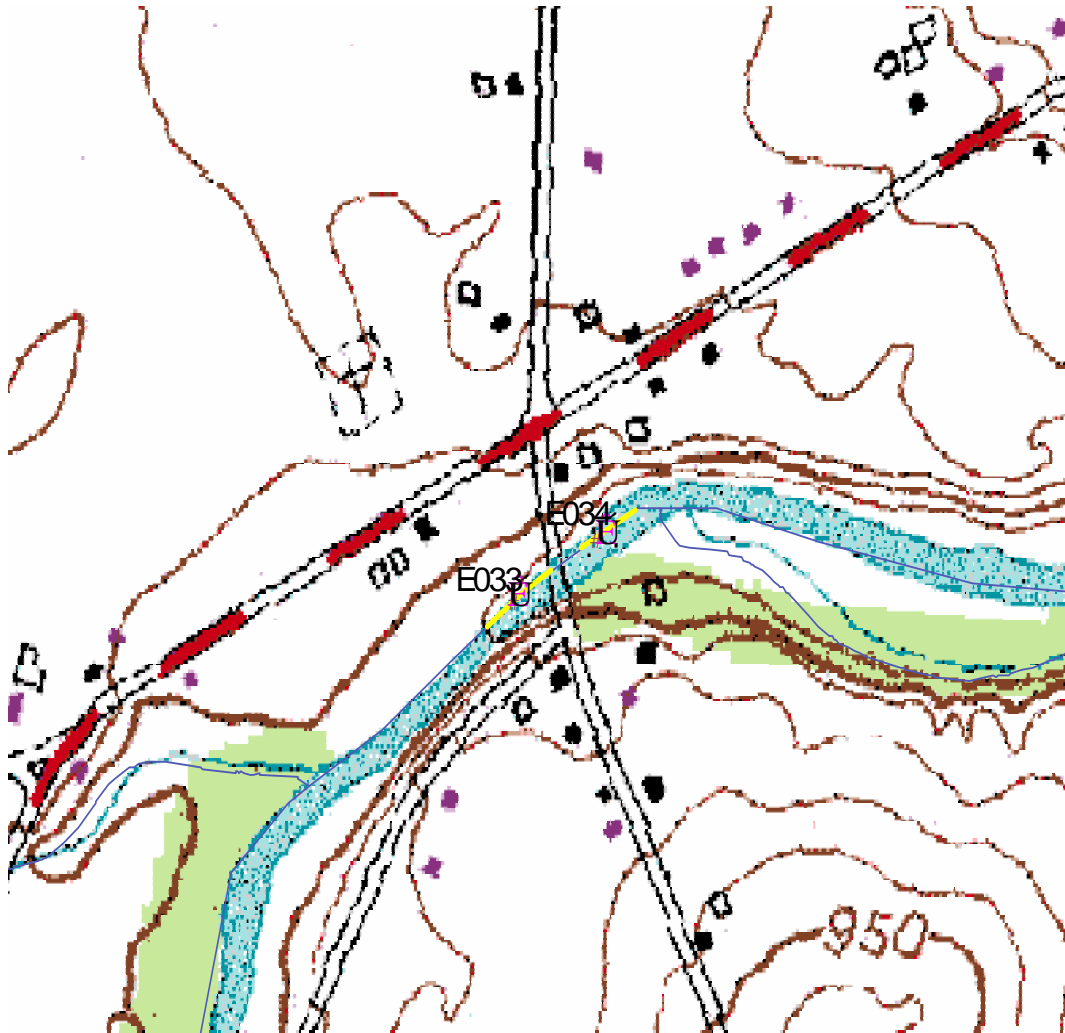
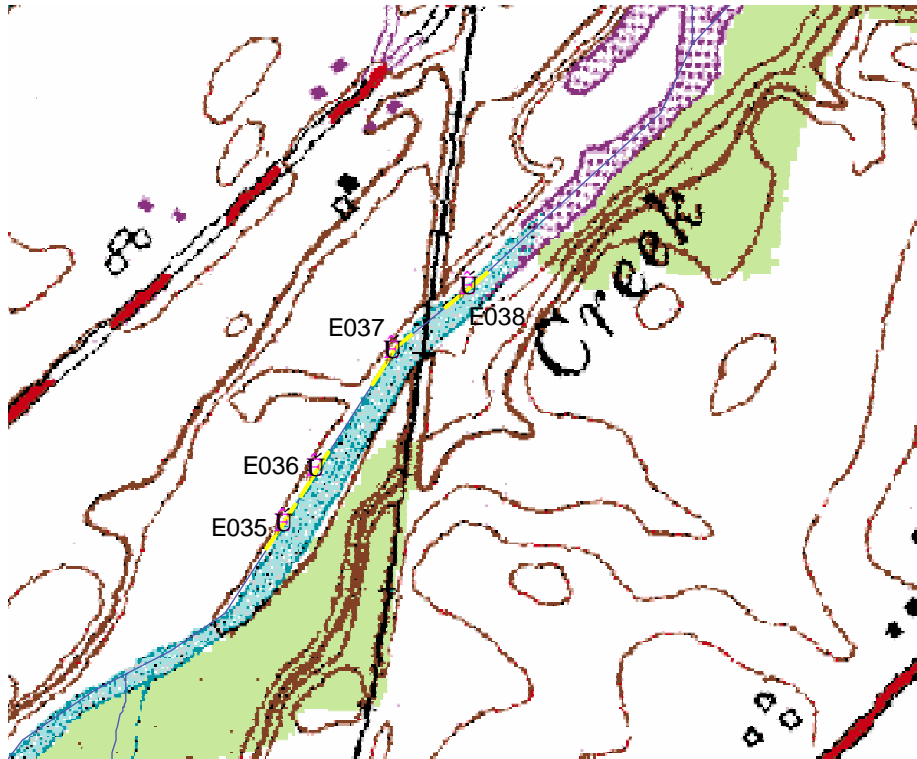
Most erosion in this area is near the railroad tracks.

At erosion point E036, the right bank slope is very steep.

Near the railroad bridge, at erosion points E037 and E038, erosion is also occurring.

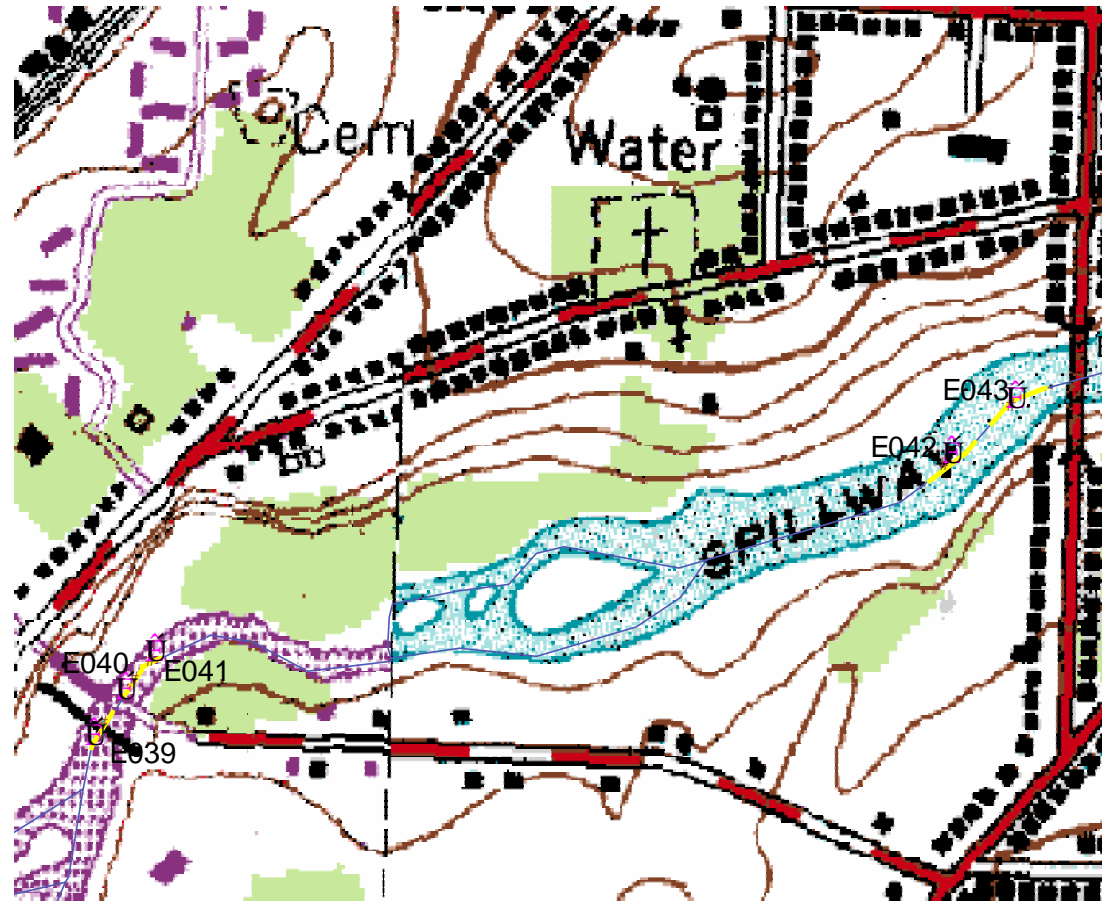
The erosion that is occurring in this section can be attributed to the lawn mowing practices of residents. As a result, erosion has made the left and right banks steep in this area.

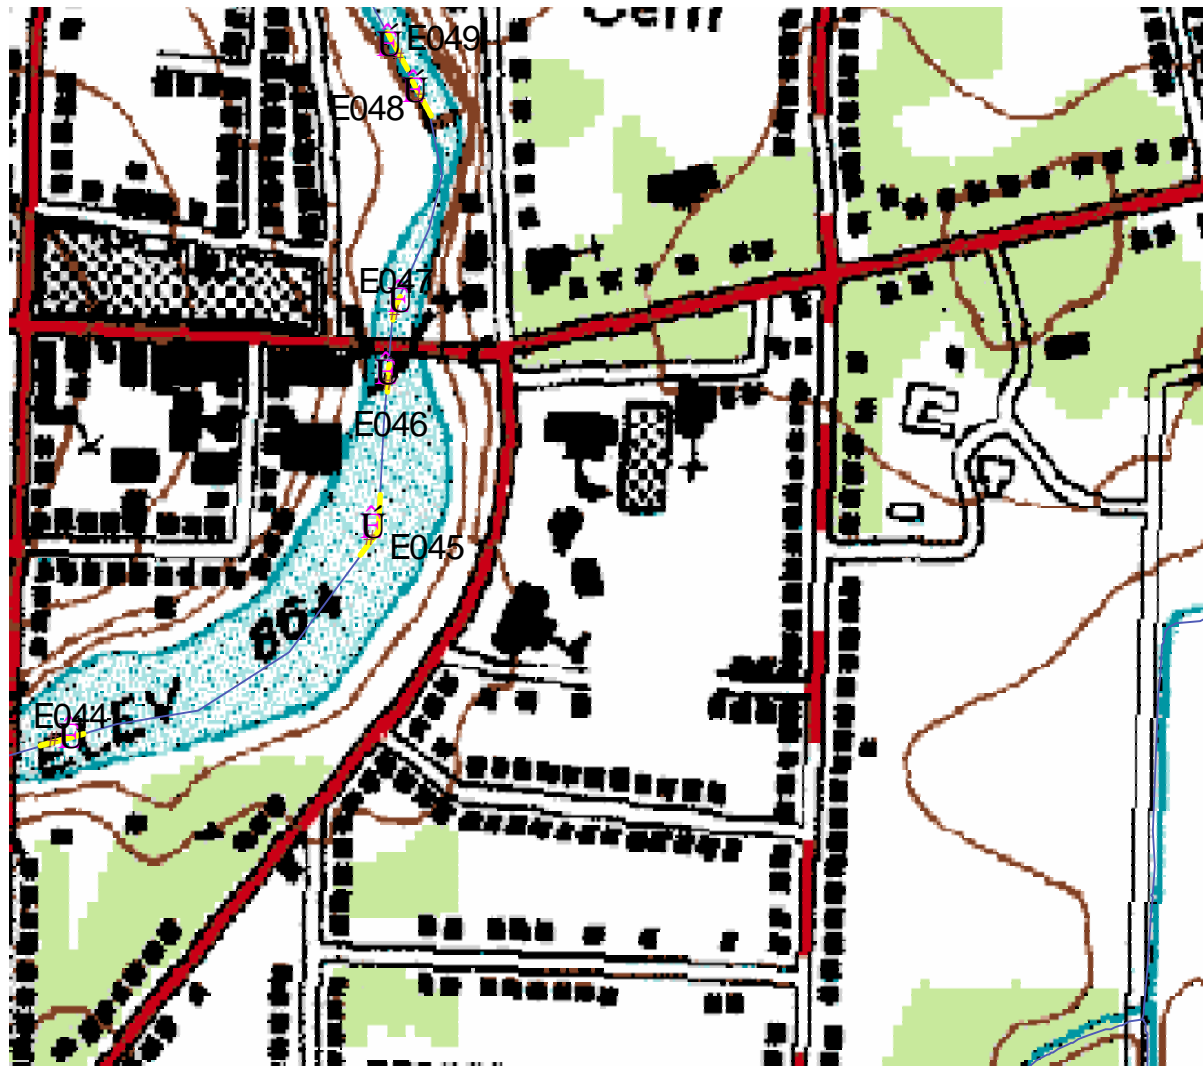
This section is also experiencing increased erosion due to lawn mowing practices.

At erosion points E046 and E047, buffers are forcing water over to the opposite side, leading to increased erosion.

Banks in this section are very steep. At erosion point E048, several trees appear as if they may soon fall into the creek.

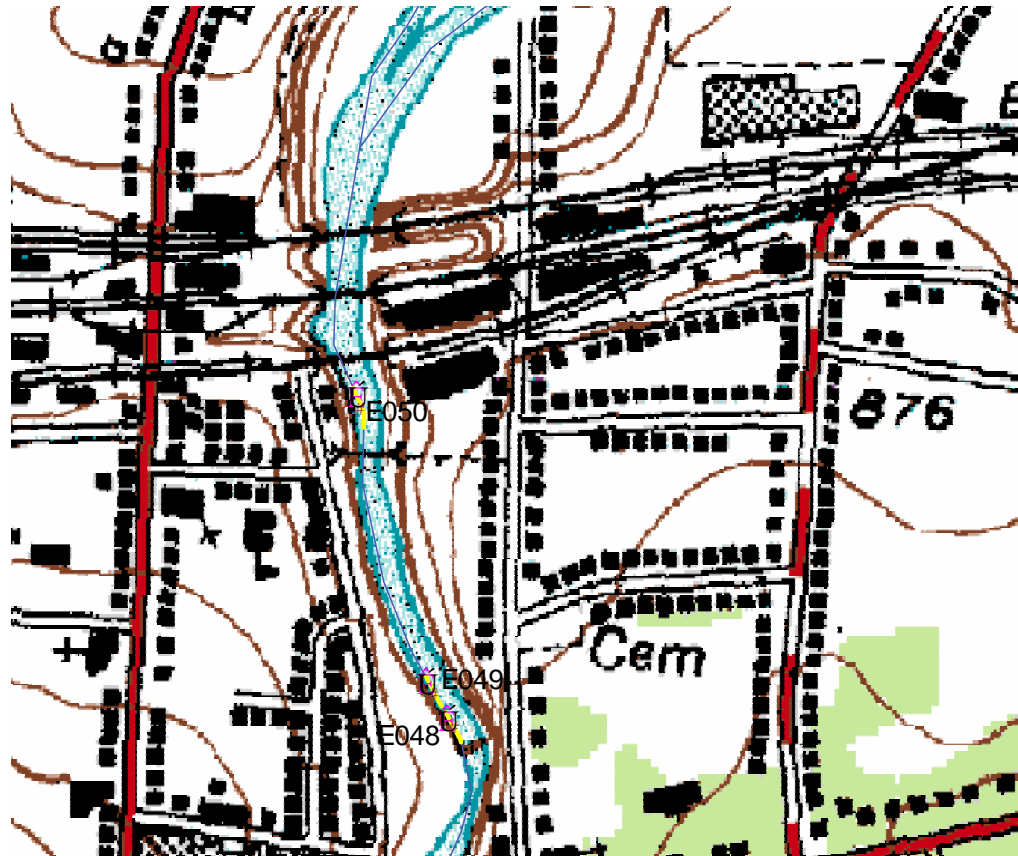
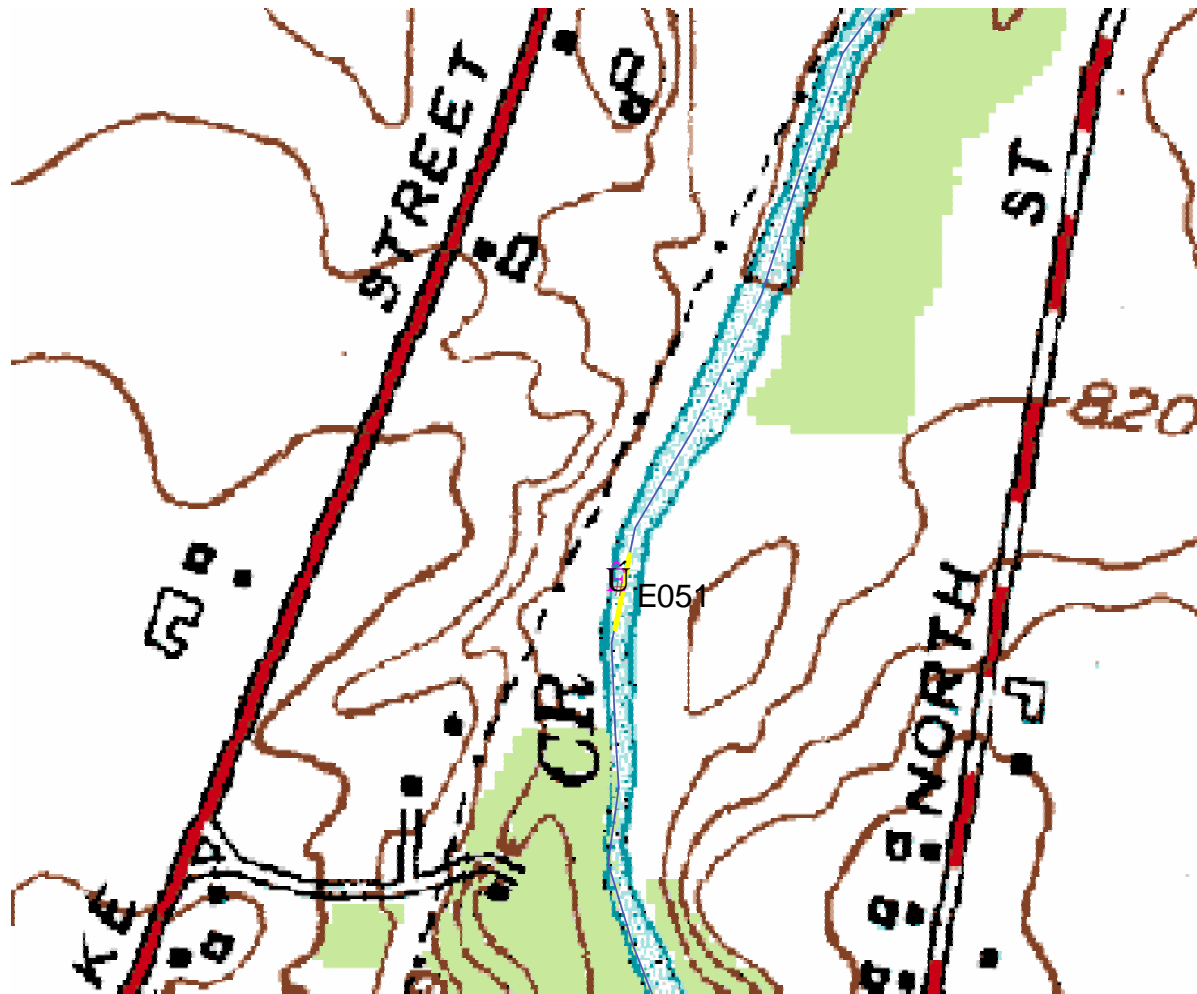
Erosion point E051 is experiencing erosion as a result of debris near the left bank. The most erosion is occurring on the right bank as a result.

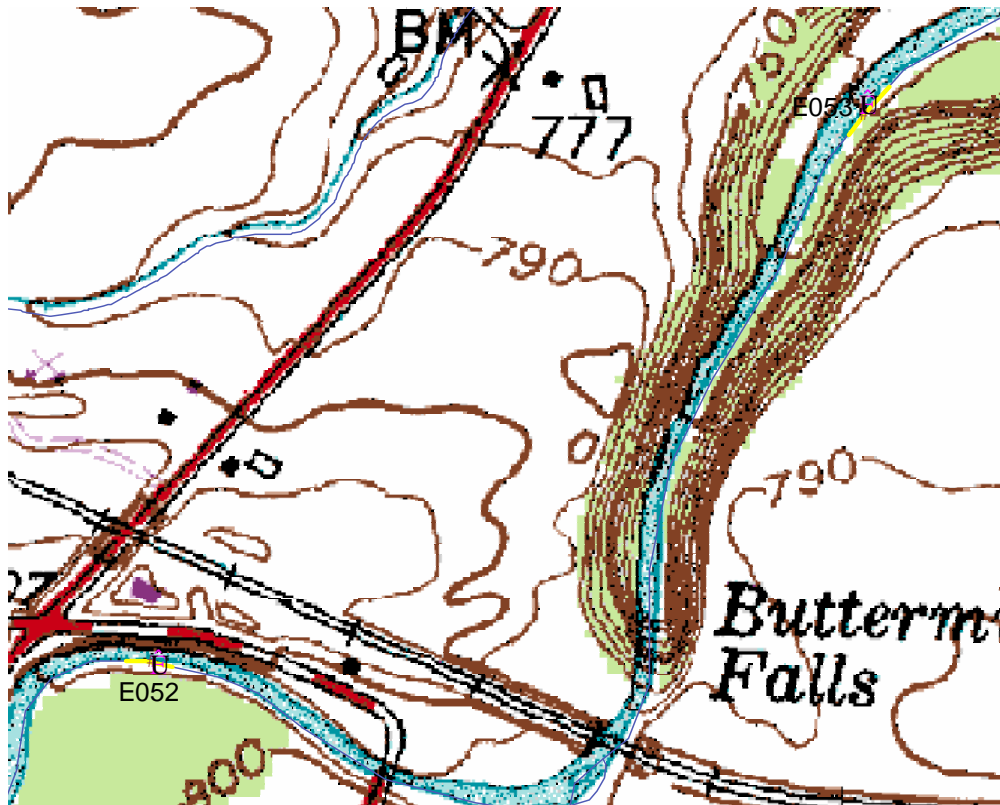
At erosion point E052, erosion is occurring along the left bank, near the road.

At erosion point E053, the right bank is undergoing massive erosion. There also exists the potential for logs jams at this erosion point.

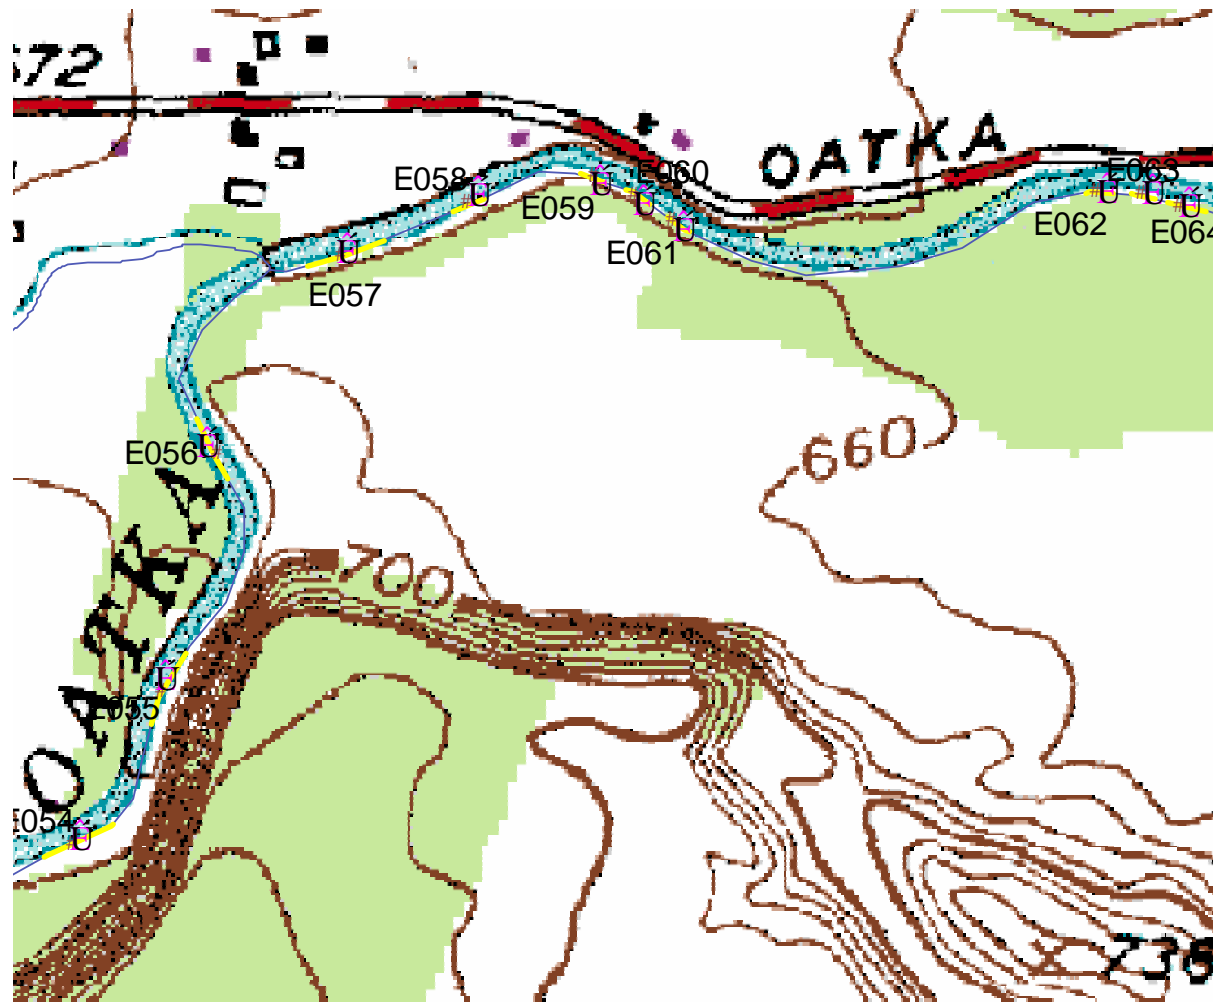
Between erosion points E054 and E058, there are several log jams and trees that can potentially fall into the creek, resulting in log jams.

At erosion points E061 and E062, the creek is eroding the soil closest to the road, creating a problem in the future.

At erosion points E065 and E066, erosion is occurring on the right banks.

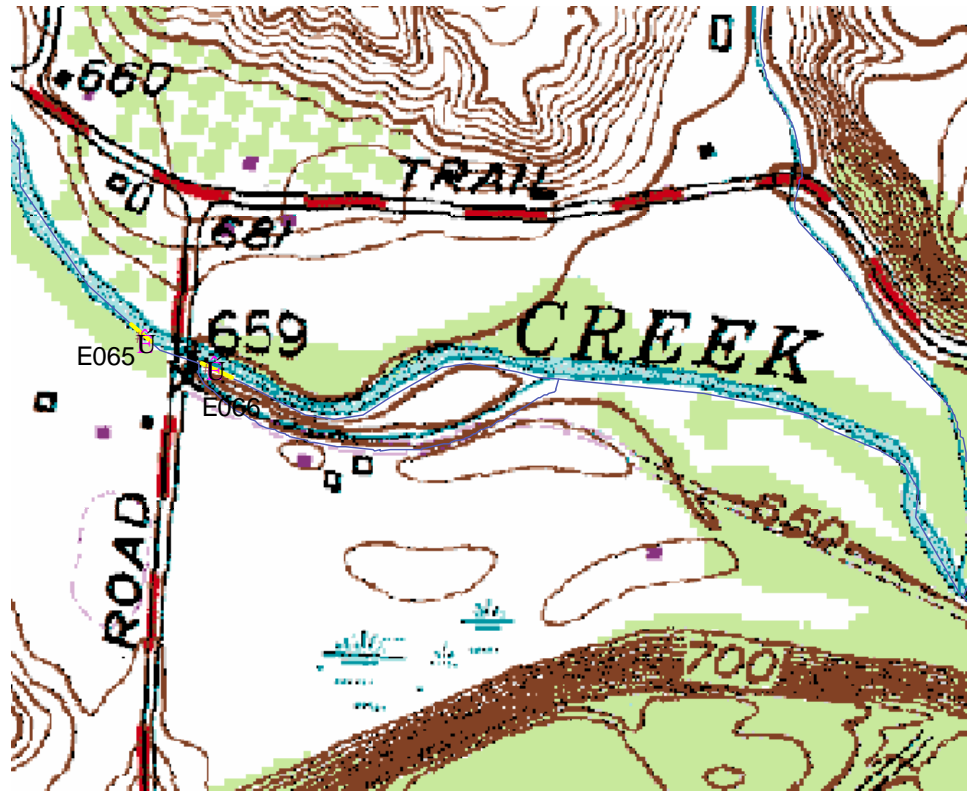
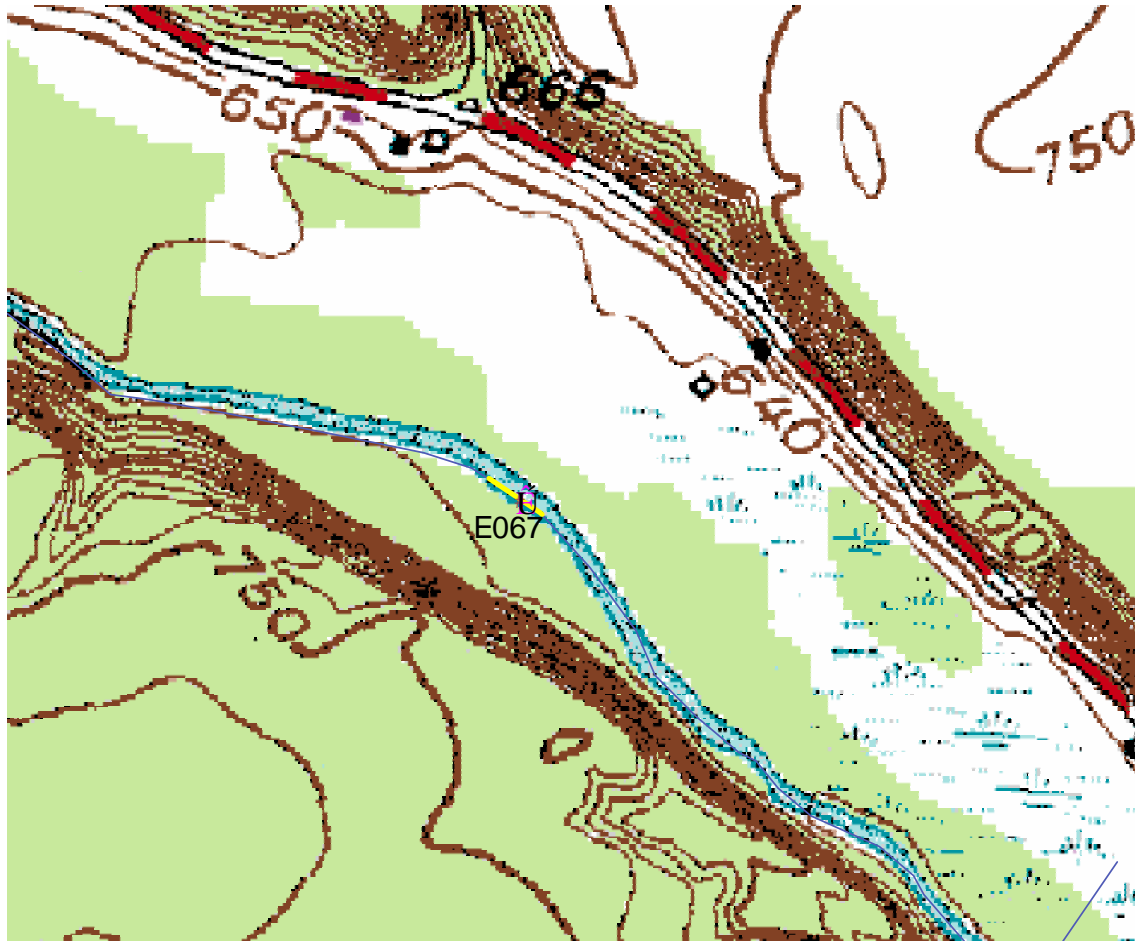
Here, at erosion point E067, the right bank is undergoing the most erosion. However, it should be noted that both banks are very steep in this area.

The left bank of erosion point E068 is experiencing erosion. Here, the creek is getting close to the road.
