Genesee & Wyoming Counties Joint Flood Mitigation Plan

August 2003

This Report Was Prepared For:
Genesee County Emergency Management Office

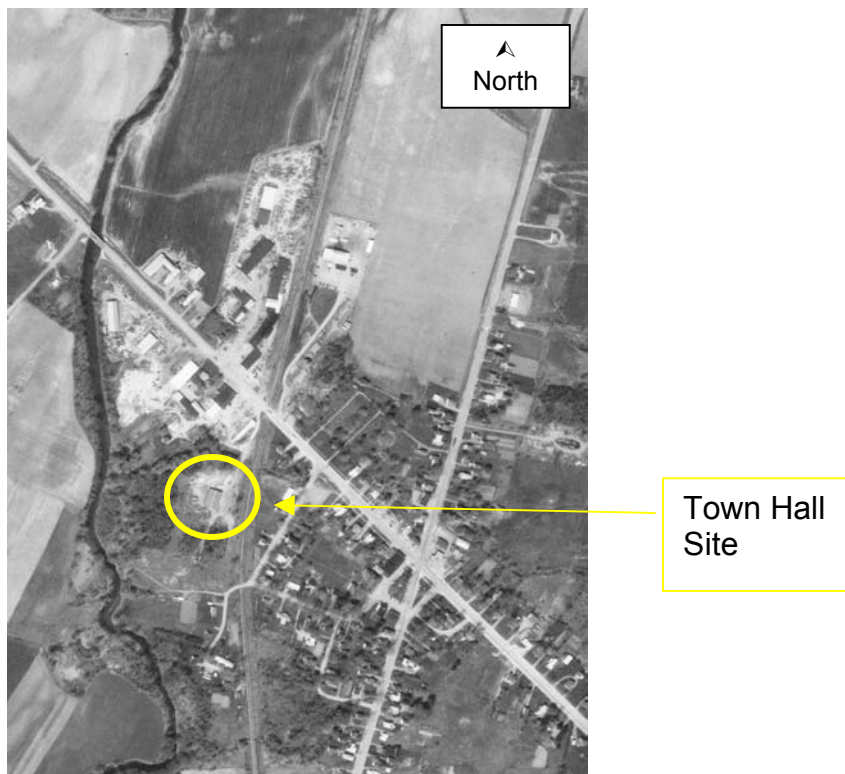
Figure 4.2d. Pavilion Town Hall Site, 1968

The Town Hall building is present on the 1968 photo. It is located approximately 150 feet south of the tributary stream and 900 feet north of Oatka Creek. The area immediately adjacent to the Town Hall site remains in deciduous woods. Development continues on the Hansen site and other adjacent properties.

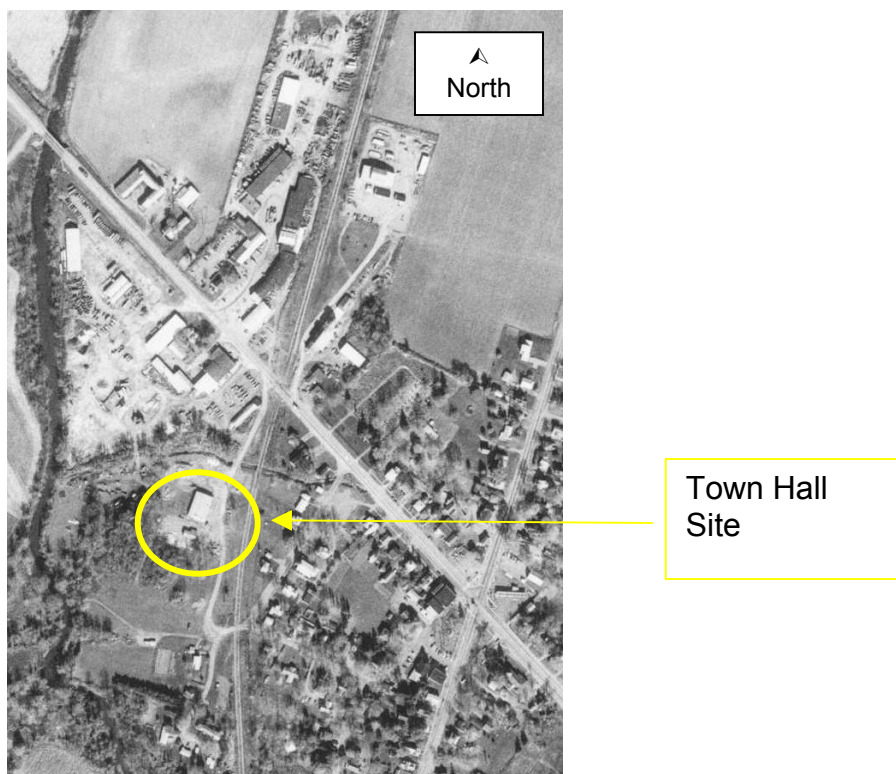
Figure 4.2e. Pavilion Town Hall Site, 1974

In 1974, a second smaller building is evident on the Town site. Deciduous woods around the site has been cleared. The tributary channel is quite prominent in this photo, possibly because the tree canopy was cleared. A new road has been constructed from the developed area north of the site, across the tributary channel to a parking area, adding another culvert crossing. The tributary appears to be piped in the vicinity of some houses near Rt. 63.

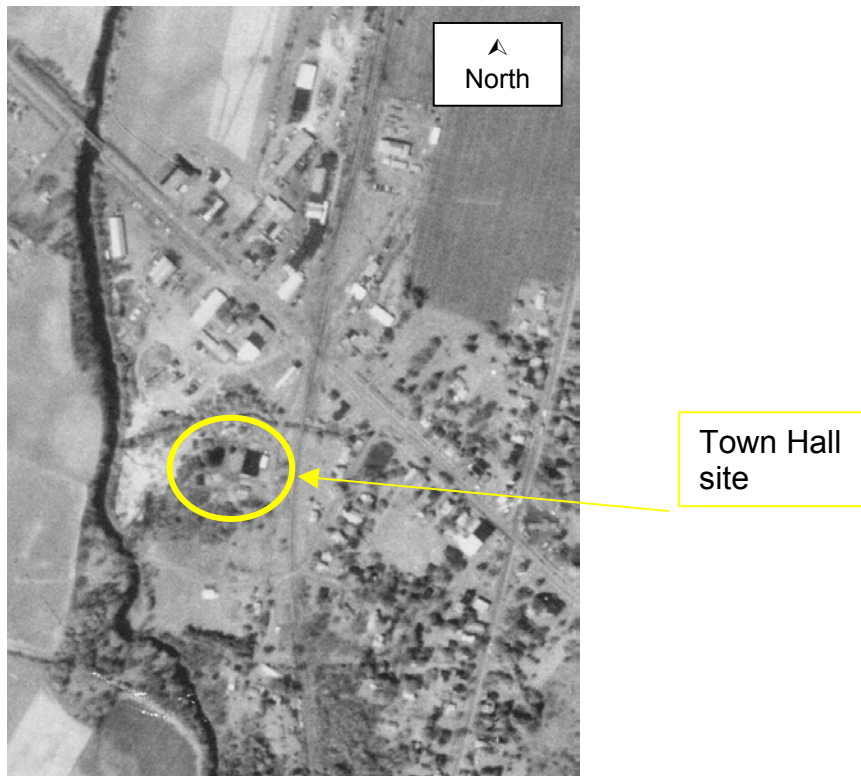
Figure 4.2f. Pavilion Town Hall Site, 1985

In 1985 an addition is visible on the Town Hall/Garage building. The tributary stream channel is developing a tree canopy.

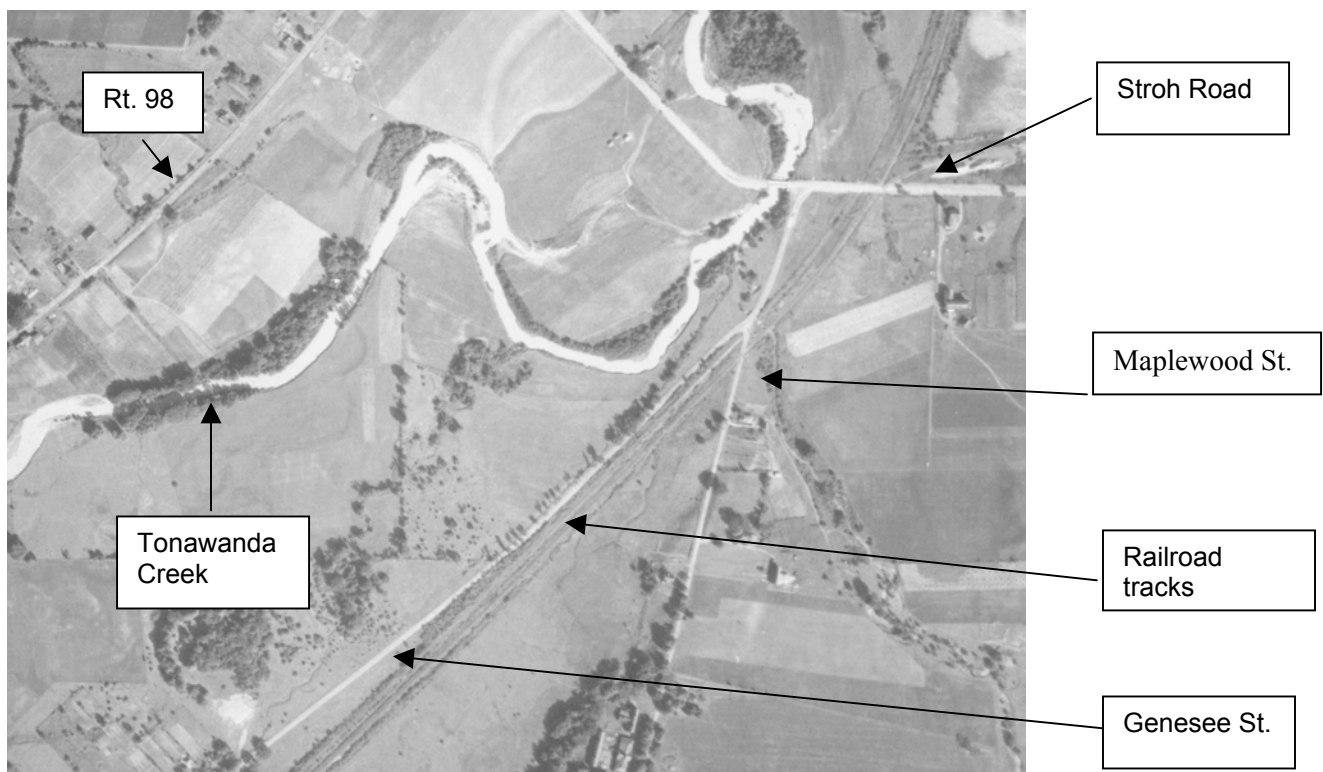
Figure 4.3a. Maplewood and Genesee Streets, Town of Alexander, 1938

In 1938, three homes are located within 1000 feet of the culvert under Maplewood Street. After the tributary passes under the railroad tracks, it then passes under a side street and then the intersection on Maplewood and Genesee St before joining the Tonawanda. The confluence is approximately 540 feet south of the bridge on Stroh Road.

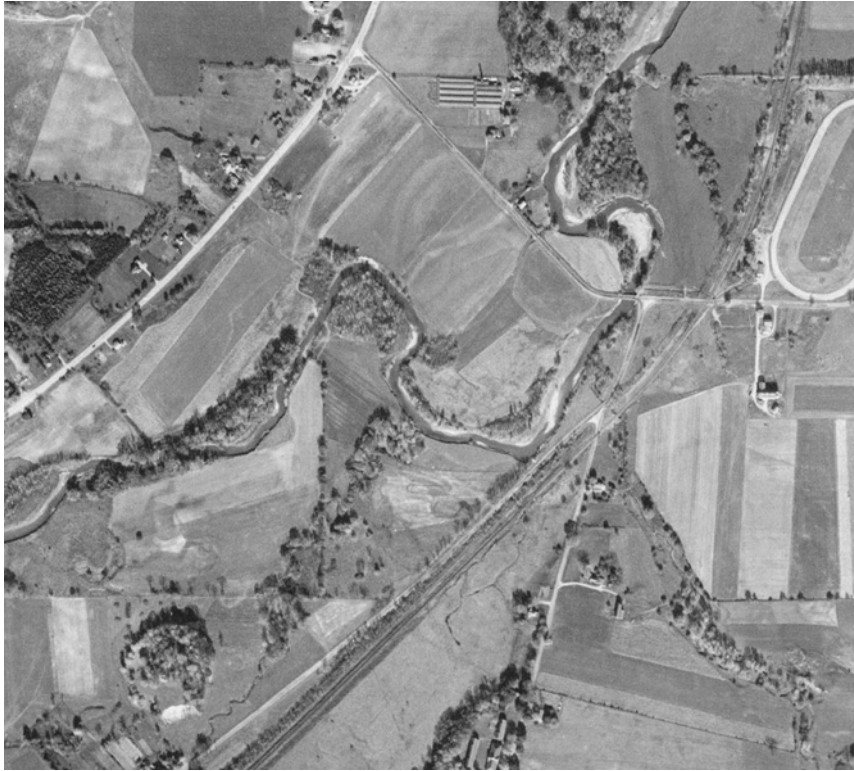
Figure 4.3b. Maplewood and Genesee Streets, Town of Alexander, 1954

In 1954 there are still only 3 houses within 1000 feet south of the Maplewood St. culvert. Several small drainage ditches are located in the field in between Genesee and Maplewood St. From 1954 to 2002, the number of houses within 1000 feet of the Maplewood Street culvert does not change.

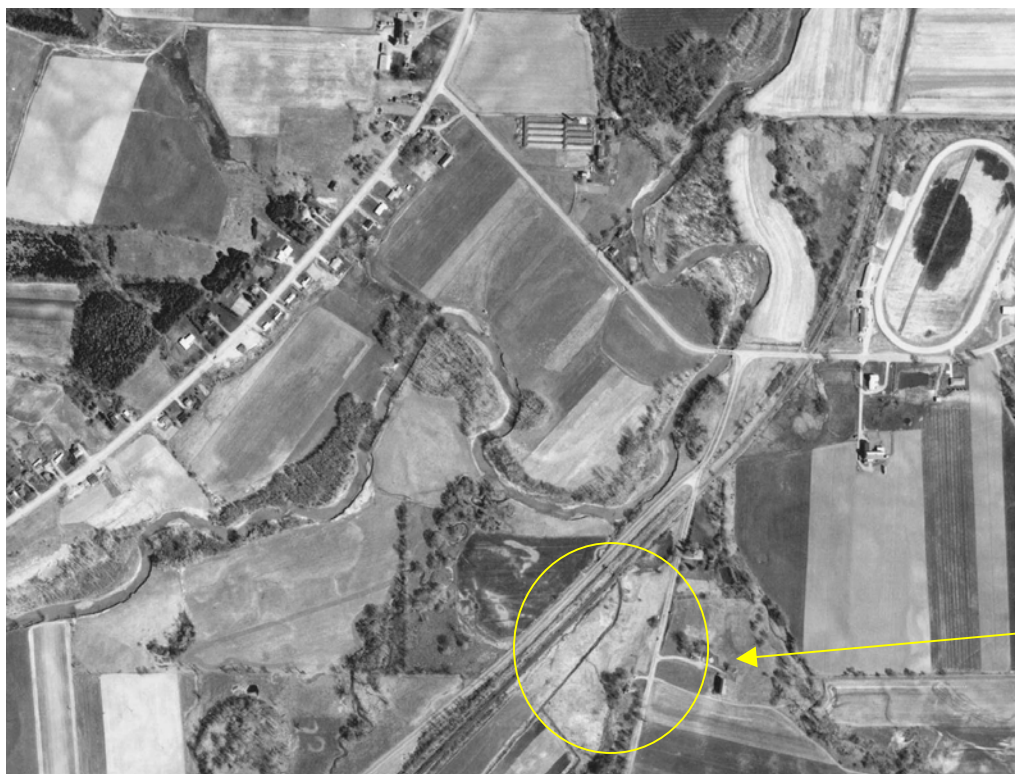
Figure 4.3c. Maplewood and Genesee Streets, Town of Alexander, 1968

In 1968 the field between Genesee Street and Maplewood Street has been drained by constructing ditches around the field and creating a straight drainage ditch from Genesee Street into the Tonawanda.

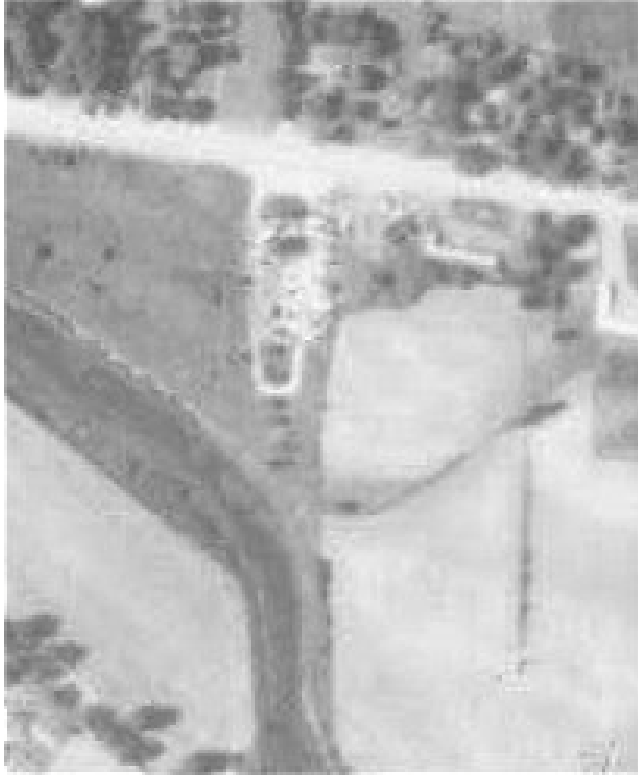
Figure 4.4b. West End Trailer Park, Town of Batavia, 1963

The 1963 photo shows approximately 15-20 mobile homes on the site. The channel is lined with mature deciduous trees. The closest mobile home is approximately 230 feet from the channel top of bank.

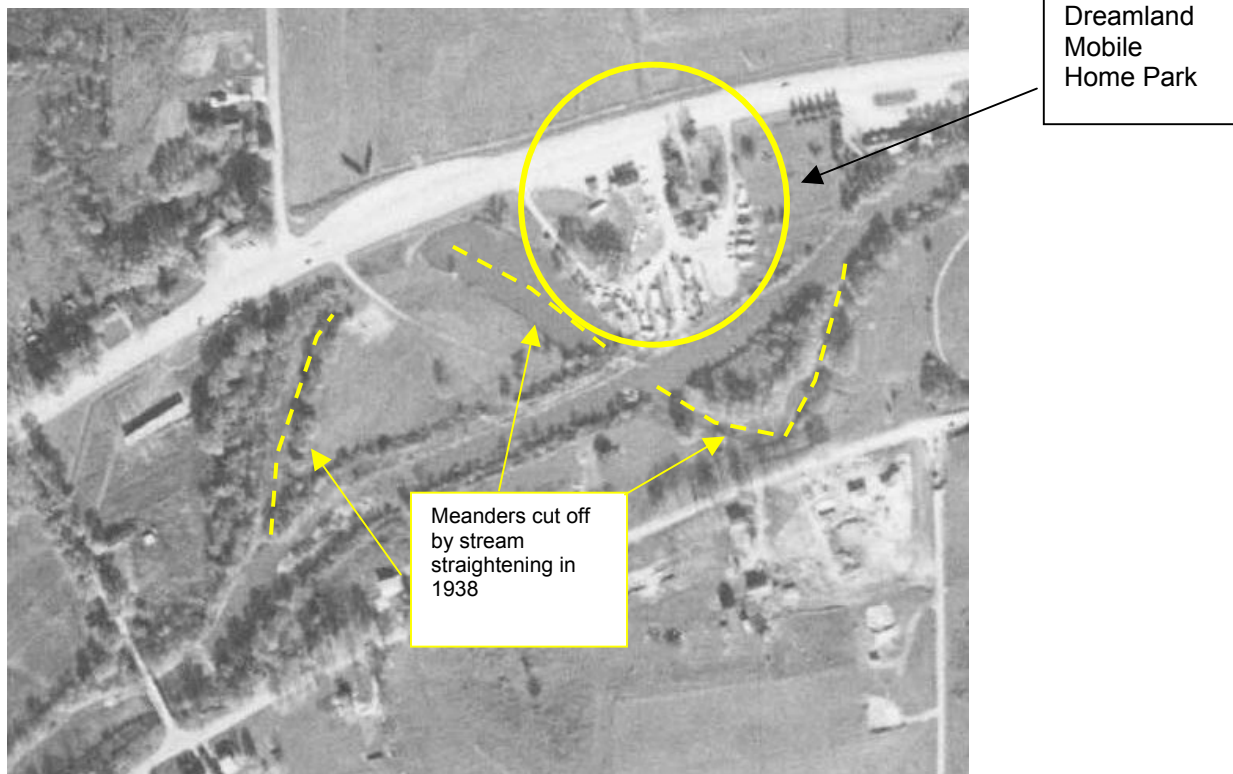
Figure 4.5b. Dreamland Mobile Home Park, Town of Batavia, 1954

The 1954 air photo shows a cul-de-sac road that serves the mobile home development. This road comes within 90 feet of the northern top of bank of Tonawanda Creek. Approximately 17 mobile homes are evident in the photo. The north bank of the creek is either mowed or unvegetated in the vicinity of the mobile home development. The south bank shows a line of young deciduous trees and shrubs. The old meander forms a pond on the west side of the mobile home development. Vegetation around this pond is mowed lawn.

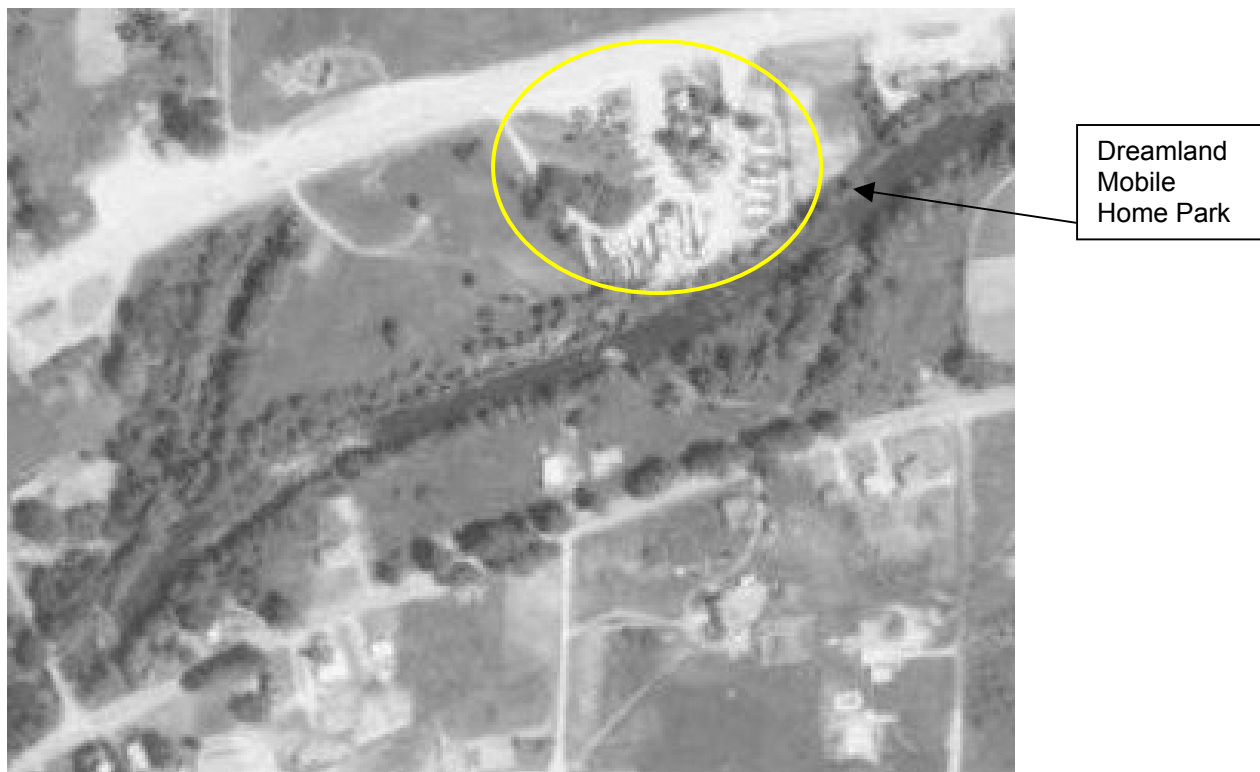
Figure 4.5c. Dreamland Mobile Home Park, Town of Batavia, 1963

The 1963 air photo shows some expansion of the road system serving the development. The meander pond is still evident. Approximately 20-25 mobile homes are located on the site.

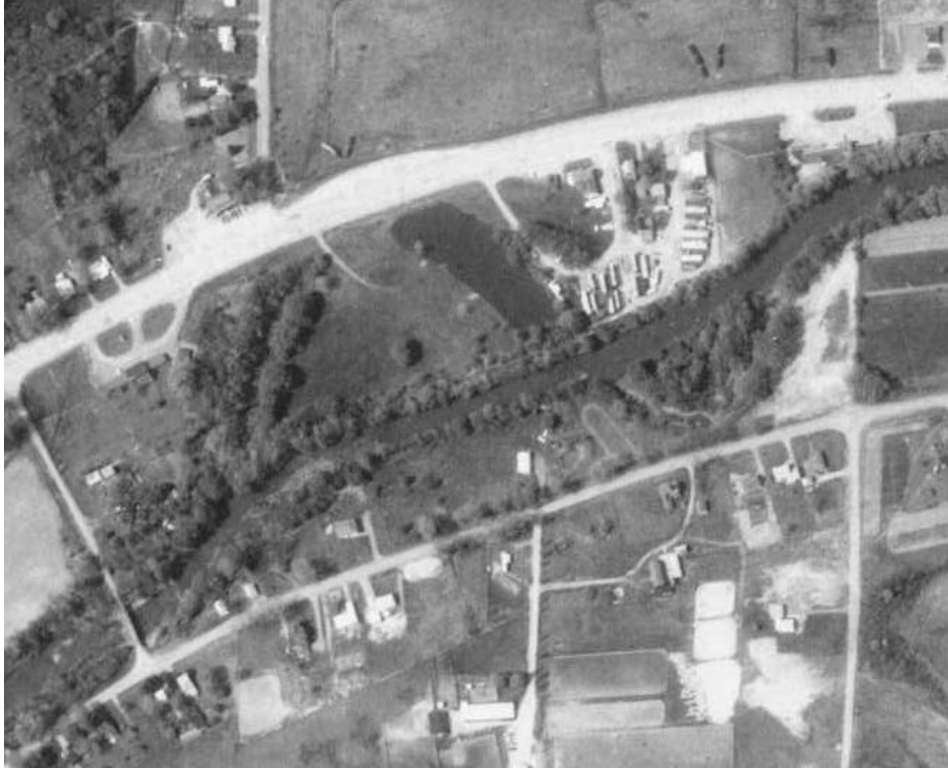
Figure 4.5d. Dreamland Mobile Home Park, Town of Batavia, 1968

The 1968 air photo shows approximately 21 mobile homes on the site. The stream configuration has not changed appreciably since the 1963 photo. The trees along the Tonawanda Creek have developed a larger canopy since 1963. Five mobile homes are located immediately adjacent to the creek bank.

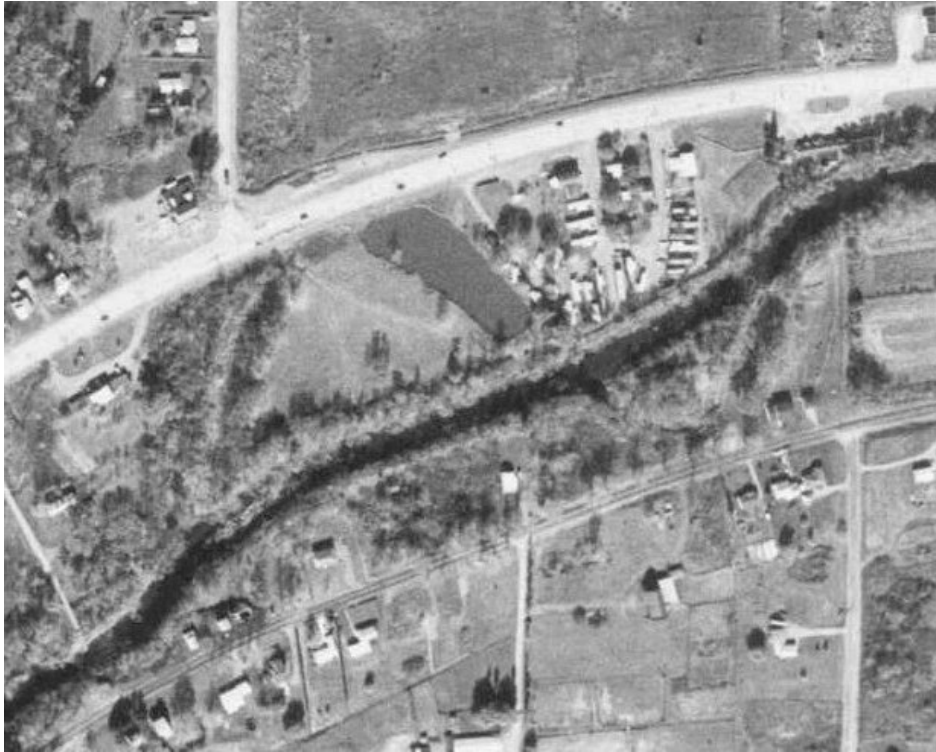
Figure 4.5e. Dreamland Mobile Home Park, Town of Batavia, 1974

Twenty four mobile homes occupy this development in the 1974 photo. Six mobile homes are located within 50-60 feet of the channel top of bank. The channel bank is lined with a continuous canopy of deciduous woody vegetation.

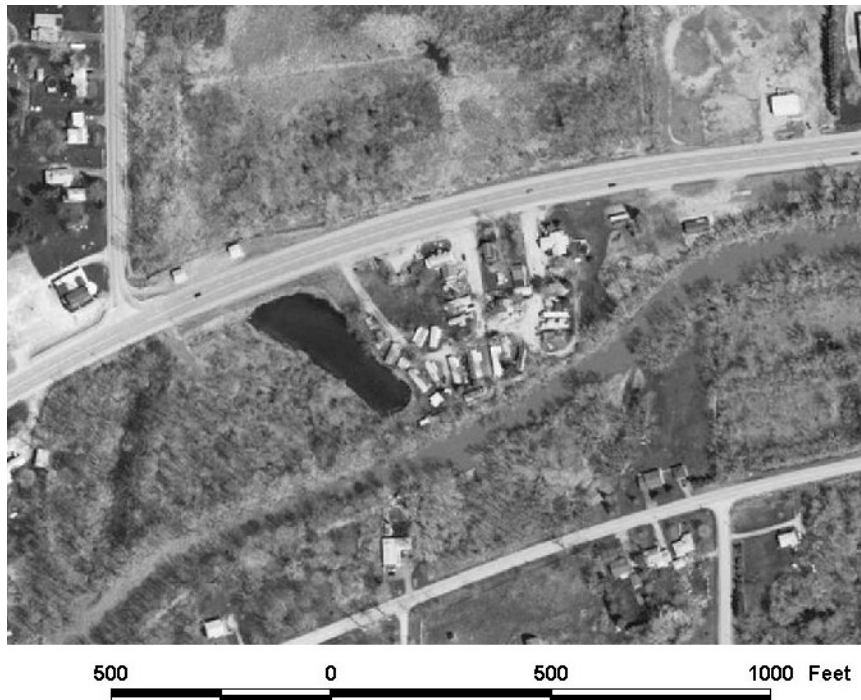
Figure 4.5g. Dreamland Mobile Home Park, Town of Batavia, 2002

In a 2002 air photo, approximately fifteen mobile homes are evident. The nearest homes are approximately 60 feet from the top of the bank. Approximately 7 homes are located immediately adjacent to the creek channel.

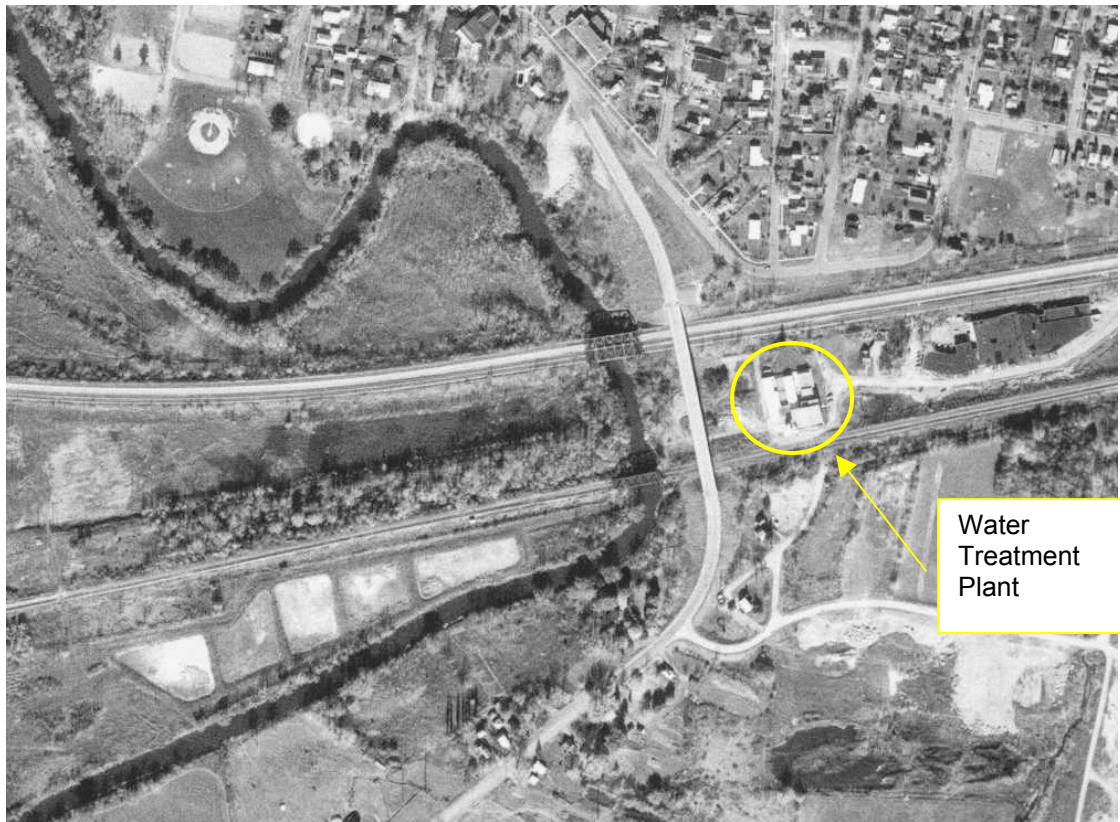
Figure 4.7d. Batavia Water Treatment Plant, 1974

1974 – Some filling is evident on the east bank of Tonawanda Creek approximately 400 feet north of the north railroad track. The plant outfall appears to be in the same location. Plant access appears to be via an underpass under the CSX tracks or an at-grade crossing off Creek Street from the south.

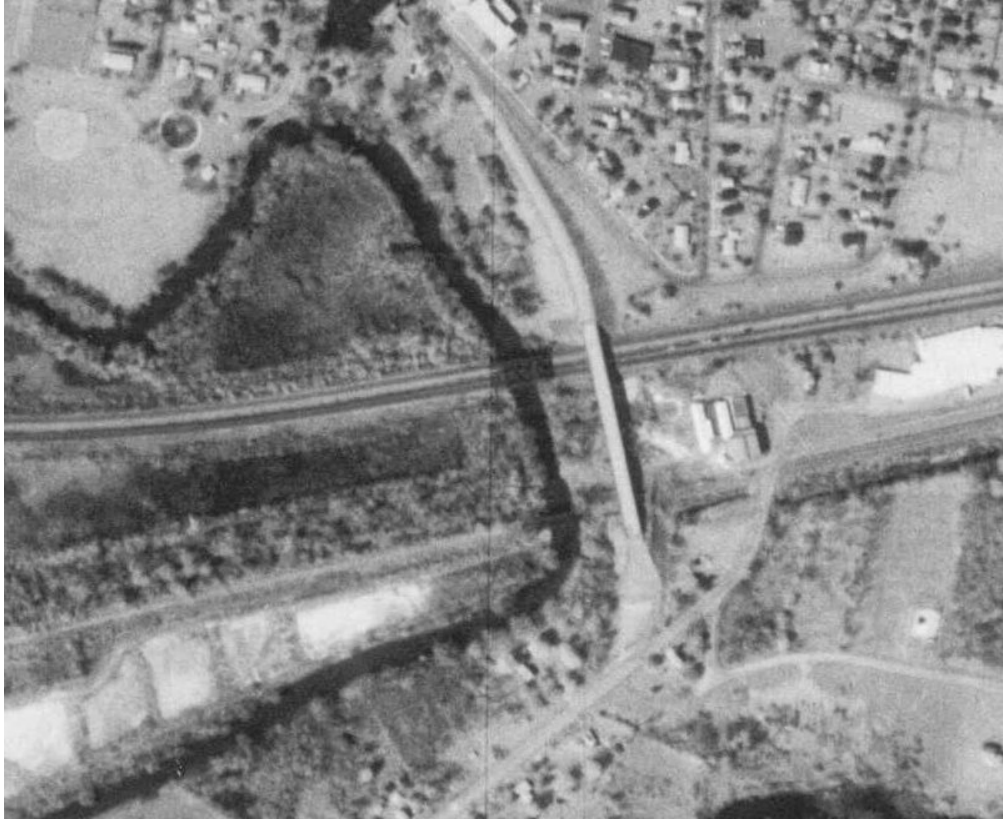
Figure 4.7e. Batavia Water Treatment Plant, 1985

1985 – Plant site appears to consist of four buildings. The outfall previously evident appears to have been eliminated. The overpass road (Creek Street) is still present. Access to the site is via an at-grade crossing off of Creek Street over the southern railroad track. The southern track appears to be unused.

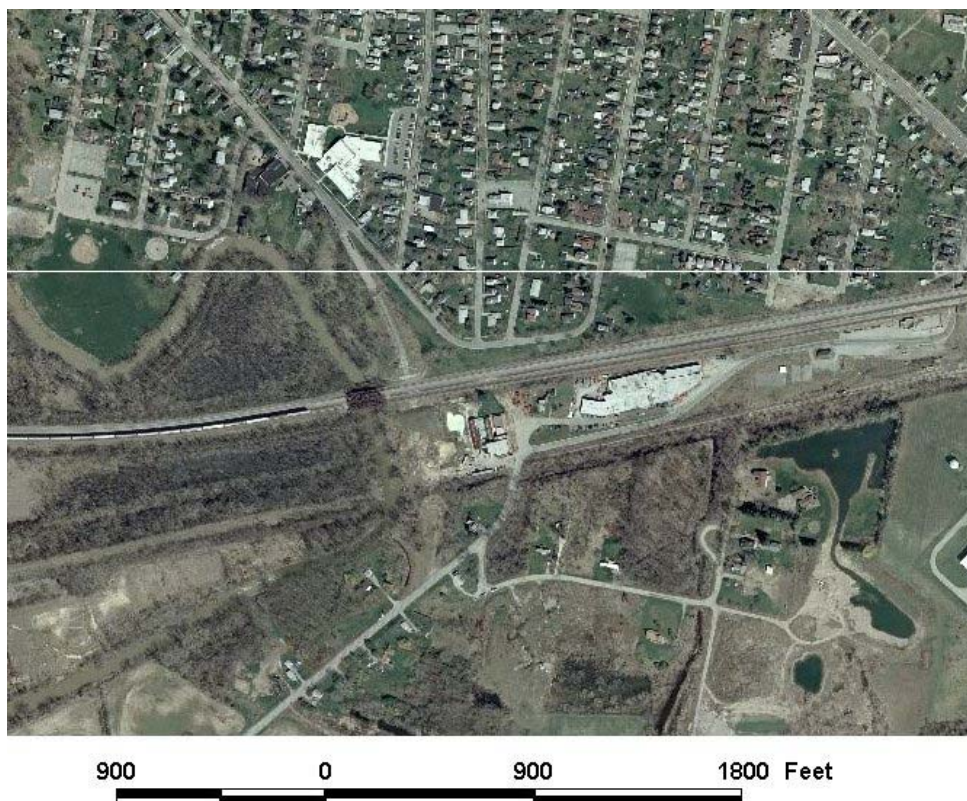
Figure 4.7f. Batavia Water Treatment Plant, 2002

2002 – The overpass road first described in the 1963 photo has been removed. The bridge over Tonawanda Creek for the southern railroad track has been removed. The outfall appears to have been eliminated.

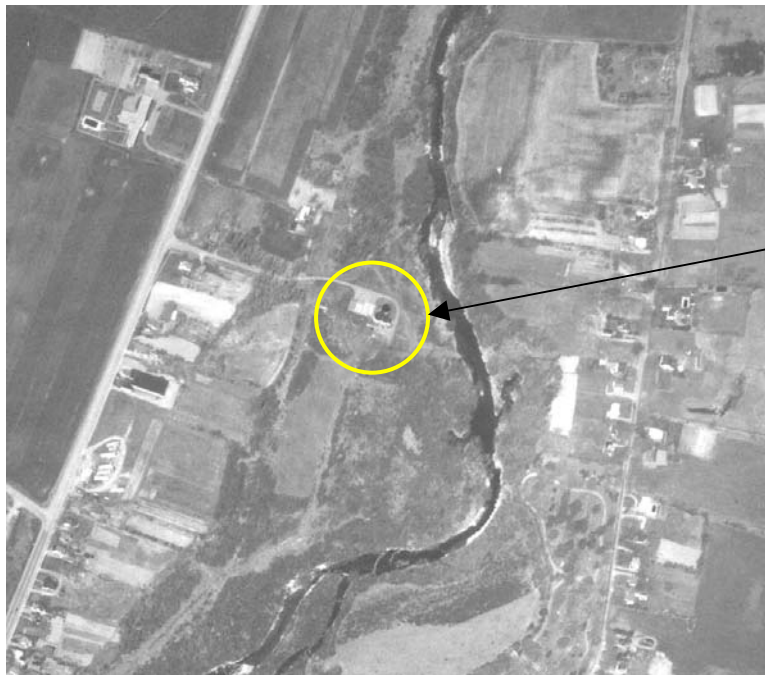
Figure 4.8d. Village of LeRoy Wastewater Treatment Plant, 1968

The 1968 photograph of the site shows an additional digester or clarifier (round structure), and a new building. Trees have been removed on the plant site down to the stream bank. A few trees remain, but not a solid canopy as in earlier photographs.

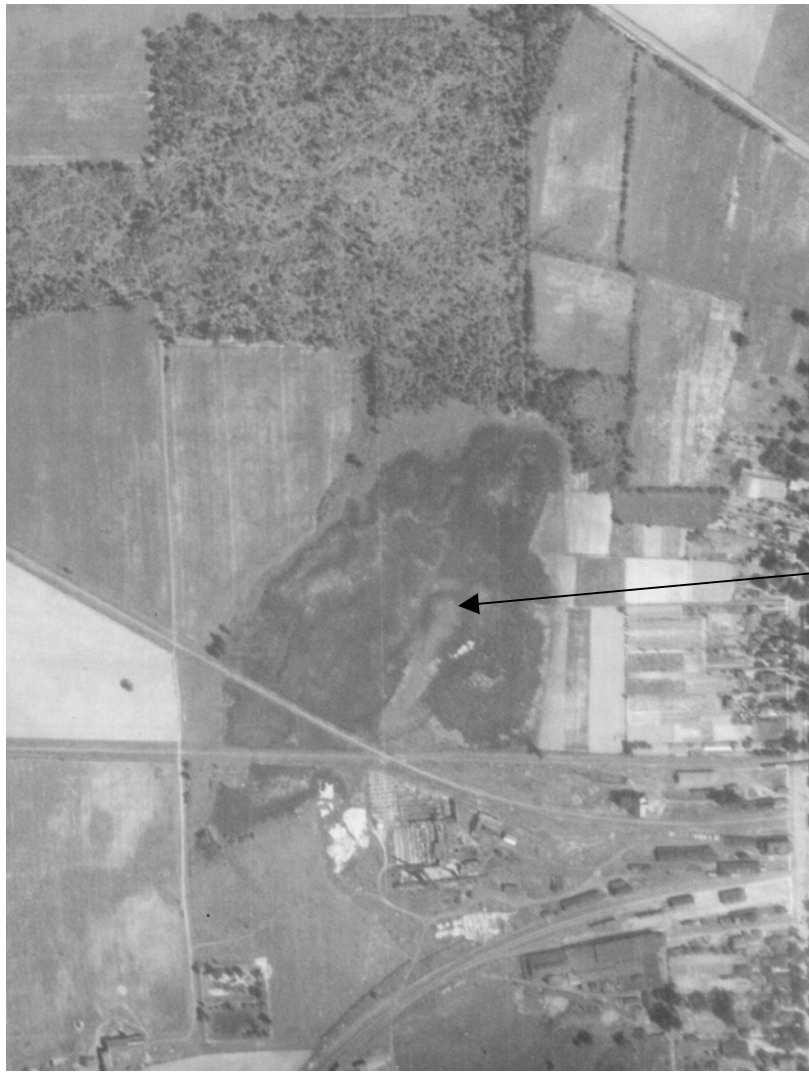
Note large wetland
area north of New
York Central Tracks

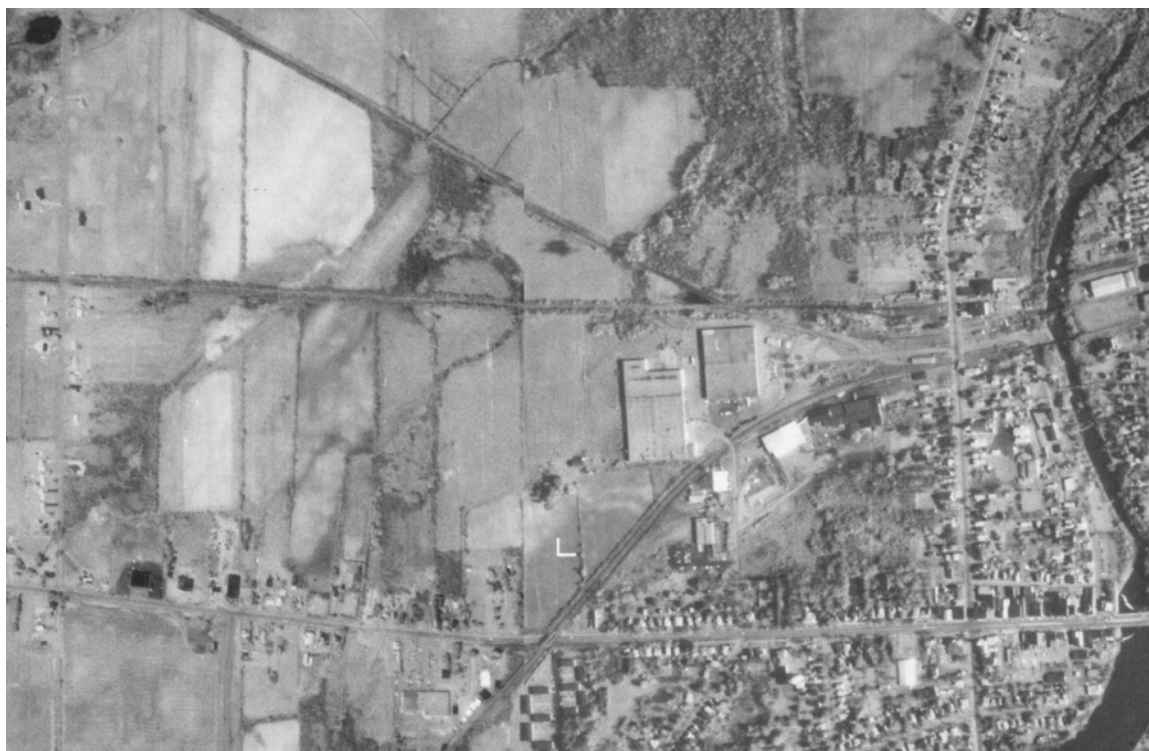
Figure 4.9c. Village of LeRoy Northwest Quadrant, 1985 (composite)

The 1985 photo shows filling adjacent to the unnamed tributary west of the Rite Aid site.

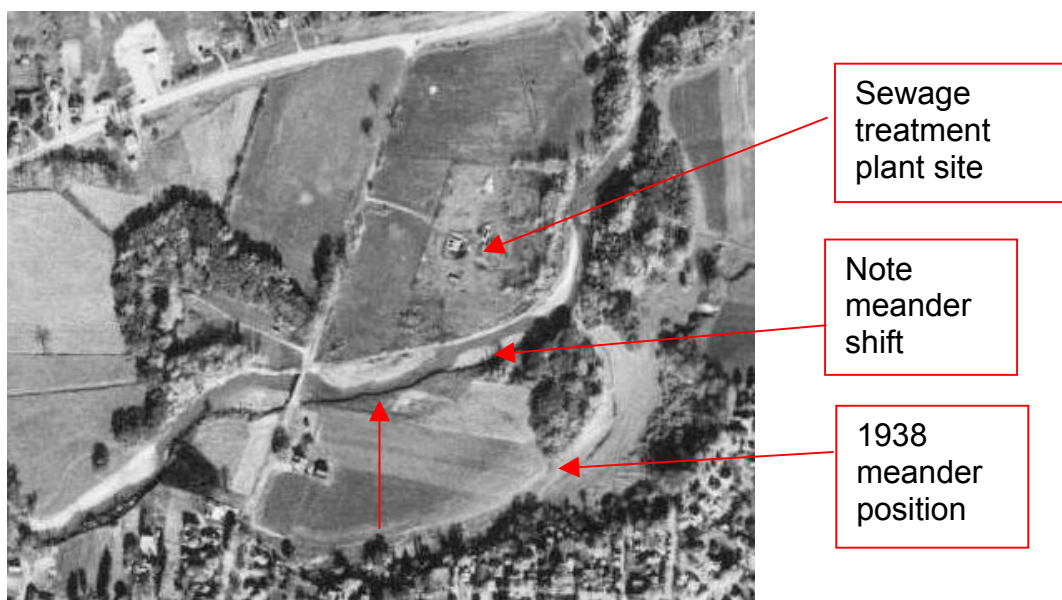
Figure 4.11b. 1954 air photo of Prospect Street and Tonawanda Creek Channel. Note the northward shift in the main channel.

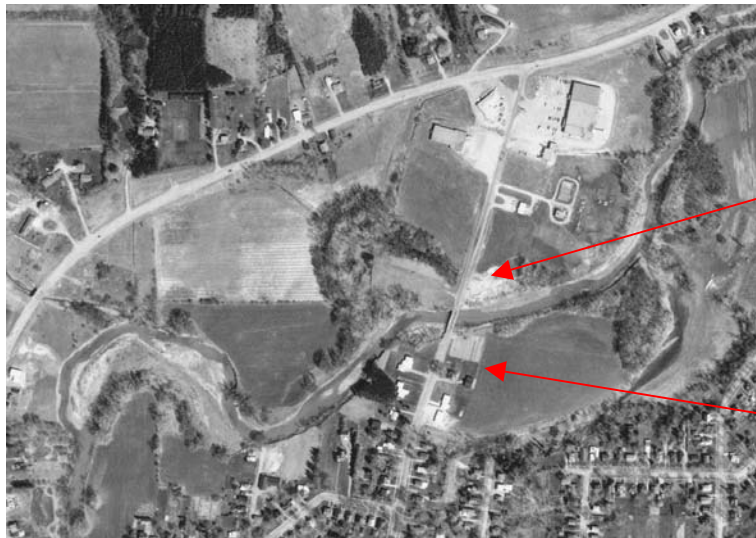
Figure 4.11d. 1968 air photo of Prospect Street Sites.

Note filling at
northeast
quadrant of
Prospect St.
bridge

Note new
development
along
Prospect St.

The 1968 air photo shows a few additional buildings north of Tonawanda Creek in the vicinity of the sewage treatment plant. Five new houses are evident between the old meander channel and the present location of the creek channel. The medical building site shows as an old meander channel. The digester building is approximately 175 feet from the west bank of Tonawanda Creek.

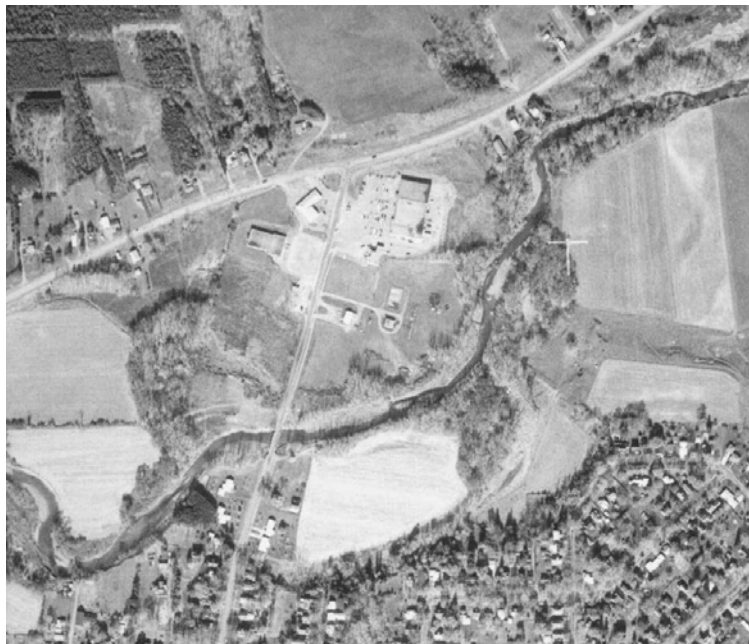
Figure 4.11e. 1974 air photo of Prospect Street sites.

The 1974 photo shows evidence of some filling and clearing on the site of the medical building. The stream channel appears to be moving eastward, away from the digester building on the sewage treatment plant site. The distance between the west bank and the digester has increased to about 300 feet.

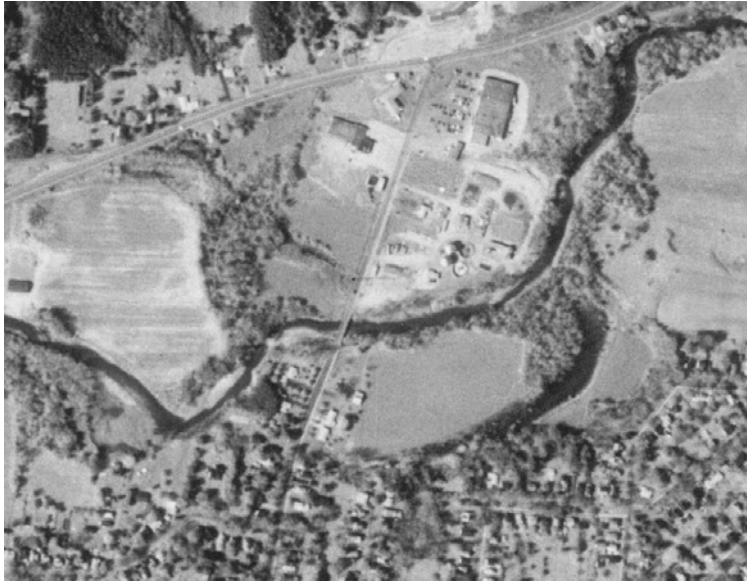
Figure 4.11f. 1985 air photo of Prospect Street sites

The 1985 air photo shows continuing development of the sewage treatment plant site. The channel meandering does not appear to be threatening the sewage treatment plant buildings directly; however, the nearest digester is approximately 140 feet from the channel. The medical building site remains undeveloped.
