Draft
Genesee & Wyoming Counties
Joint Flood Mitigation Plan

Genesee & Wyoming Counties Joint Flood Mitigation Plan

August 2003

This Report Was Prepared For:
Genesee County Emergency Management Office

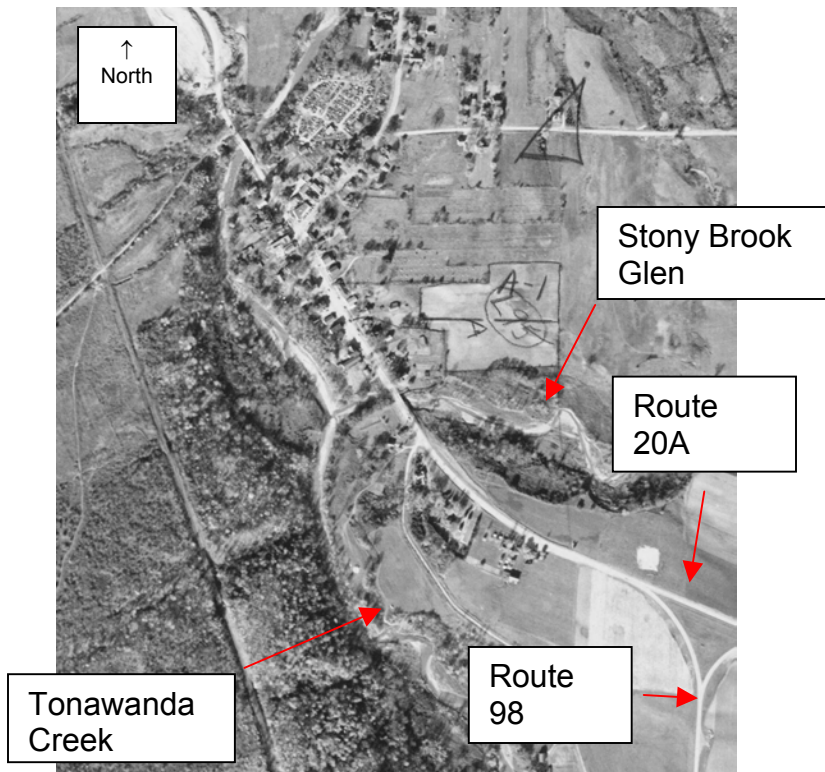
Figure 4.1a 1954 Photo of Varysburg. Meanders and sediment loading in Stony Brook Glen are evident.

The fire hall does not exist in the 1954 air photographs. Eleven homes are visible in the area where the fire hall will be. The Stony Brook Glen tributary meanders frequently before it passes under Route 98 and finally joins the Tonawanda.

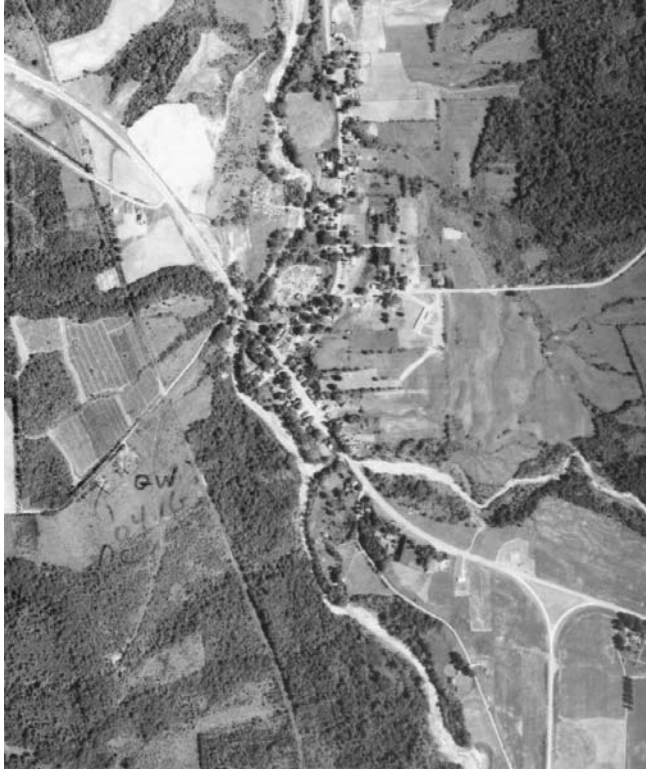
Figure 4.1b 1963 photo of Varysburg. Note recent straightening on Stony Brook Glen.

The fire hall was not constructed in 1963 but 12 houses are visible in the area where it will be located. The Stony Book Glen tributary stream has been straightened for several hundred feet before it passes under Route 98. More stream straightening is evident on the Tonawanda channel upstream of the fire hall site 2800 feet south of where the Tonawanda passes under Route 98 where a large meander was taken out of the stream.

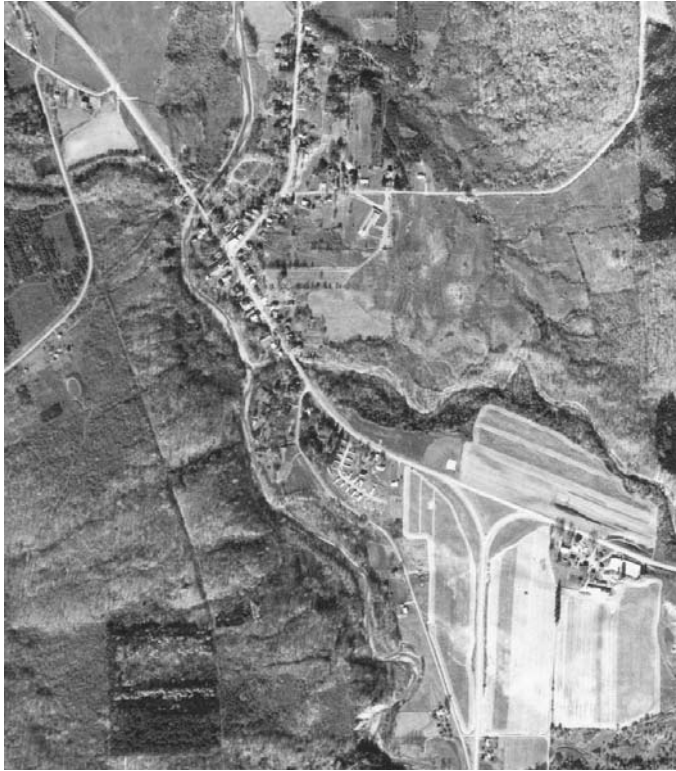
Figure 4.1c. 1974 air photo of Varysburg

The Varysburg Fire Hall is not evident in the 1974 air photo. However, fifteen houses are evident in the area where the fire hall will be. Tree cover along the stream channels for the same area has been mostly cleared away (between the Tonawanda culvert under Route 98 and the Stony Brook Glen tributary stream culvert under Route 98). The Stony Brook Glen tributary is starting to meander again in the area that was straightened in the 1963 air photos. That tributary now presses right up to the tree line and follows its curves perfectly.

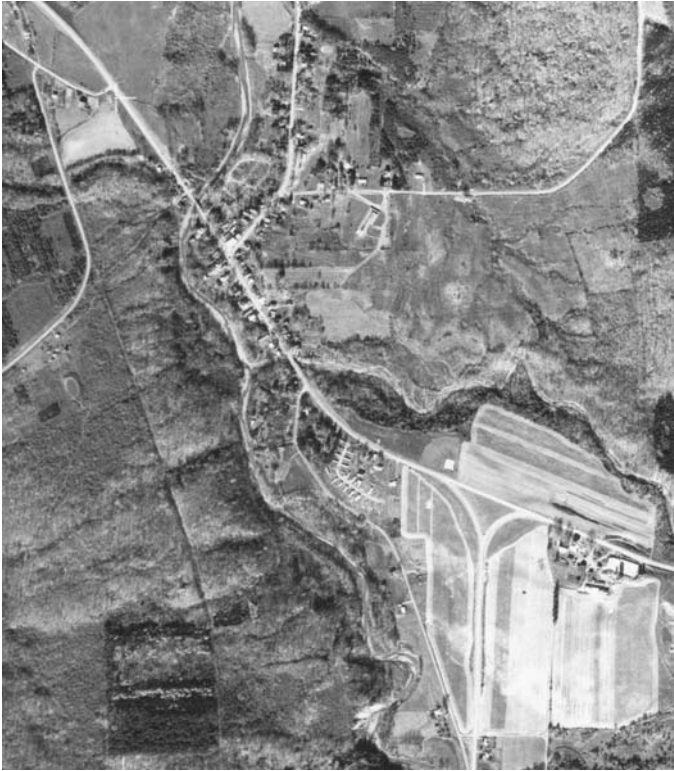
Figure 4.1d. 1985 Air Photo of Varysburg

By 1985 the fire hall has been built, it is located half way in between the two culverts under Route 98. Fourteen other buildings are also evident in this same area that face the same flood concerns as the fire hall. The Stony Brook Glen tributary has now formed a large meander in the area where it was previously straightened. While the dense woods still exist just to the south of this stretch, the tributary no longer follows along it. A new meander has formed on the Tonawanda south of the new fire hall and perpendicular to the spot where Route 98 splits. This large meander is a correction by the stream in response to the straightening observed in 1974; the speed increased and gave the stream more energy that needed to be discharged.

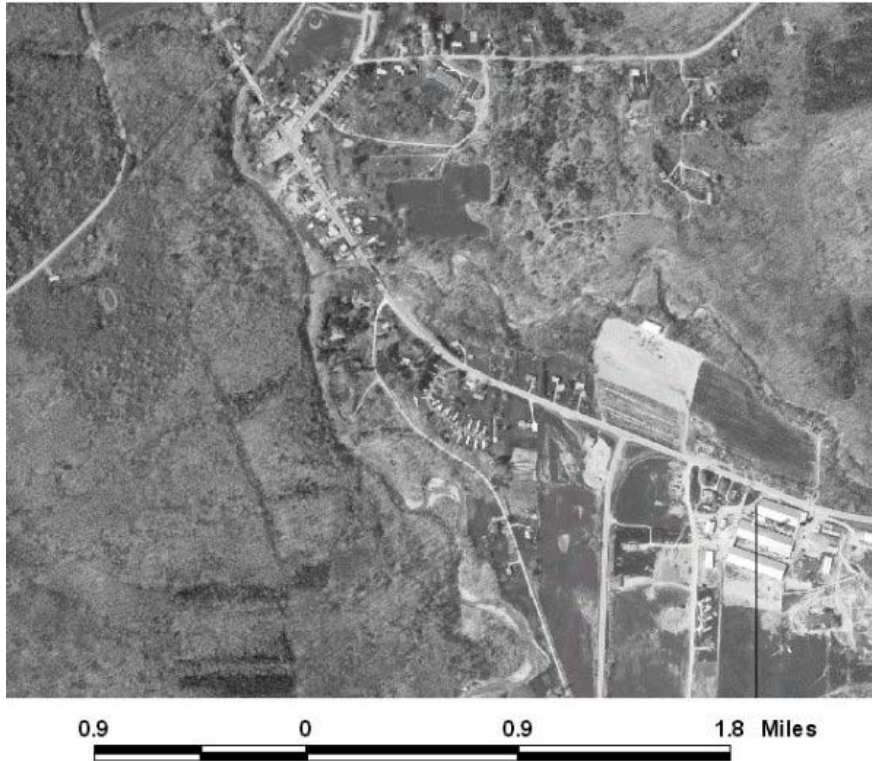
Figure 4.1e. 2002 Air Photo of Varysburg

In 2002, 16 other buildings surround the fire hall in the flood-prone area. The meander at the point perpendicular to where Route 98 splits now measures 103 feet from its original scar, which is where it was in 1985. The meander seems to have cut a new path and is now staying there. Approximately 110 feet south on Creek Street from that meander was a sharp 90-degree bend in 1985; it has now rounded itself out by cutting a wider bend east towards the road but does not threaten the road at this time.

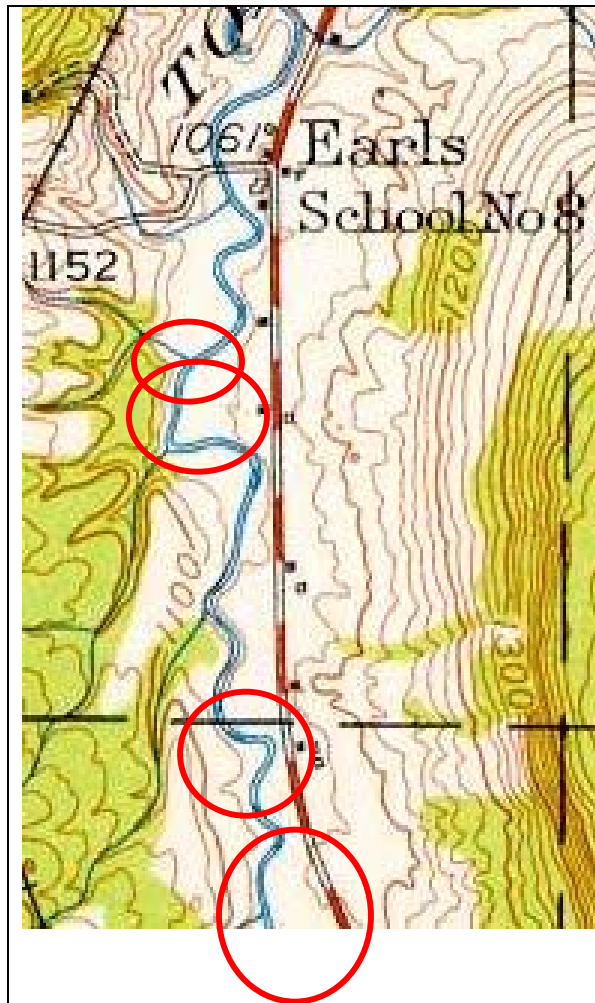
Figure 4.2a. Detail from 1949 Attica, NY 7.5' Topographic Quadrangle Map

Site 135 is a stretch of the Tonawanda Creek that was measured from a pond about 800 feet south of the Sheldon town line to the crossroads of Eck Road and Route 98, a little more than a mile north along the stream. The elevation of the stream channel drops from approximately 1070 feet to approximately 1040 feet at the crossroads of Eck Road and Route 98. The road elevation at Eck Road is 1061 feet. This stretch of Tonawanda Creek meanders actively. Route 98 roughly parallels the east side of Tonawanda Creek from Varysburg north to Eck Road. The area is sparsely settled with a few farmsteads and residences. The 1949 and 1978 revised USGS topographic maps for this stretch of Tonawanda Creek are shown side-by-side in **Figures 4.2a and 4.2b**. The areas circled in red indicate major changes in stream channel morphology from 1949 to 1978.

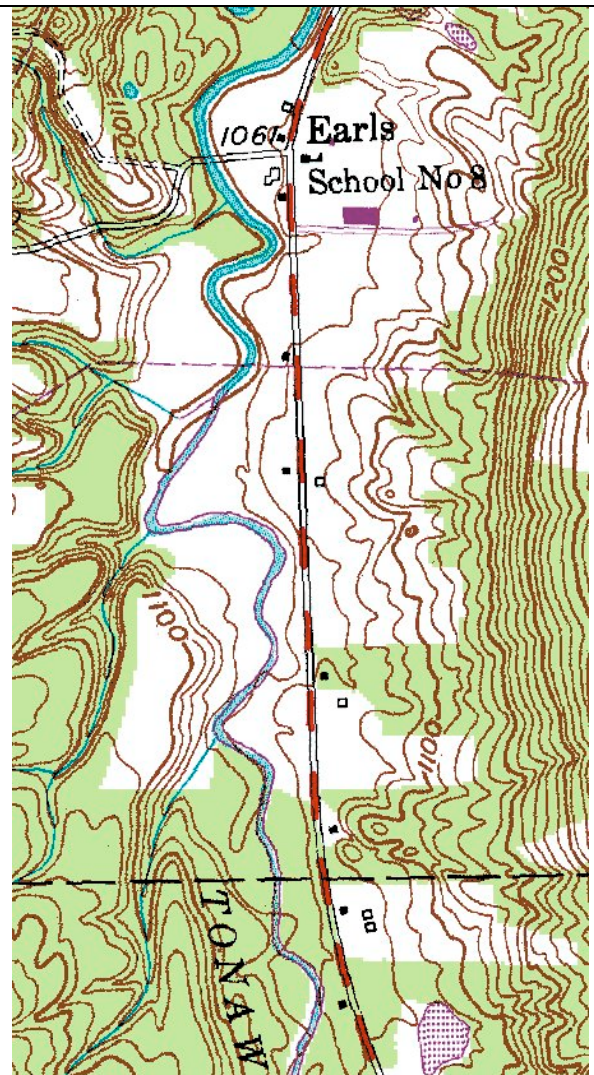
Figure 4.2b. Detail from 1978 revision of 1949 Attica, NY 7.5' Topographic Quadrangle Map

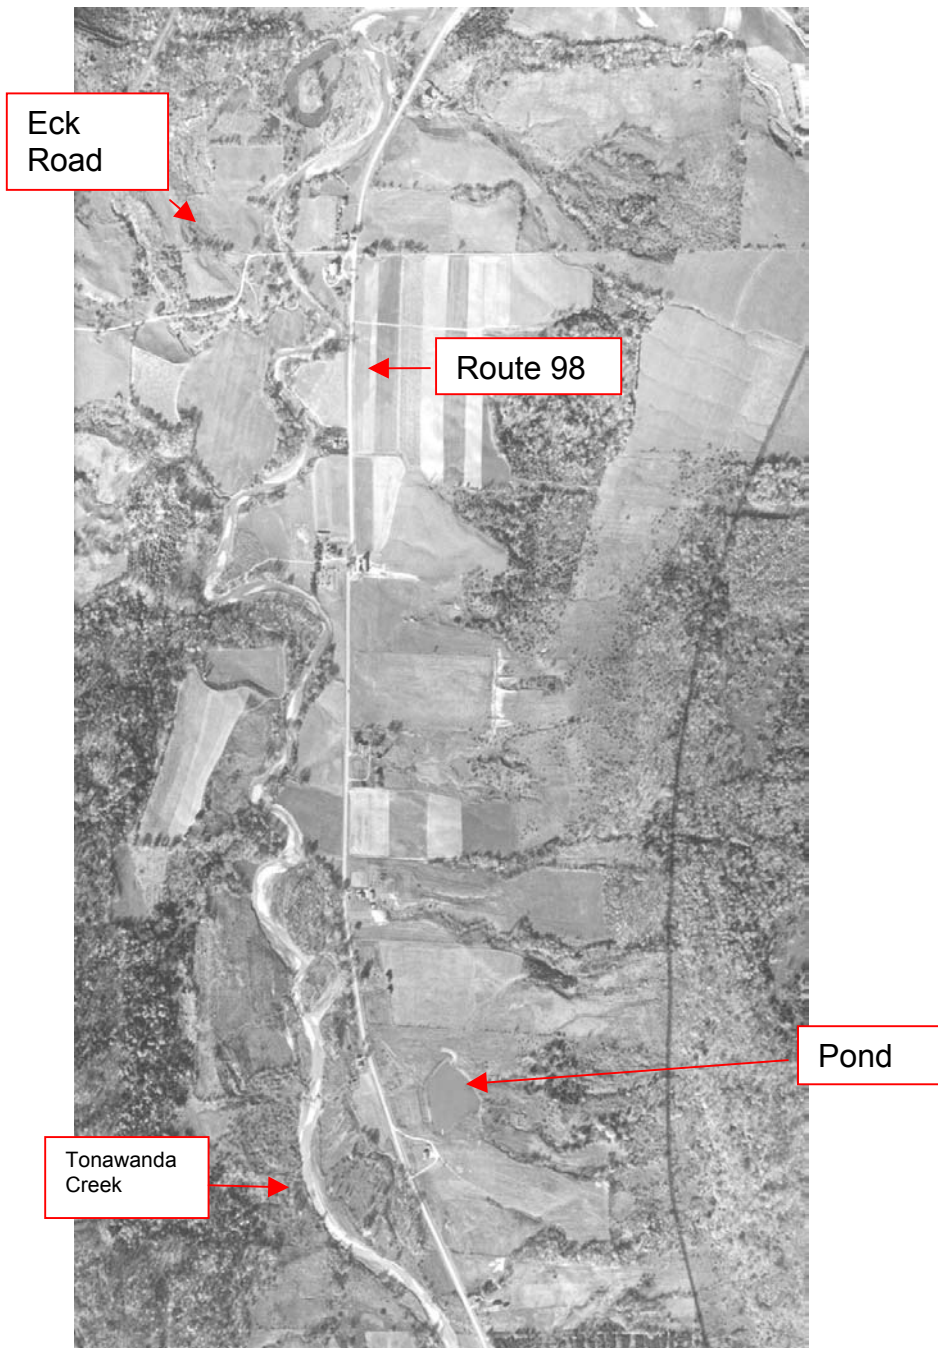
Figure 4.2c. 1954 Composite Air Photo of Site 135 Reach

Approximately four to seven homesteads may be within the meander zone of the creek. One large barn is evident adjacent to the creek channel south of Eck Road.

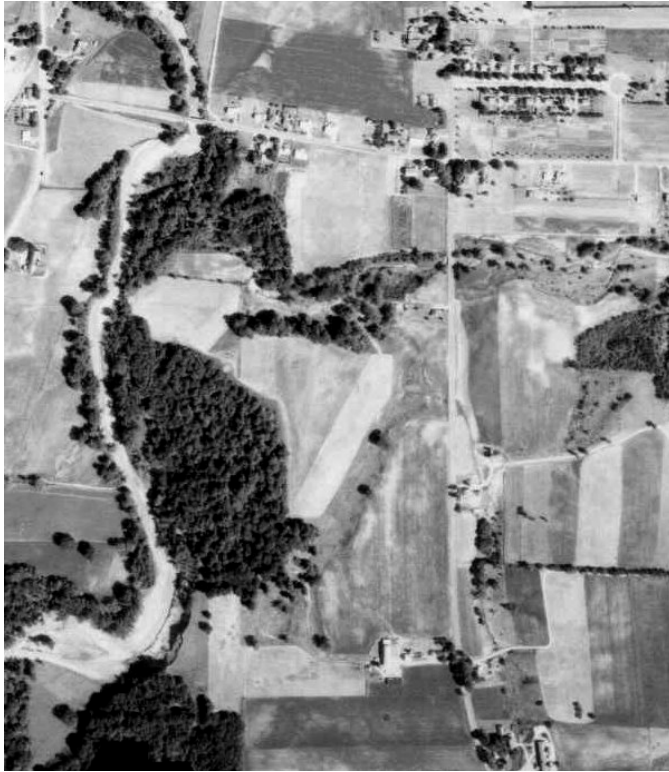
Figure 4.3b. 1963 Photo of Crow Creek at Exchange Street, Town of Attica

The 1963 air photo shows little change in the Crow Creek tributary channels except for some additional woody vegetation along the banks. A large meander at the photo lower left on the Tonawanda Channel appears to have been reinforced with stone or gabions. A heavy silt load creates the light appearance of the water in the Tonawanda channel.

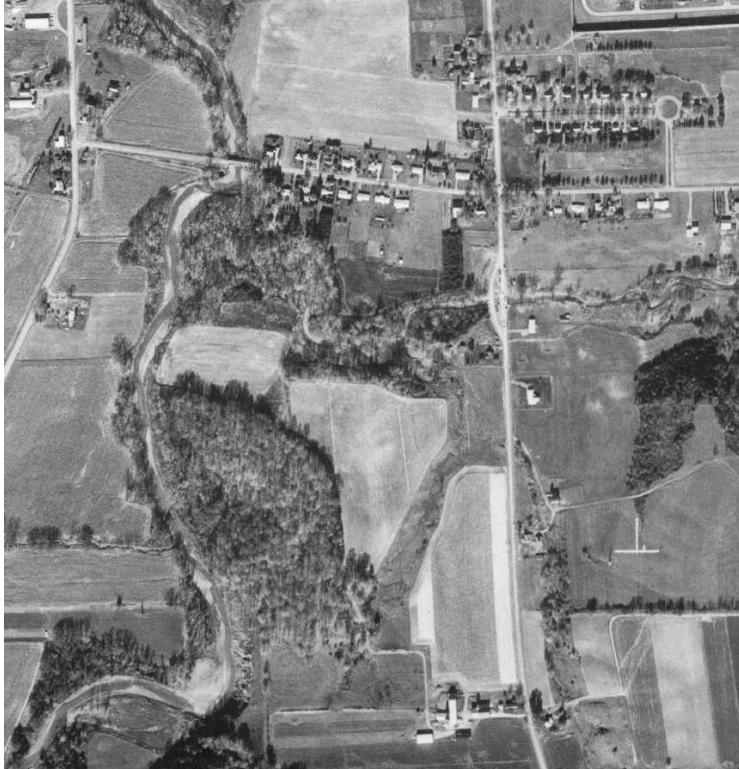
Figure 4.3c. 1974 Air Photo of Crow Creek tributaries at Exchange Street, Town of Attica

In 1974 the number of driveways have not changed but the number of buildings has increased to 17. Crow Creek also passes under Exchange Street at a bridge 830 feet north of the culvert and in 1974 the bridge is bypassed and looks to be under construction. Several new homes are now visible along Dunbar Road west of Exchange Street.

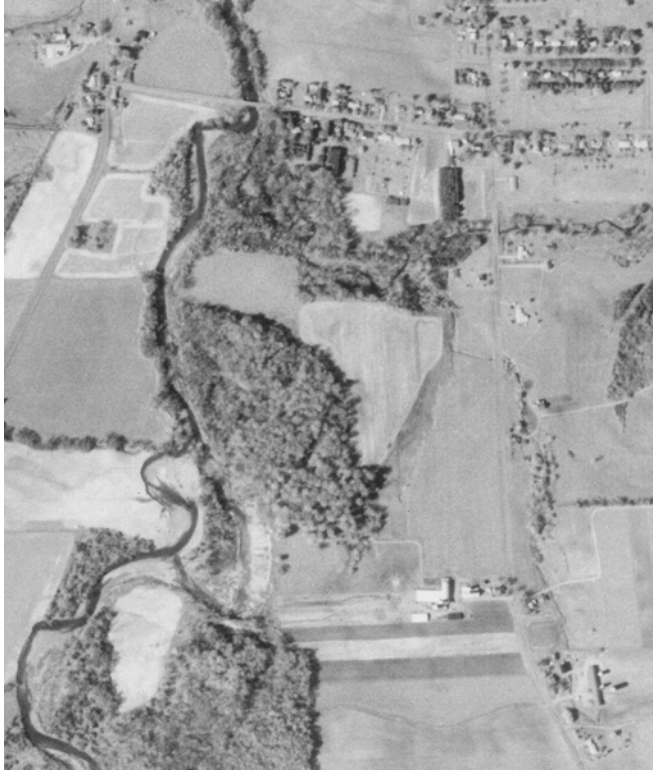
Figure 4.3d. 1985 Air Photo of Crow Creek tributaries at Exchange Street, Town of Attica

In 1985 there were no changes to the homes and driveways along the tributary. The Exchange Street bridge over Crow Creek has been repaired. The stream channels appear to be slightly more vegetated than in previous photos. The Tonawanda channel continues to meander actively south of Dunbar Road. A right-angle turn on the Tonawanda south of Dunbar is significant because it causes ice-jamming during spring melt.

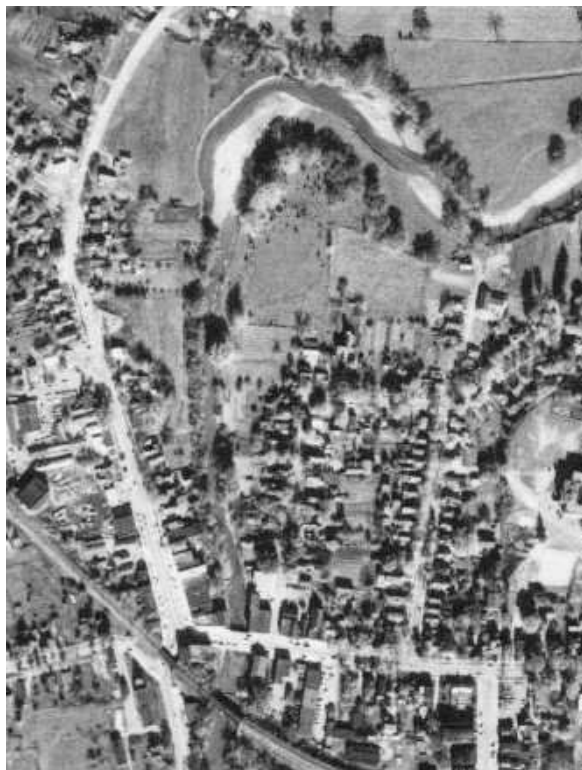
Figure 4.4b. 1954 Air Photo, Water Street Area, Village of Attica

The 1954 air photo shows that the Village/Fire Hall is now present on the site. Eleven houses are evident on the west side of Water Street. The stream channel appears to have been straightened or cleared for approximately 1200 feet north of the Route 238 bridge.

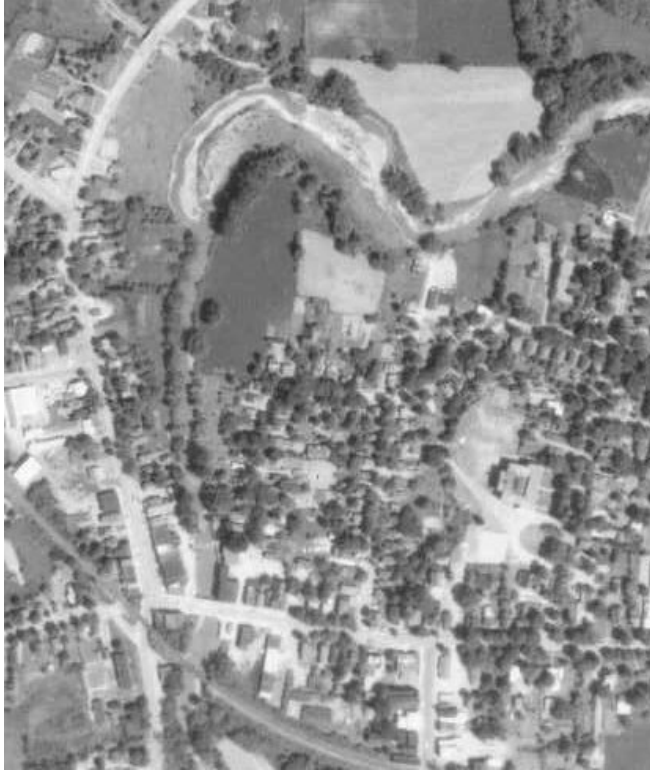
Figure 4.4c. 1968 Air photo, Water Street Area, Village of Attica

The 1968 air photo shows the channel in approximately the same location as it is today. The house north of the Fire Hall is located approximately 50 feet east of the east bank of Tonawanda Creek. The channel bank opposite the Fire Hall has been paved and reinforced. The channel appears to be meandering more actively toward the north. The most northern house on Water Street appears to be about 250 feet from the east bank of Tonawanda Creek.

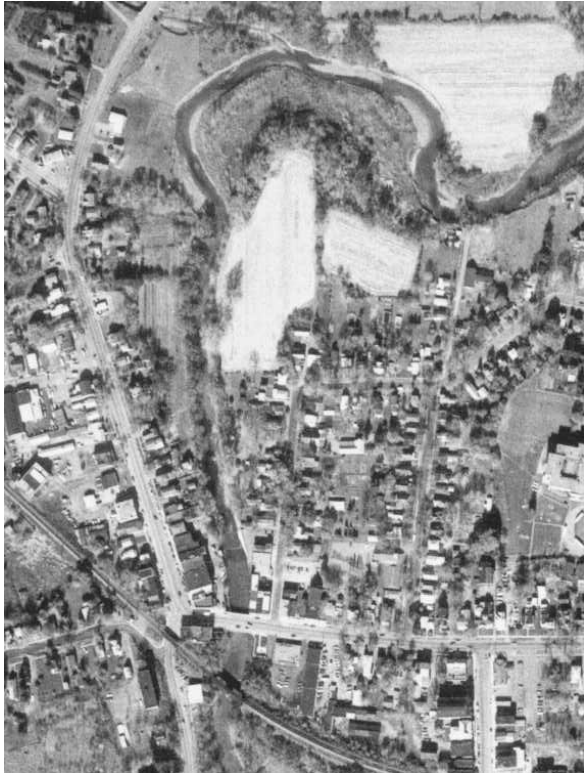
Figure 4.4d. 1974 Air photo of Water Street area, Village of Attica

The 1974 air photo shows houses north of the Fire Hall to be about 40 feet from the top of the channel bank. It appears that some erosion took place between 1968 and 1974. At the north end of Water Street, the stream channel has moved approximately 60 feet west and north of the last house. The photo shows that at least two structures have been removed since the 1968 flood. Beginning approximately 200 feet north of the Route 238 bridge, the channel is now lined with a thin line of deciduous trees.

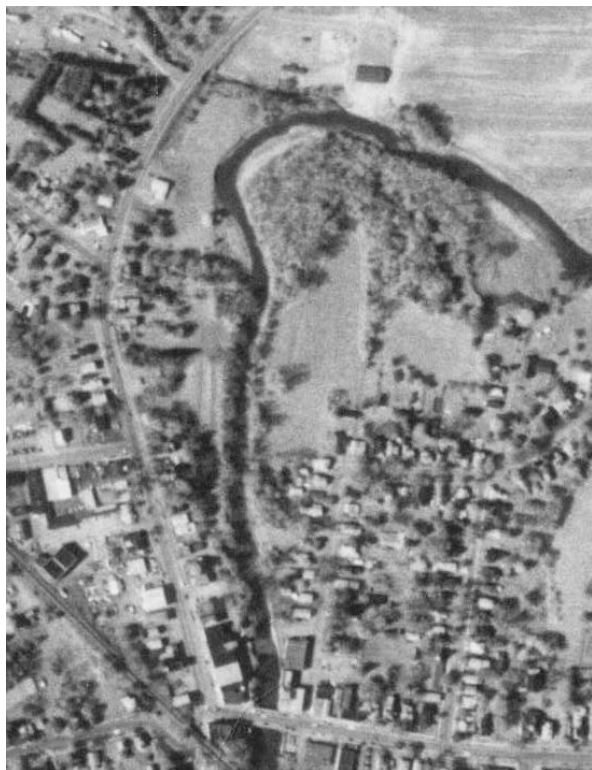
Figure 4.4e. 1985 Air photo, Water Street Area, Village of Attica

The 1985 air photo shows approximately 10 houses on the west side of Water Street. The Fire Hall appears much the same as in previous photos. The back of the most northern house on Water Street is located 230 feet east of the Tonawanda Channel.

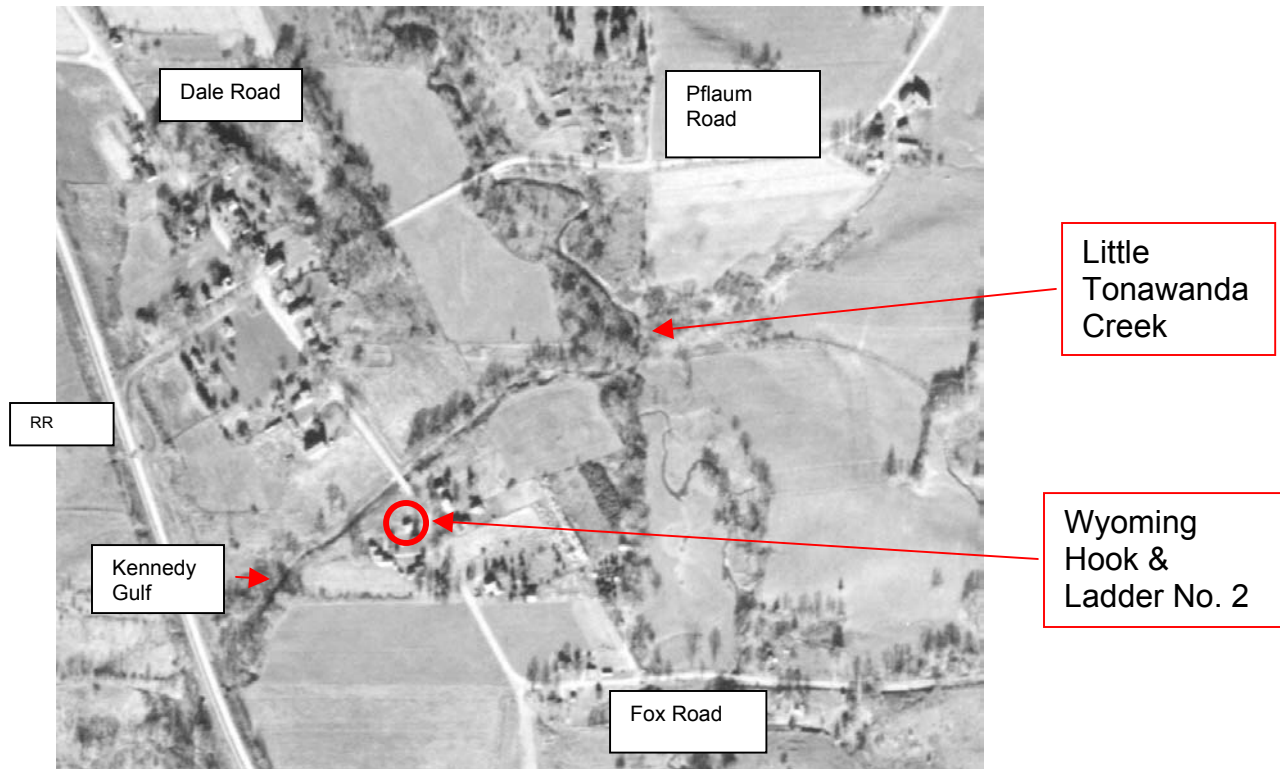
Figure 4.5a. 1954 Air Photo of Hamlet of Dale, Town of Middlebury, Wyoming County

In 1954 the stream channel near the fire hall has been straightened and is devoid of much foliage from the railroad tracks to Dale Road. The tree line follows the old scar of the stream bank where it meandered in this area.

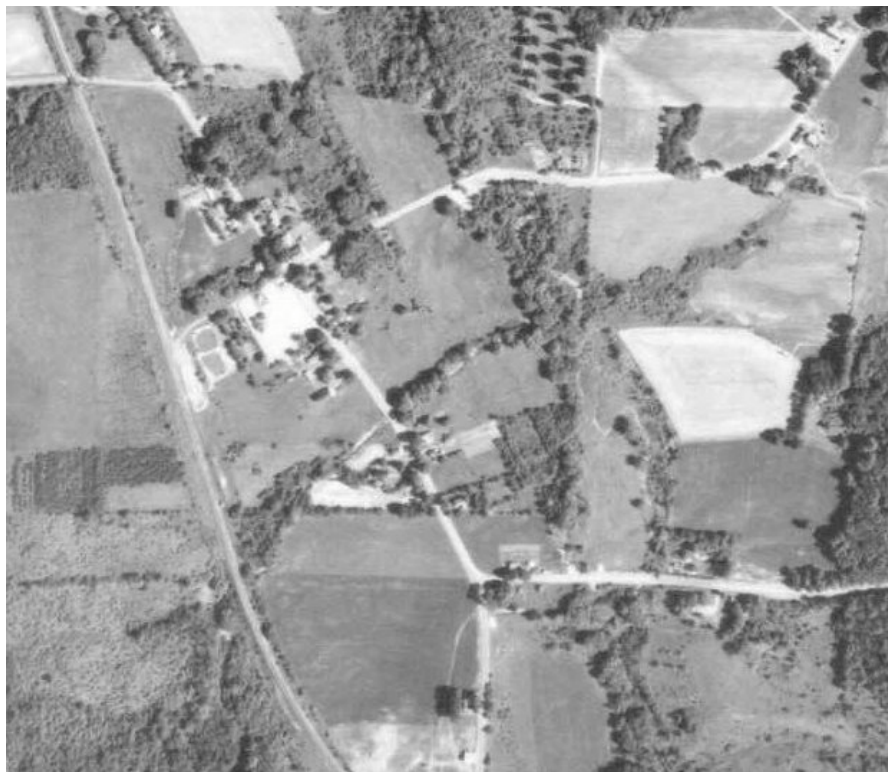
Figure 4.5b. 1963 Air Photo of Hamlet of Dale, Town of Middlebury

In 1963 the Kennedy Gulf tributary passes under a second road that has been built next to Dale Road at the section where the river was straightened to pass under Dale Road some time prior to 1938.

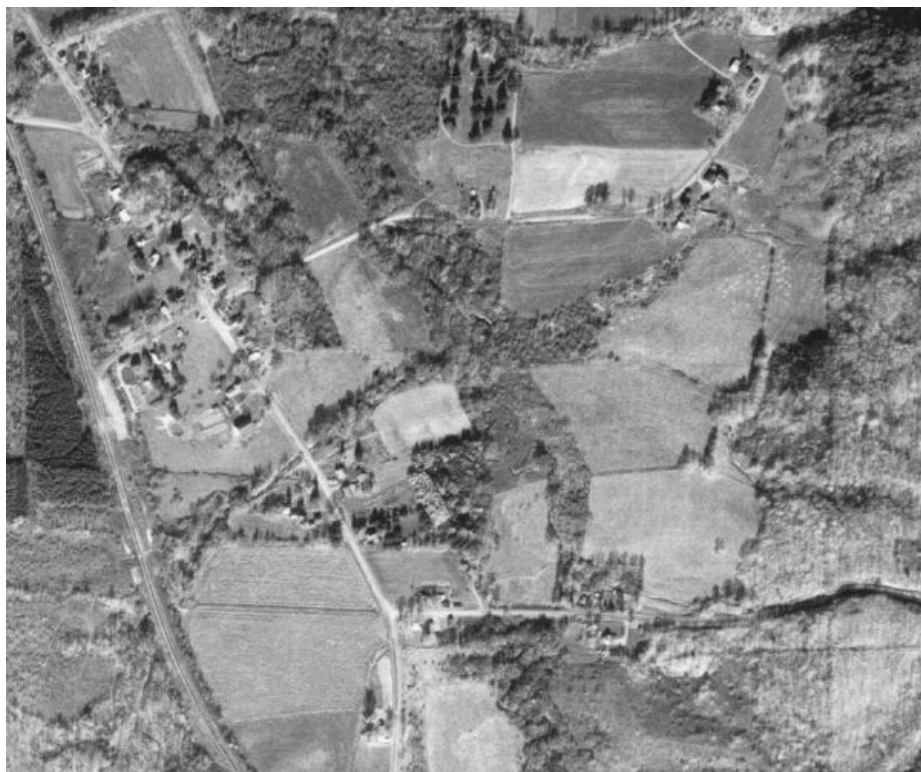
Figure 4.5c. 1974 Air Photo of Hamlet of Dale, Town of Middlebury

In 1974 the site has not changed. The area from the railroad to the culvert under Dale Road is still devoid of foliage along the stream bank.

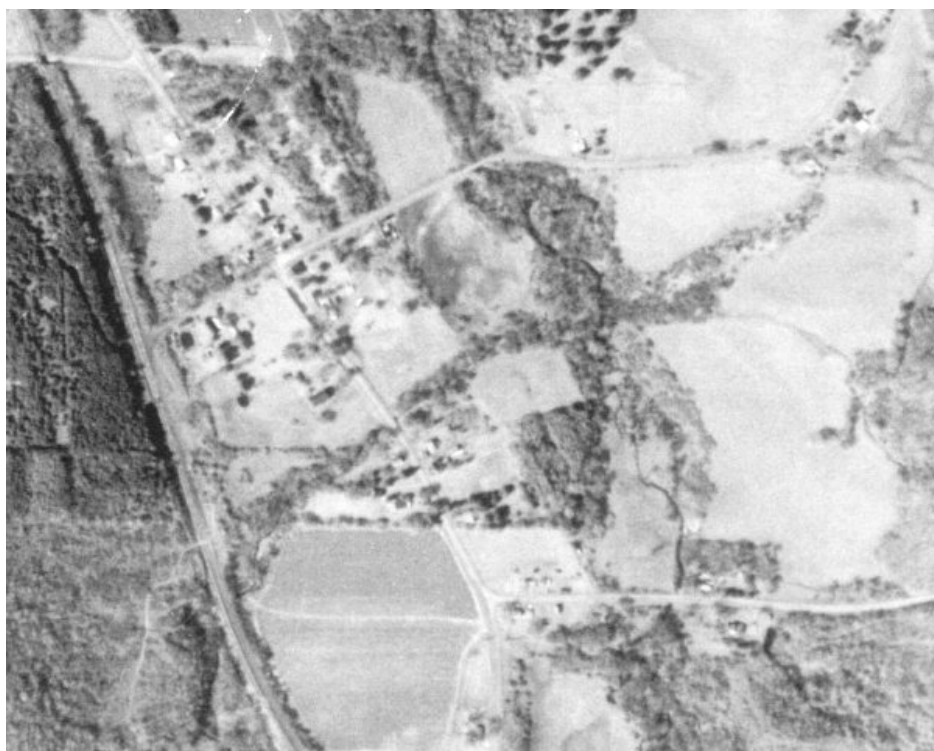
Figure 4.5d. 1985 Air Photo of Hamlet of Dale, Town of Middlebury

In 1985 no noticeable changes have taken place to the area around the fire hall. The surrounding area has been cleared of much of its heavy woodland area except for around the stream channel.

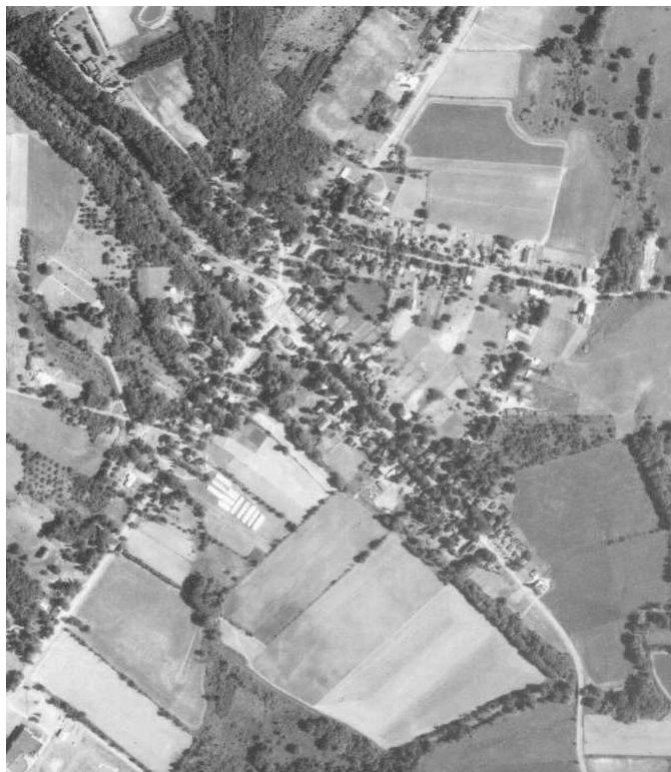
Figure 4.6b. Village of Wyoming, 1963

The 1963 air photo showed a change in the course of Oatka Creek in the vicinity of this site. Channels are still tree lined. Land use in vicinity of pump house is mainly agricultural with residential and small commercial on Main Street.

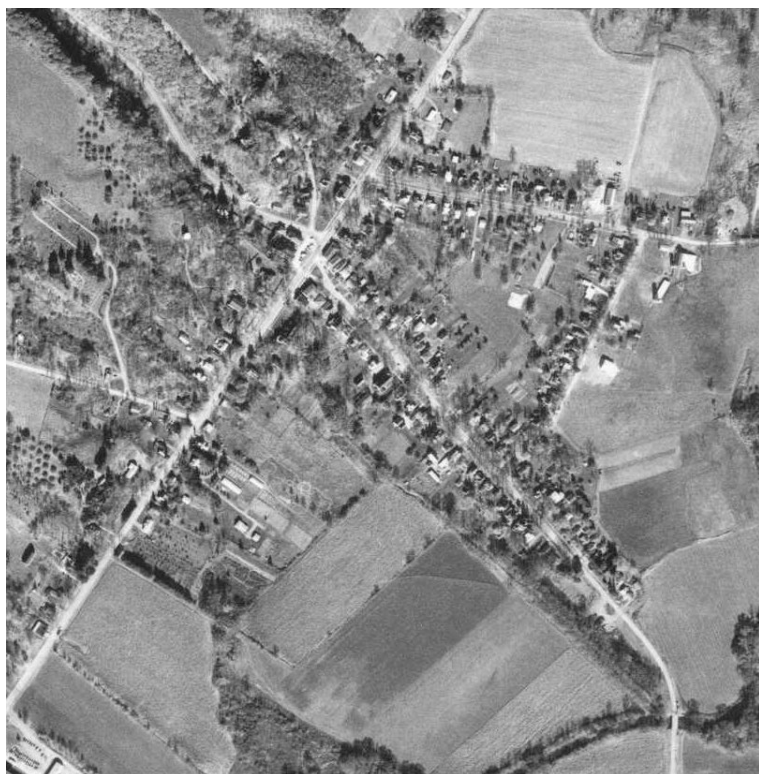
Figure 4.6c. Village of Wyoming, 1974

The 1974 air photo shows one additional residence within 500 feet of the pump house site. An additional driveway and small building have been constructed adjacent to the original small building. Tree canopy hides much detail on these structures.

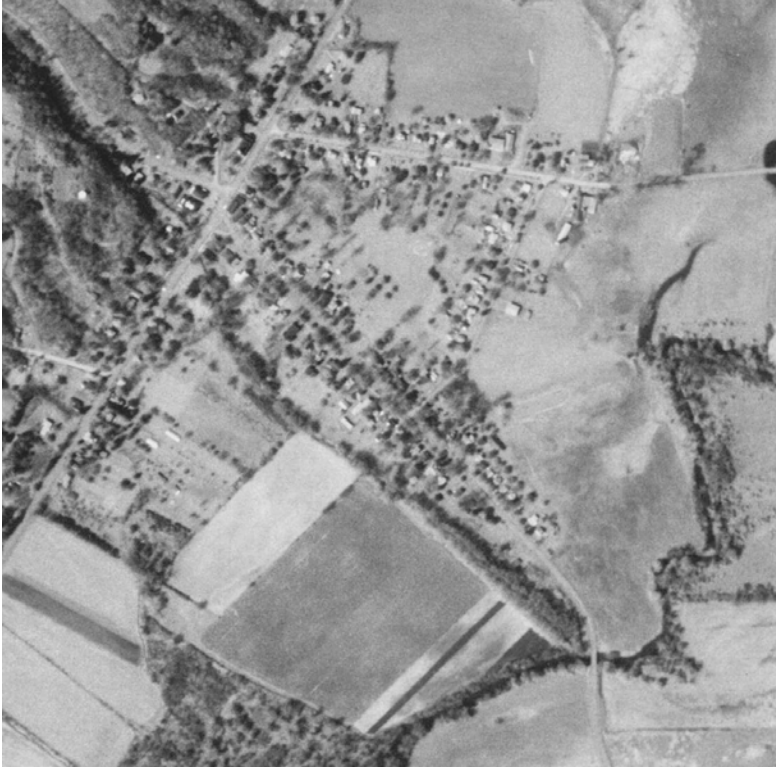
Figure 4.6d. Village of Wyoming, 1985

The 1985 air photo shows the same number of residences within 500 feet of the site. Tree canopy and lack of focus limit detailed analysis of building distance from channel bank.

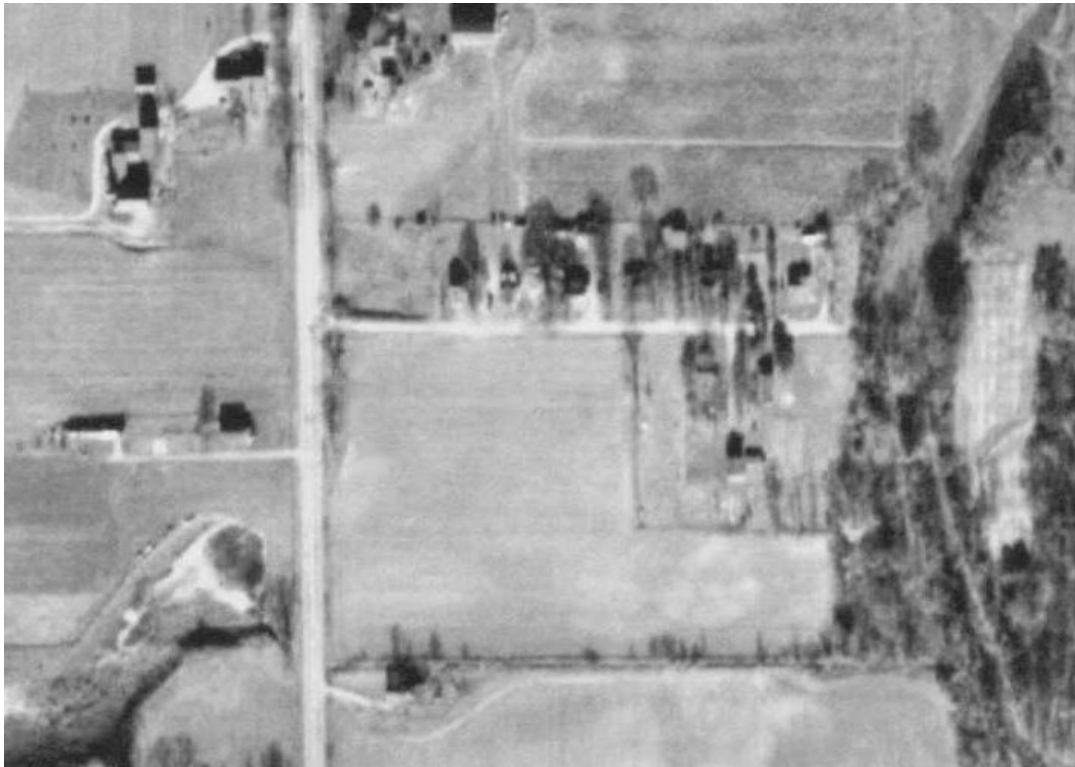
Figure 4.7a. Homes on Martinsville Road, Town of Warsaw, 1954

In 1954 on Martinsville Road, 5 houses are visible including the three that are identified as being problems in the site description. Two tributaries feed into the Oatka within 800 feet upstream of Martinsville Road.

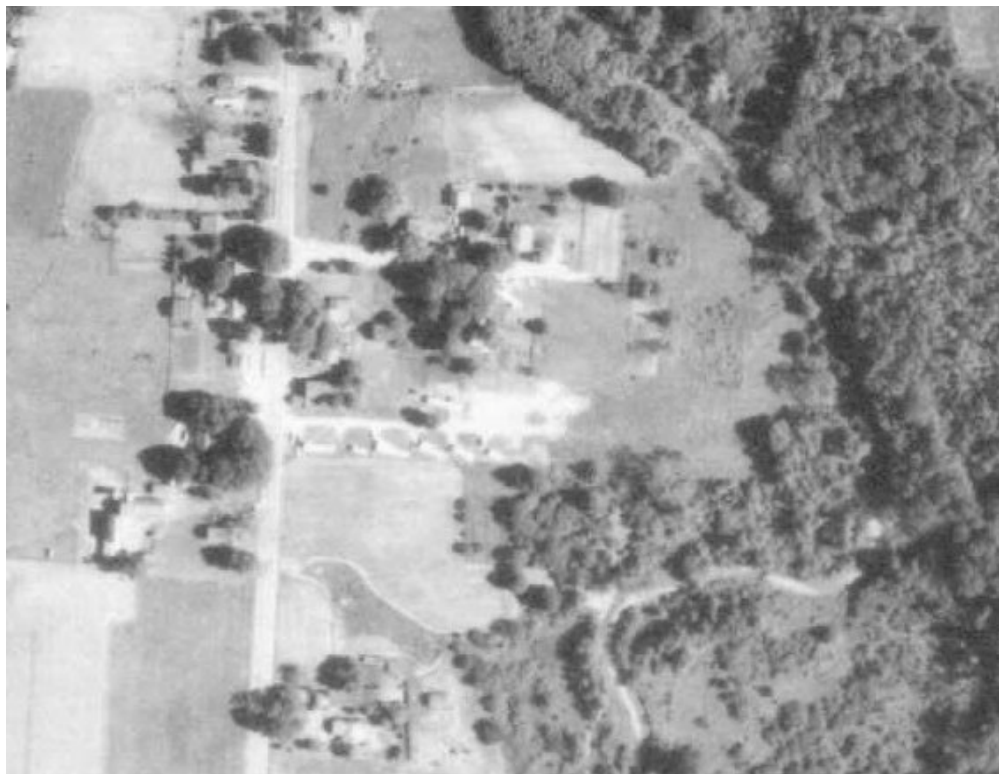
Figure 4.8b. Francis Herrmann Trailer Park, Town of Warsaw, 1963

In 1963 a new road has been put in and the first 6 trailers now occupy the Francis Herrman Trailer Park. Some of the homes that were located in the area of the trailer park in 1954 are gone but most of them still exist.

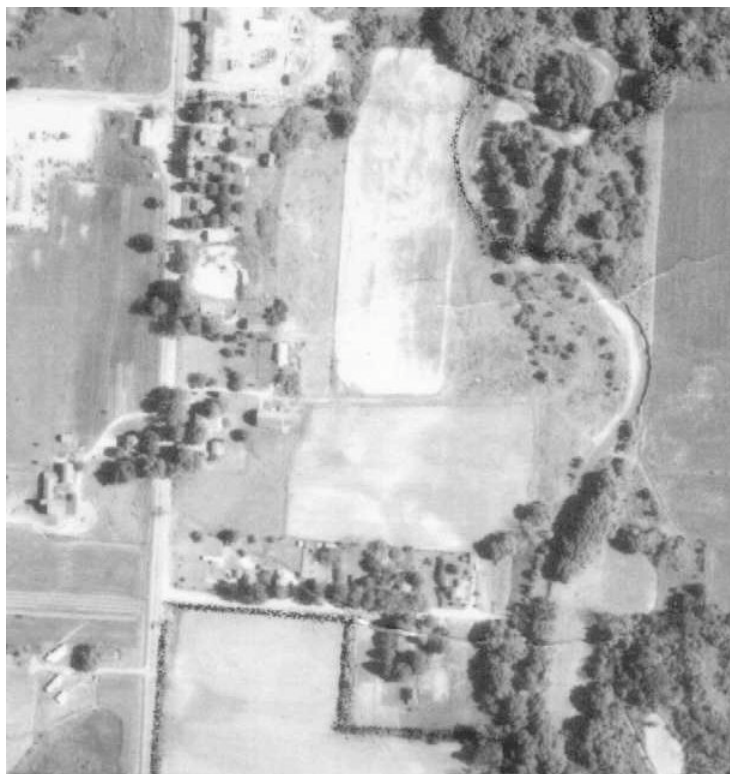
Figure 4.7c. Martinsville Road, Town of Warsaw, 1963

Martinsville Road has also seen growth with the addition of seven new houses to the street. Every point of measurement on the Creek has had a slight move but there have been no major changes.

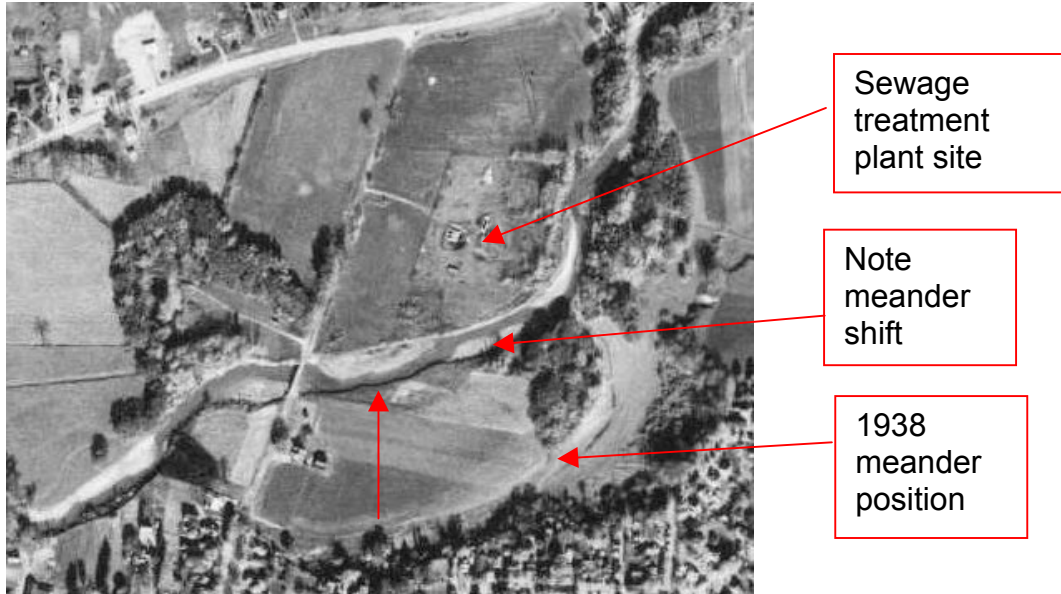
Figure 4.10b. 1954 air photo of Prospect Street and Tonawanda Creek Channel. Note the northward shift in the main channel.

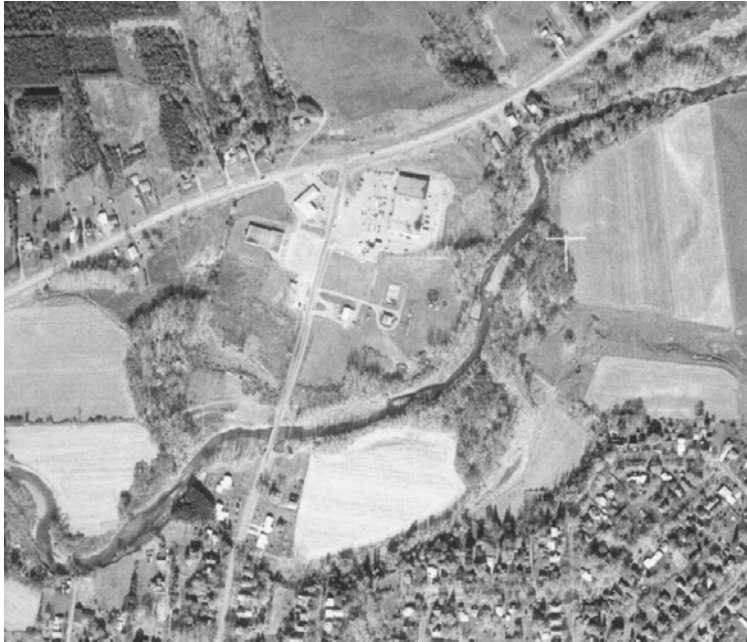
Figure 4.10e. 1974 air photo of Prospect Street sites.

The 1974 photo shows evidence of some filling and clearing on the site of the medical building. The stream channel appears to be moving eastward, away from the digester building on the sewage treatment plant site. The distance between the west bank and the digester has increased to about 300 feet.

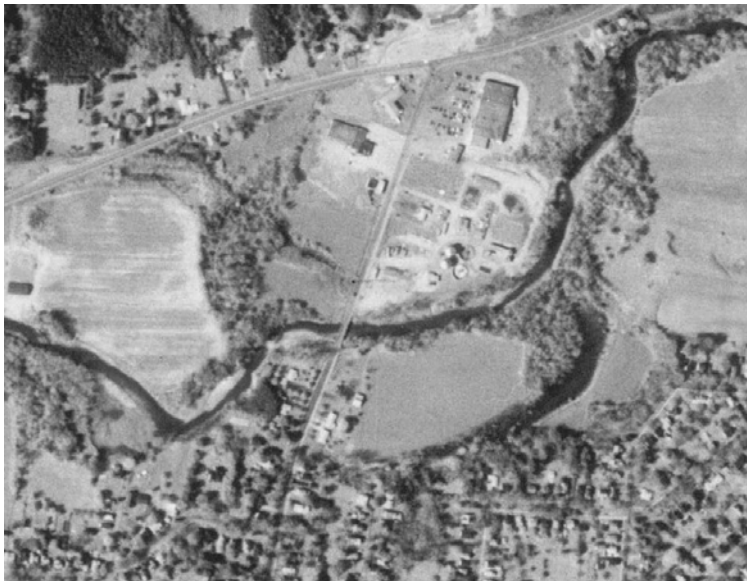
Figure 4.10f 1985 air photo of Prospect Street sites

The 1985 air photo shows continuing development of the sewage treatment plant site. The channel meandering does not appear to be threatening the sewage treatment plant buildings directly; however, the nearest digester is approximately 140 feet from the channel. The medical building site remains undeveloped.
