Draft
Genesee & Wyoming Counties
Joint Flood Mitigation Plan

Genesee & Wyoming Counties Joint Flood Mitigation Plan

Town of Middlebury

August 2003

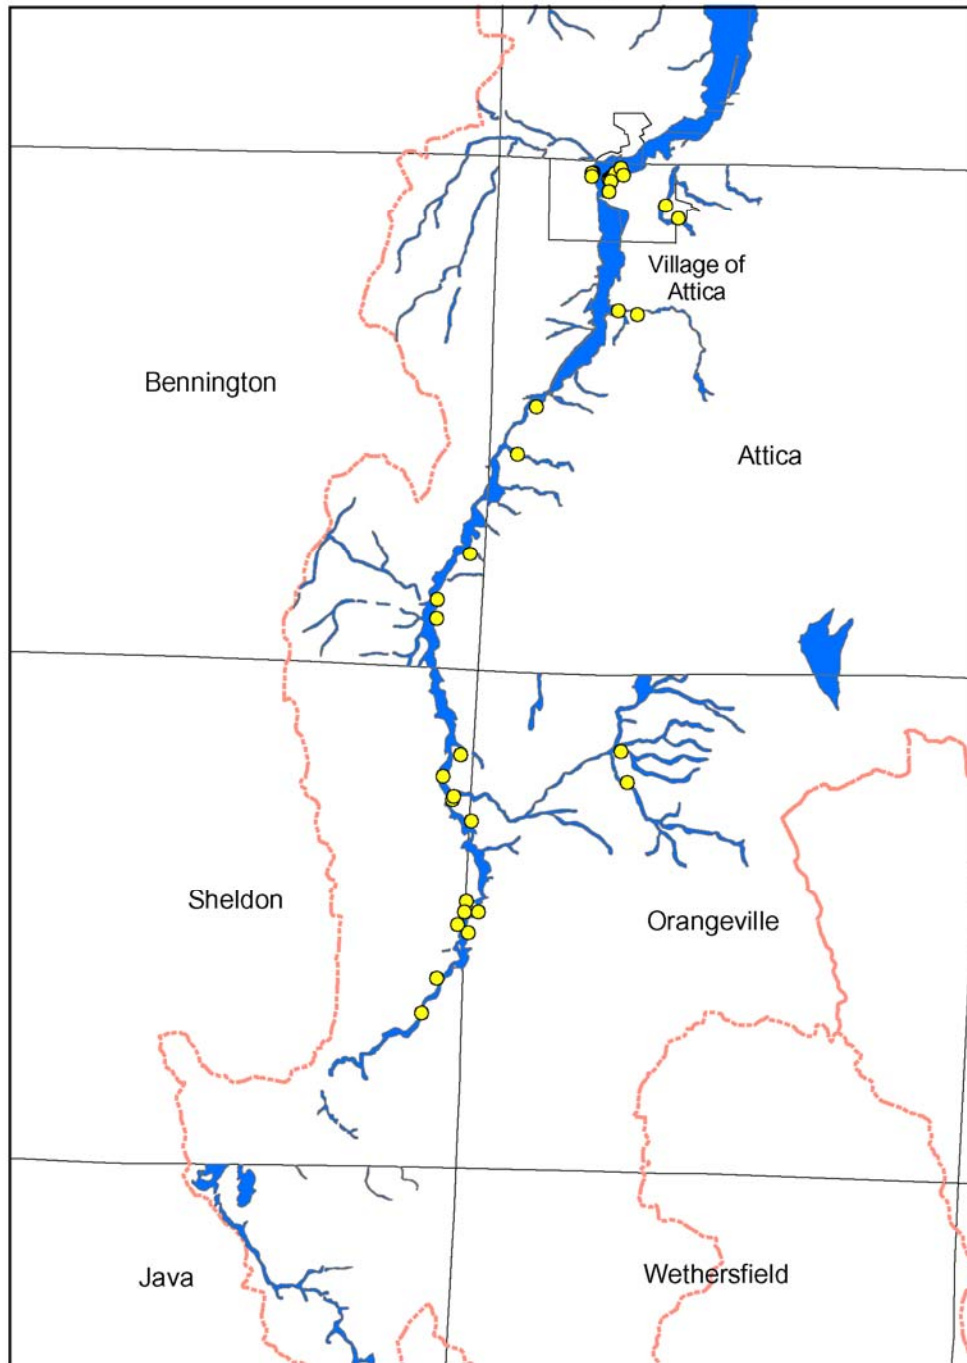
Map 4.2b

Additional Flooded Areas Tonawanda Creek Watershed, Wyoming County
