# Genesee & Wyoming Counties Joint Flood Mitigation Plan

## Town of Warsaw

August 2003

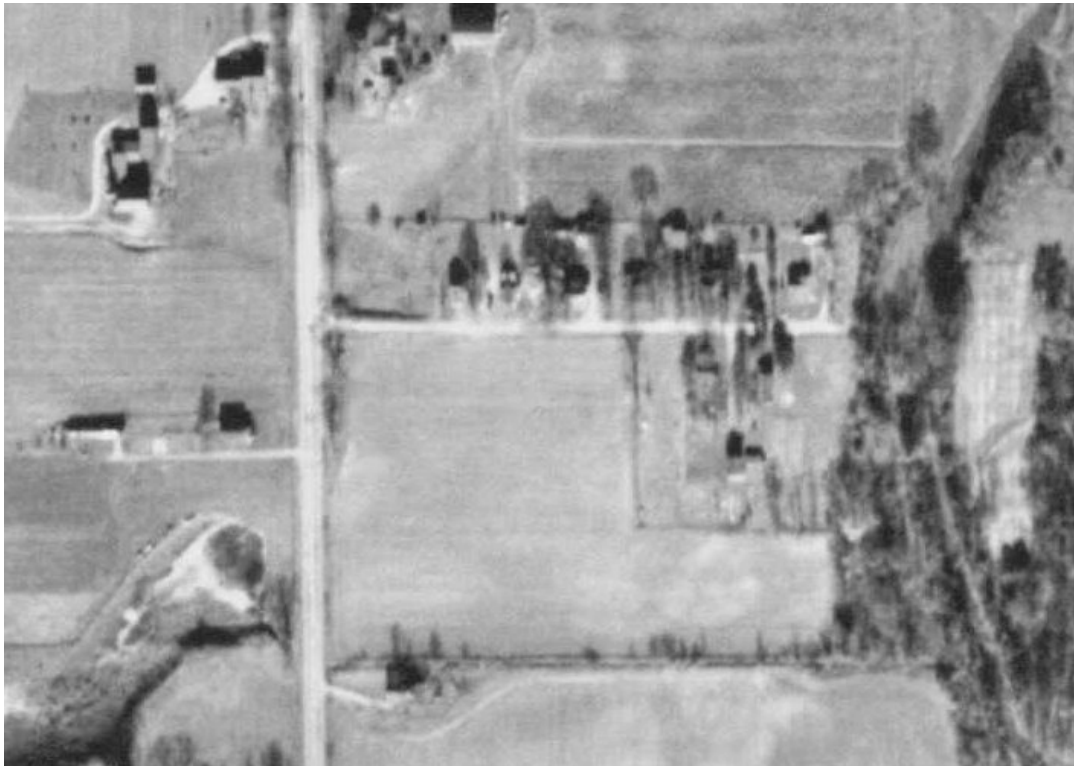
Figure 4.7a. Homes on Martinsville Road, Town of Warsaw, 1954

In 1954 the trailer park does not yet exist. In its place is a road and 8 single-family homes. Four unnamed tributaries join Oatka Creek within 1000 feet south of the trailer park.
