**Draft**  
**Genesee & Wyoming Counties**  
**Joint Flood Mitigation Plan**

# Genesee & Wyoming Counties Joint Flood Mitigation Plan

## Village of Wyoming

August 2003

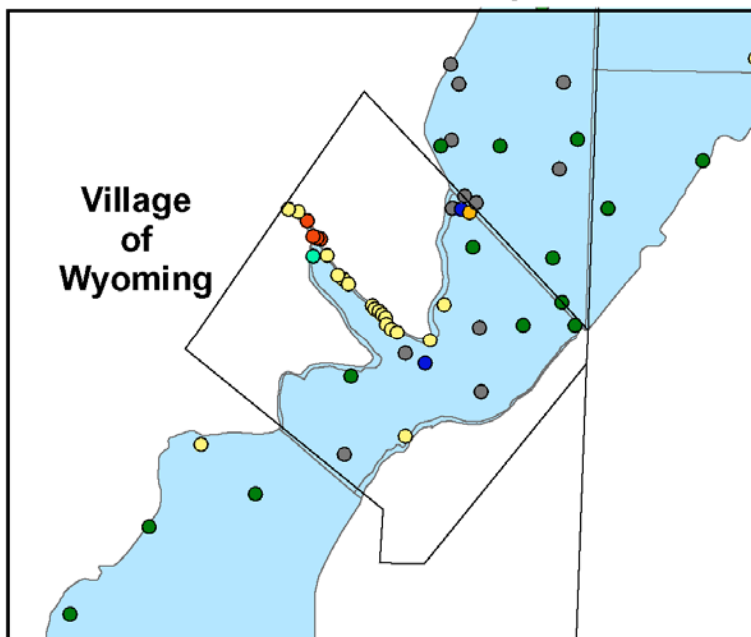
## Map 2.3k

### Land Use in the Village of Wyoming in the Oatka Creek Floodplain

All of the Village of Wyoming is in the Oatka Creek Watershed and approximately 41% is in the floodzone (see [Table 2.1](#)). An analysis of land use in the flood zone is based on the real property centroid land use classification. The centroid is the approximate center point of a real property parcel. In the Village of Wyoming there are a total of 35 real property centroids that intersect the Oatka Creek flood zone. The approximate percent of the main land uses are as follows: 11% agricultural, 49% residential, 17% vacant, and 11% commercial (see [Map 2.3l](#)).

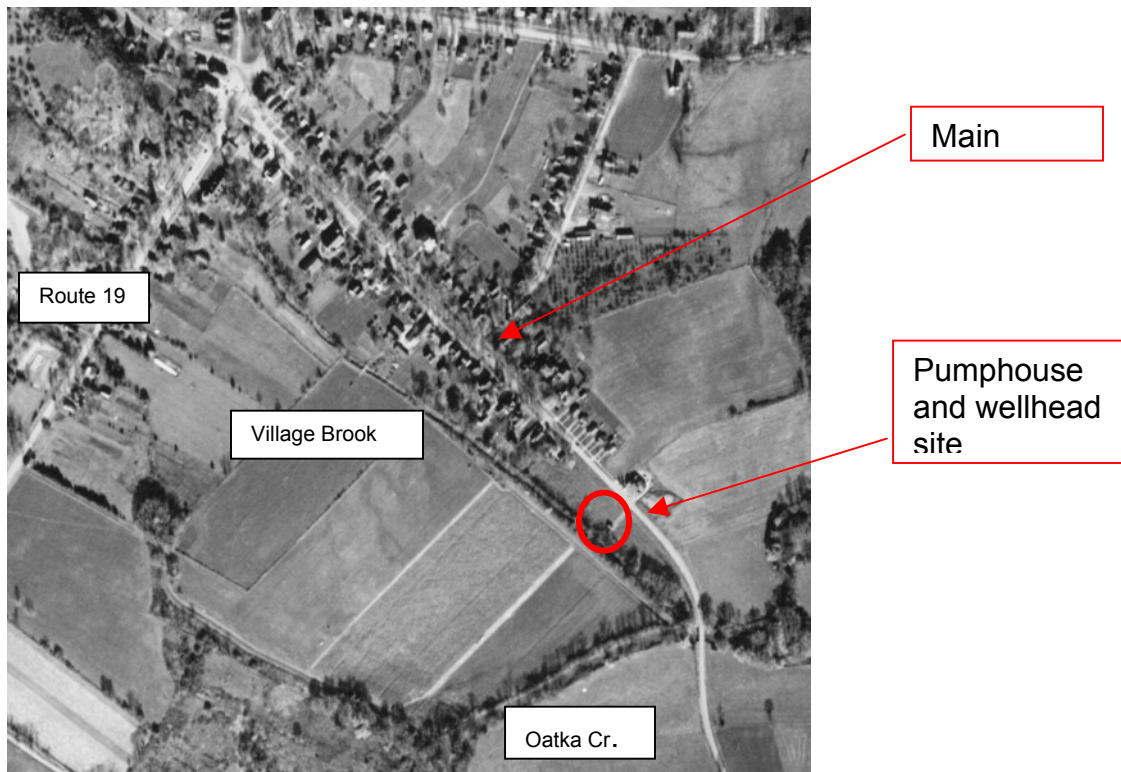
Figure 4.6a. Village of Wyoming, 1954

The Village of Wyoming Public Works building does not show in the 1954 photograph; however, a driveway access and small building (possibly the pumphouse) are located at the site. The channel of Village Brook forms a straight line between Route 19 and Oatka Creek. The channel of Village Brook is lined with a thin (< 50 feet wide) strip of deciduous trees for a distance of approximately 800 feet west and east of the site. The channel of Oatka Creek is also lined with a thin (<50 feet wide) strip of deciduous trees for several hundred feet upstream and downstream of the Main Street bridge. The establishment of trees shows that the pattern of meandering is fairly stable at this point in the Oatka Creek. Land use in the vicinity of the creek is agricultural.

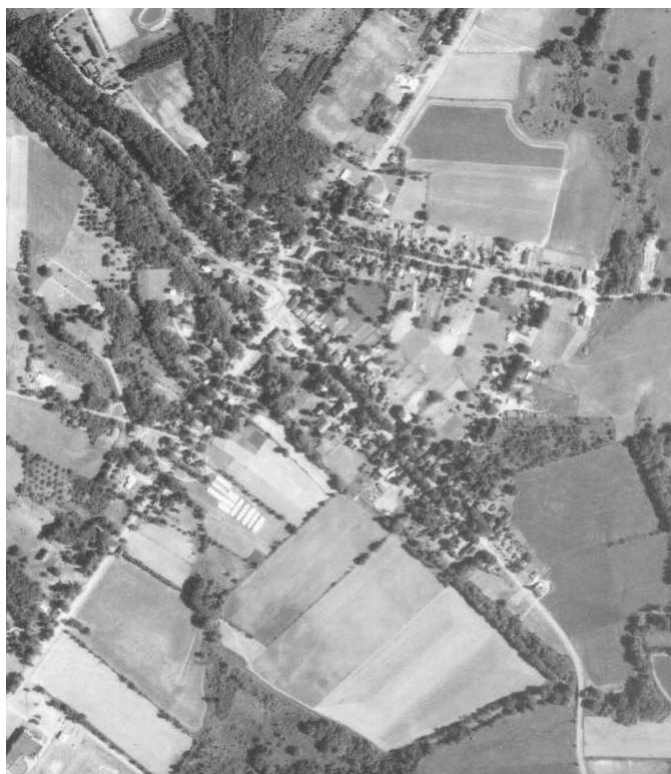
Figure 4.6b. Village of Wyoming, 1963

The 1963 air photo showed a change in the course of Oatka Creek in the vicinity of this site. Channels are still tree lined. Land use in vicinity of pump house is mainly agricultural with residential and small commercial on Main Street.

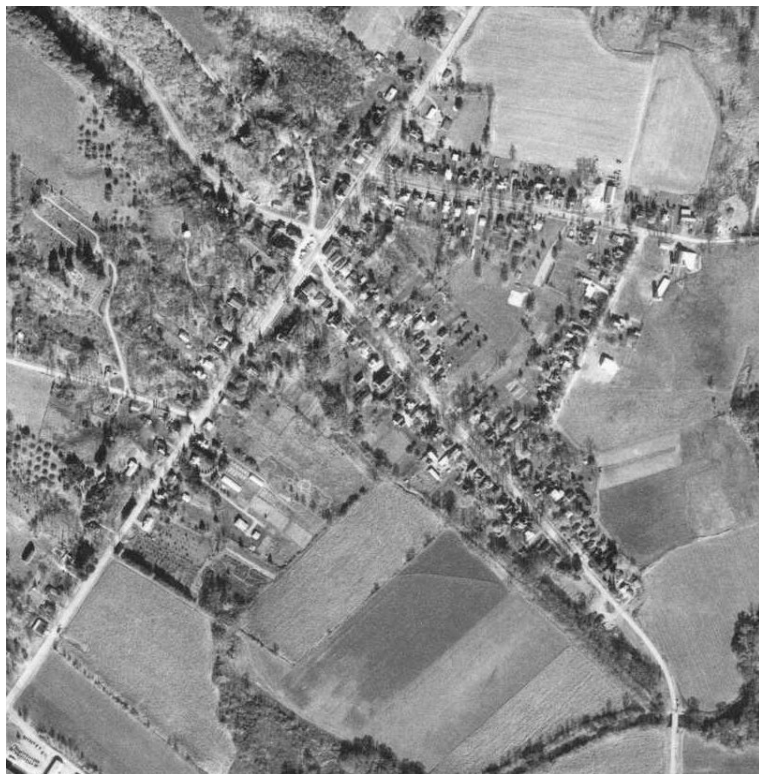
Figure 4.6c. Village of Wyoming, 1974

The 1974 air photo shows one additional residence within 500 feet of the pump house site. An additional driveway and small building have been constructed adjacent to the original small building. Tree canopy hides much detail on these structures.

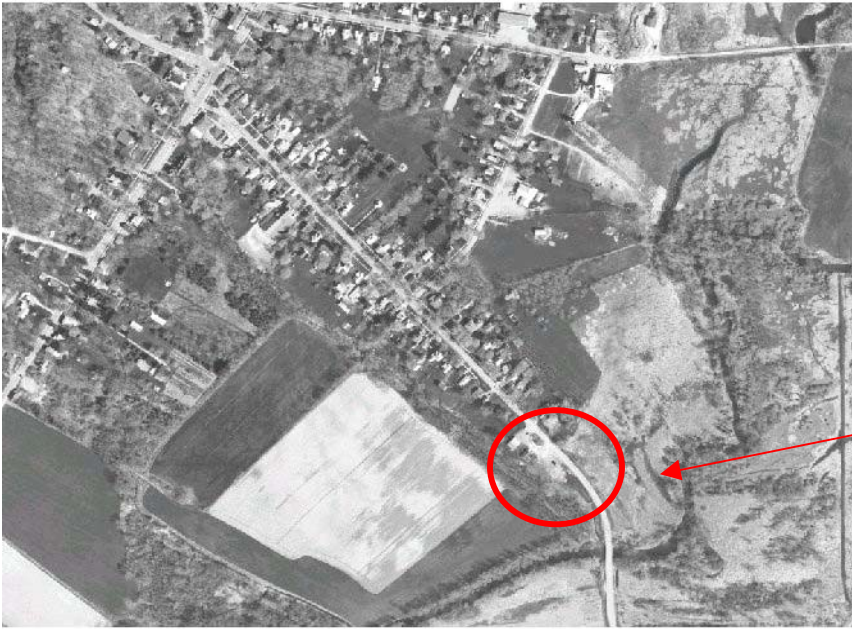
Wyoming Village  
Department of  
Public Works &  
Wellhead

The Village of Wyoming relies on groundwater for its potable water supply. The Village well is located adjacent to the Department of Public Works building. Village and County Health Department officials reported that the top of the well casing was flooded in 1998. The concern is that this well is the only public water supply for residents of the Village of Wyoming. The Village of Wyoming Department of Public Works and Pump House are located on the south side of Main Street in the Village of Wyoming, approximately 800 feet from the Main Street bridge over Oatka Creek. The building is at an elevation of approximately 955 feet above sea level. The Public Works building is located on the north side of Village Brook, approximately 830 feet upstream (west) from the its confluence with Oatka Creek. The site is located in the floodplain of Oatka Creek. From Route 19, the terrain slopes gradually east toward Oatka Creek. West of Route 19, the terrain forms a steep northeast-southwest trending valley wall. The western top of slope is at an elevation of approximately 1550 to 1600 feet. Village Brook drops approximately 600 feet over a distance of approximately 3.1 miles to its confluence with Oatka Creek. The channel gradient is approximately 0.035 over its length.
