Oatka Creek Site Inspection 2003

Genesee County Soil and Water Conservation District

2003 Inspection

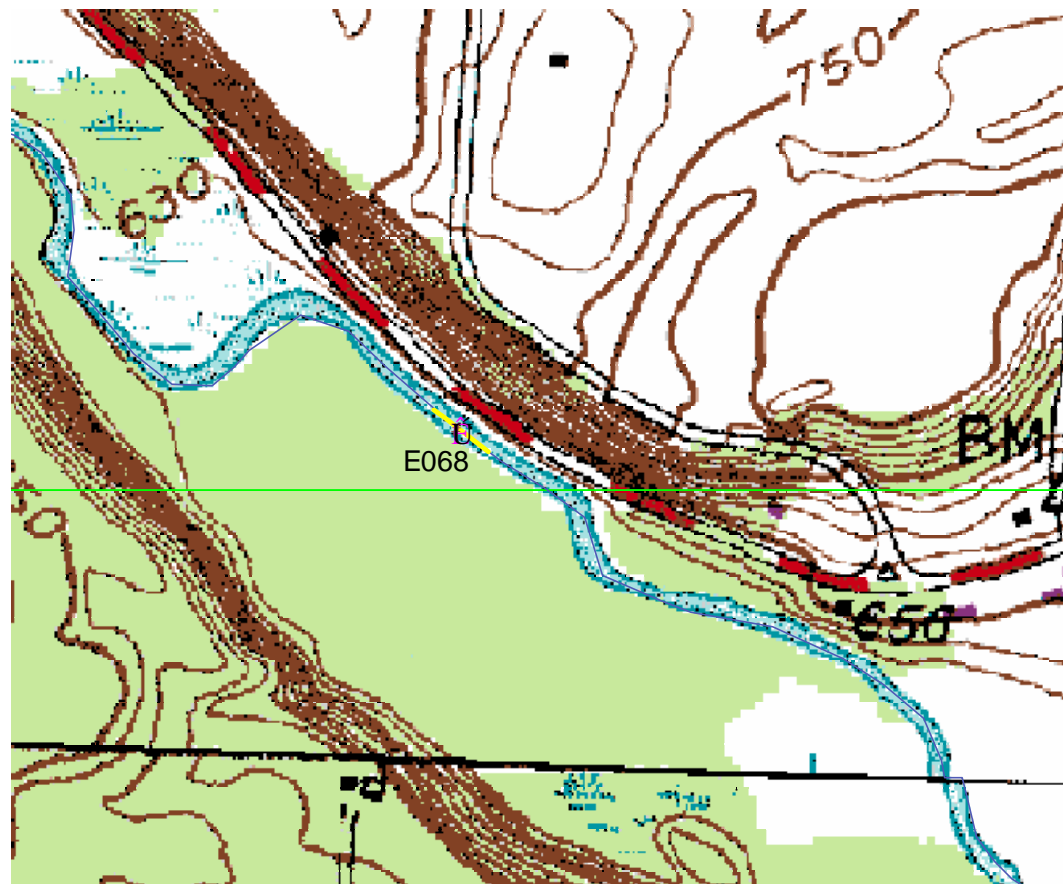
Here, at erosion point E067, the right bank is undergoing the most erosion. However, it should be noted that both banks are very steep in this area.

The left bank of erosion point E068 is experiencing erosion. Here, the creek is getting close to the road.
