Draft
Genesee & Wyoming Counties
Joint Flood Mitigation Plan

Genesee & Wyoming Counties Joint Flood Mitigation Plan

Town of LeRoy

August 2003

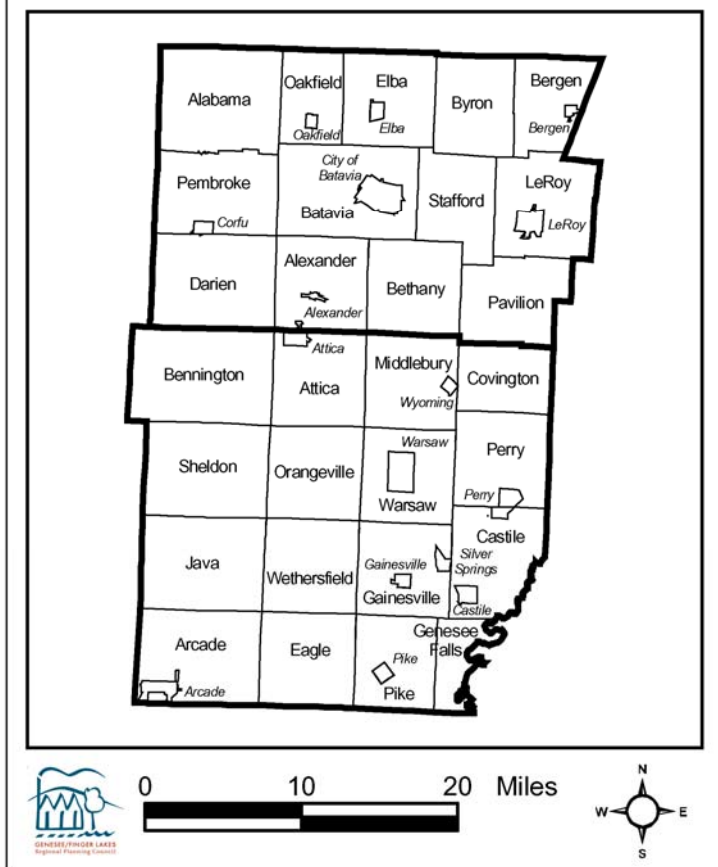
Map 2.1
Genesee & Wyoming Counties

The Town and Village of LeRoy are in eastern Genesee County (see [Map 2.1](#)). Settled in 1797, the Town formed from Caledonia (Livingston County) in 1812 as Bellona; the name was changed the following year. The Village incorporated in 1834, and has had many industrial enterprises, including patent medicine, brooms, crushed stone, salt (1883–1928), Lapp Insulator (1919–), and Union Steel Chest (1932–73). LeRoy Female Seminary, which moved to the village in 1837, was chartered as Ingham University in 1857, the first university for women in the United States; it closed 1891. A documented route of the Underground Railroad can be explored by a 17-mile tour. In 1897 Pearle Wait developed Jell-O. Lacking funds he sold his formula to Orator Woodward who successfully marketed it to make it "America's Most Famous Dessert." Though the Jell-O plant left town in 1964, a Jell-O Museum is open year-round. The annual Oatka Festival is held in July. The Thruway and I-490 (1964) facilitate commuting to Rochester and Batavia.

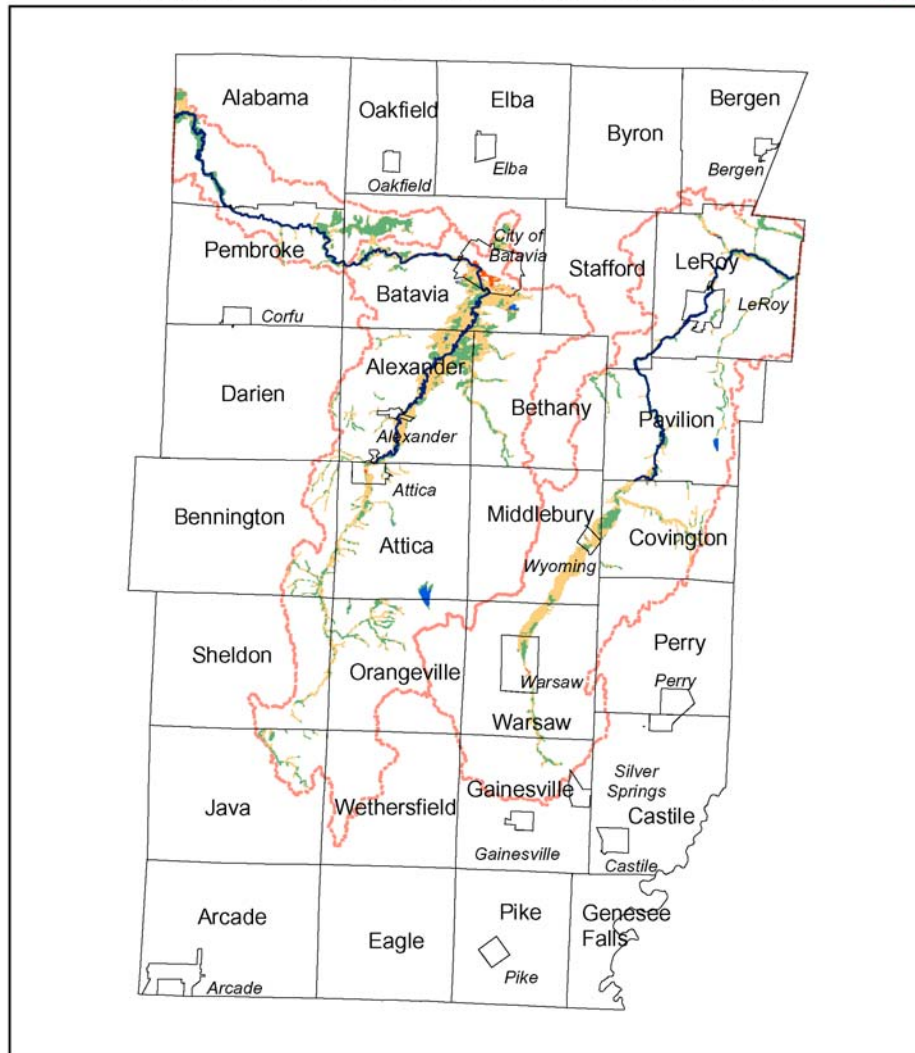
Map 2.2 illustrates the land cover in the Tonawanda and Oatka Creek 100-Year Flood Zones. Land cover in the 100-Year Flood Zone is largely fields and forest with the exception of small urbanized areas in the villages and the large urbanized area surrounding the City of Batavia. The majority of the fields are agricultural.

Floodplain Land Cover in the Oatka & Tonawanda Creek Watersheds

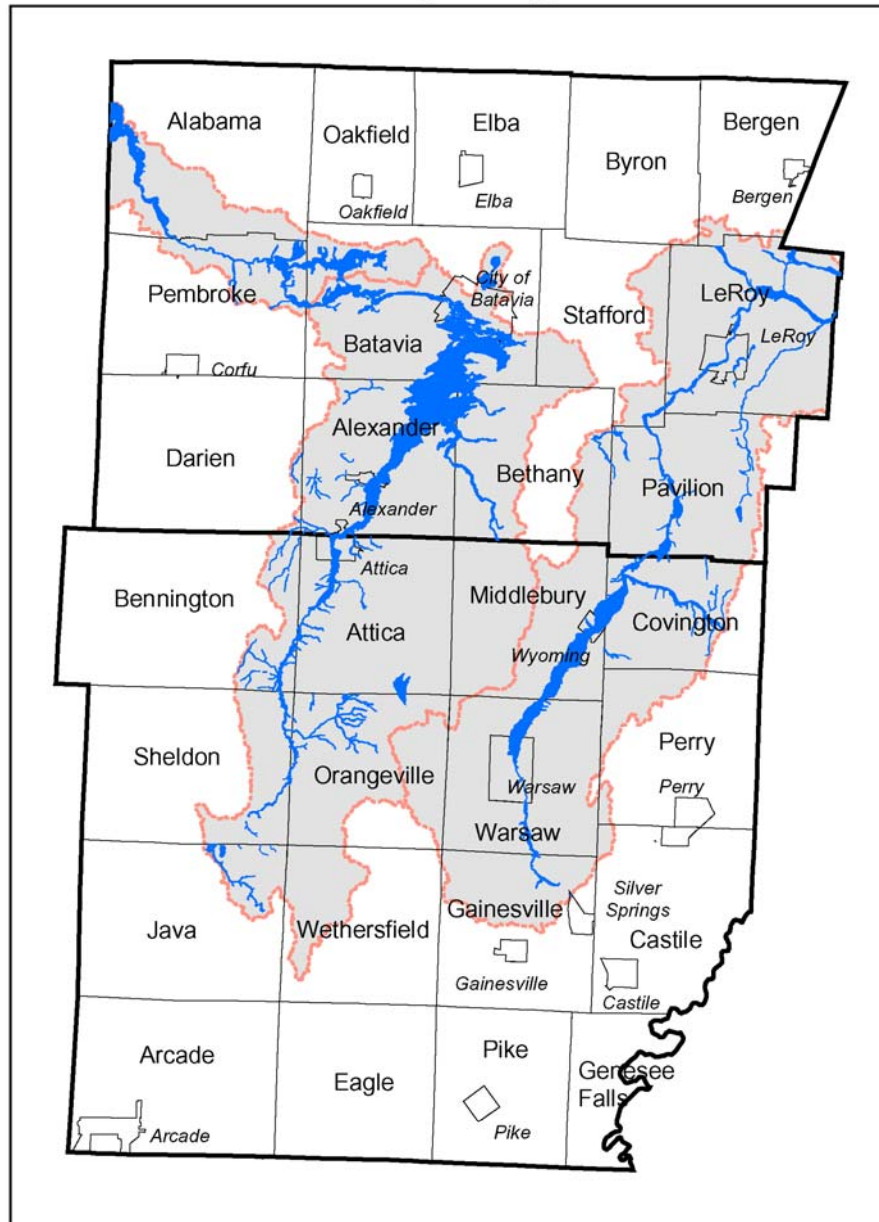
Map 4.1

Flood Zones Genesee & Wyoming Counties

Maps of the floodplain included in this report (see [Map 4.1](#)) display a generalized 100-year floodplain and floodway area for Genesee County. The 100-year floodplain is the area subject to inundation by water as a result of a flood that has a one-percent chance of occurring in any given year. These maps were prepared from digitized copies of flood hazard boundary maps and flood insurance rate maps (FIRMs) available for the project area.

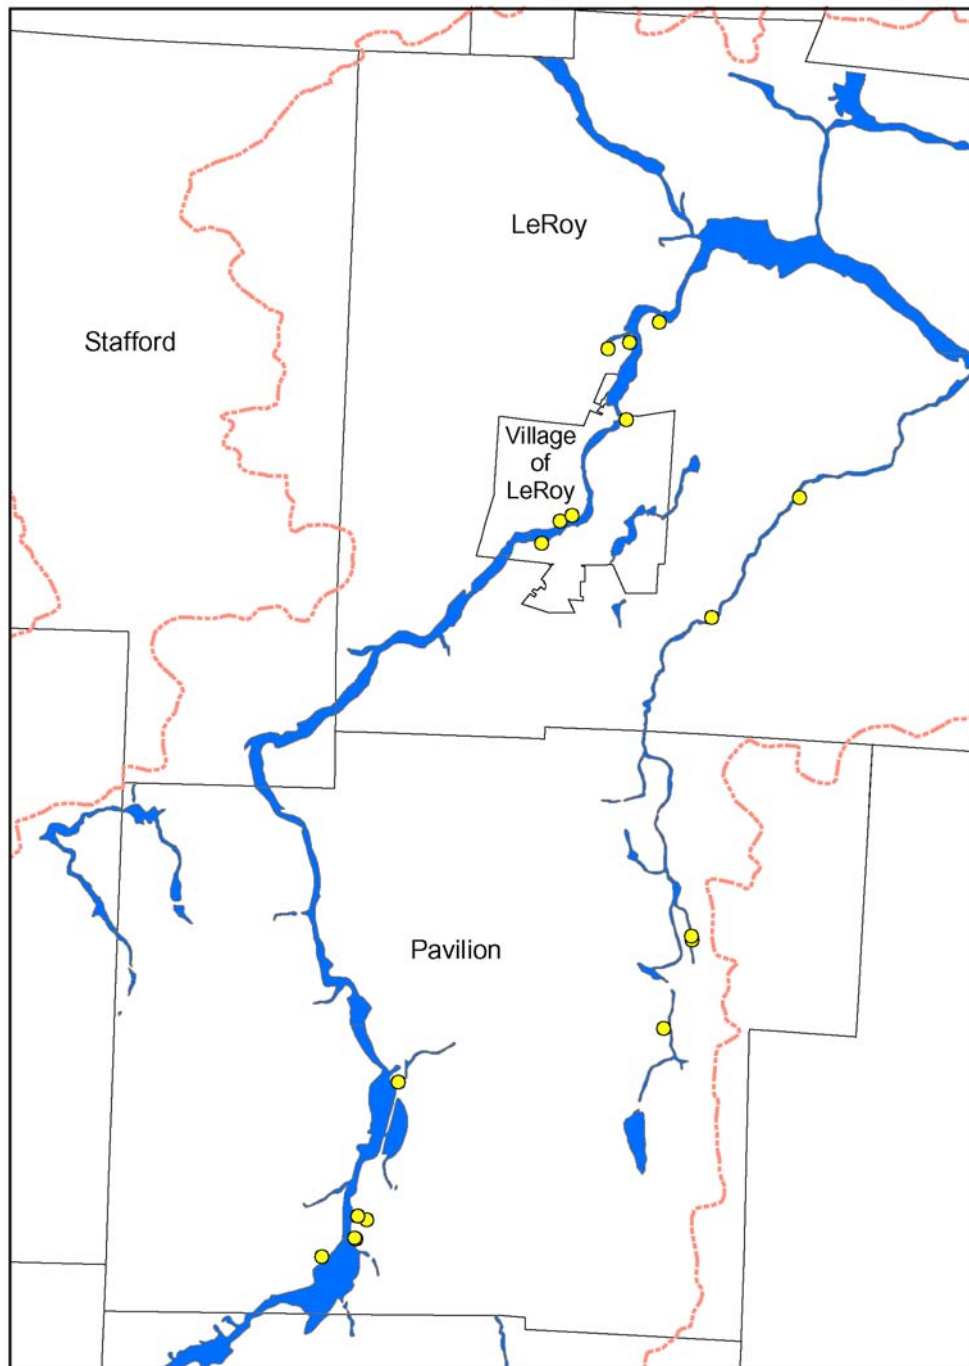
Map 4.2a

Additional Flooded Areas Oatka Creek Watershed, Genesee County

The flood hazard areas described below in **Table 4.1 and Maps 4.1**, were determined based on the residential, agricultural and commercial/industrial surveys (see **Section 4.8**) and discussions of the Planning Committee and interviews held with federal, state and county agencies and municipal representatives (see Chapter 3).

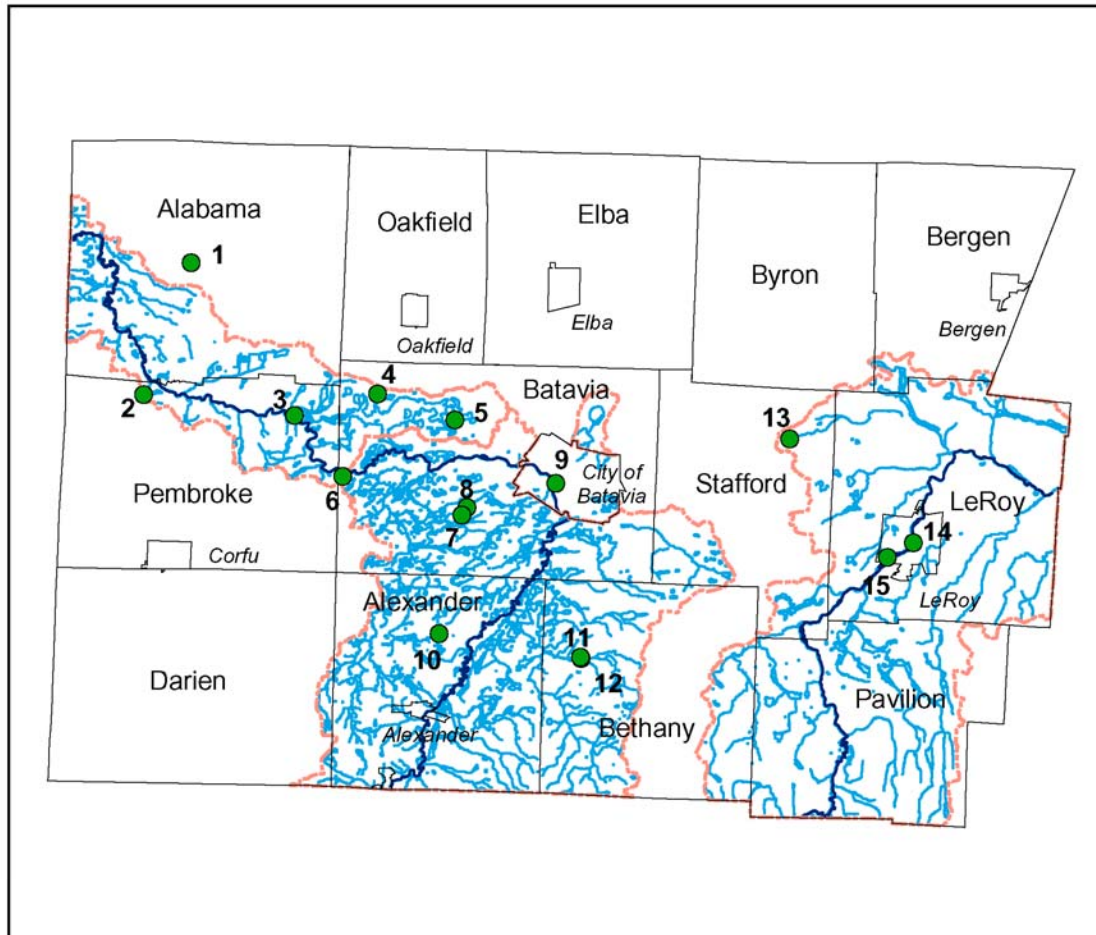
Map 4.3

Genesee County Dams

- 1 - John White Farm Pond Dam
- 2 - Indian Falls Lake Dam
- 3 - Smith Dam
- 4 - Horace Blood Marsh Dam
- 5 - Clemens & Diegelman Dam
- 6 - Crawford Dam
- 7 - Edwin Chase Farm Pond Dam
- 8 - Edwin Chase Pond Dam
- 9 - Batavia Municipal Dam
- 10 - Klossner Muskrat Marsh Dam
- 11 - Kistner Main Pond Dam
- 12 - Kistner Settlement Pond Dam
- 13 - Eddy Robertson Dam
- 14 - Oatka Creek Dam
- 15 - Oatka Creek Dam

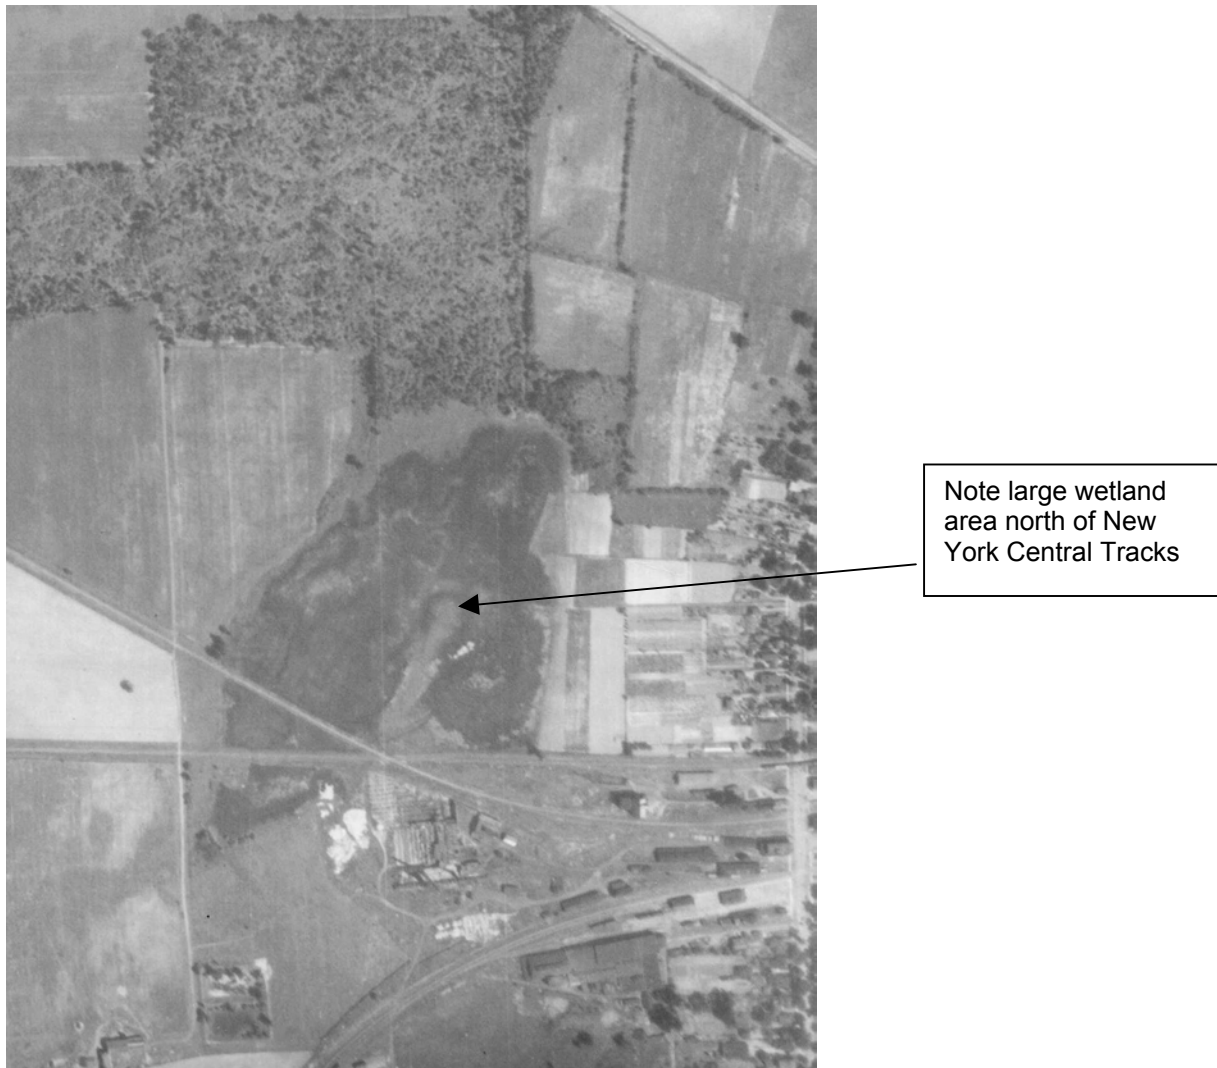
Figure 4.9a. 1938 Photo of Village of LeRoy, northwest quadrant

A review of historic aerial photographs of this site showed a steady progression of development along Rt. 5. The 1938 photo shows very little development of this site, except for road front farmsteads and a few businesses on Rt. 5.

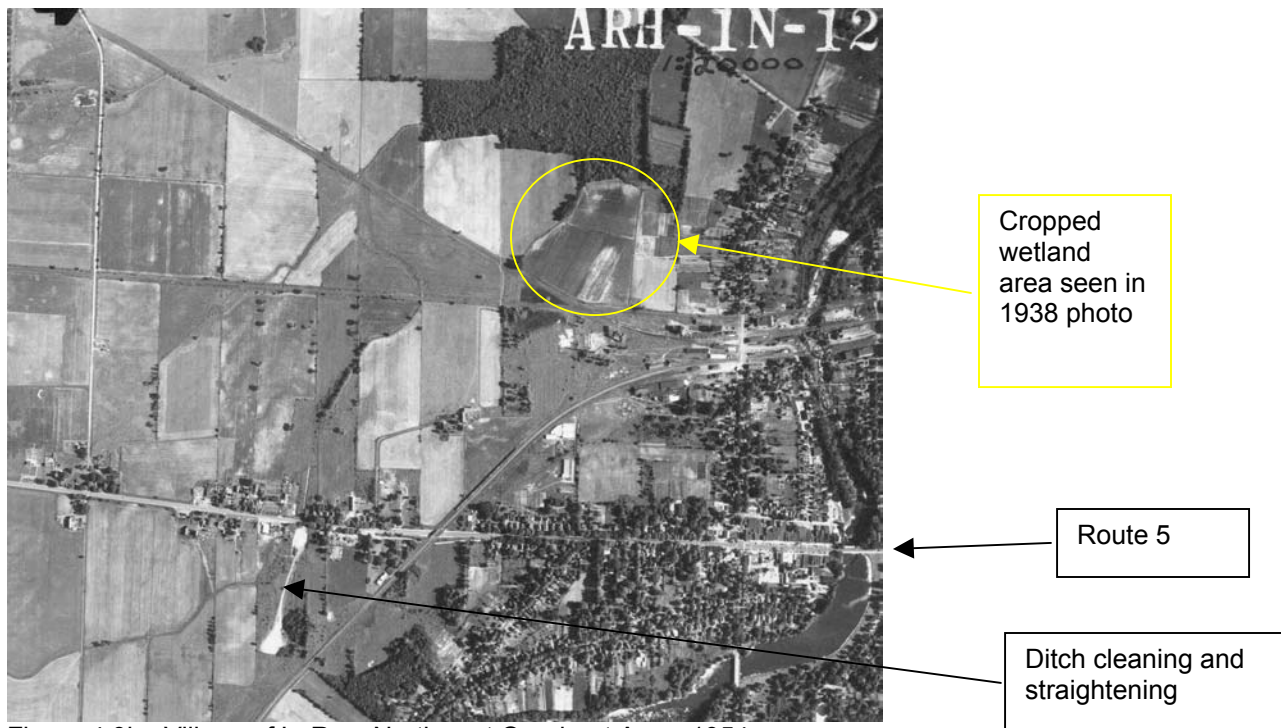
Figure 4.9b. Village of LeRoy, Northwest Quadrant Area, 1954

A large area of marshland is shown north of the intersection of the former NY Central Railroad and the CSX line. The 1954 photo shows that this marshland was ditched, drained and cropped.

Round-shaped ponds and disappearing stream channels indicate the potential for karst conditions in this area. Further investigation would be necessary to confirm the presence of solution channels that cause the disappearance of accumulated surface water.

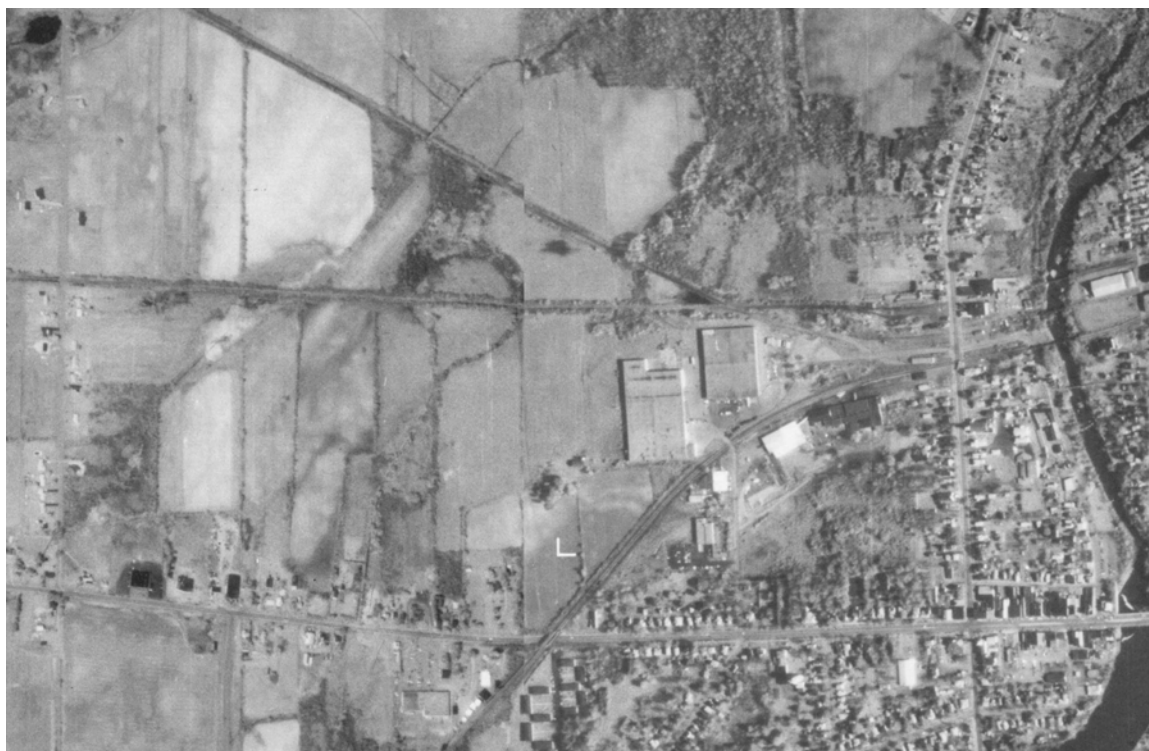
Figure 4.9c. Village of LeRoy Northwest Quadrant, 1985 (composite)

The 1985 photo shows filling adjacent to the unnamed tributary west of the Rite Aid site.

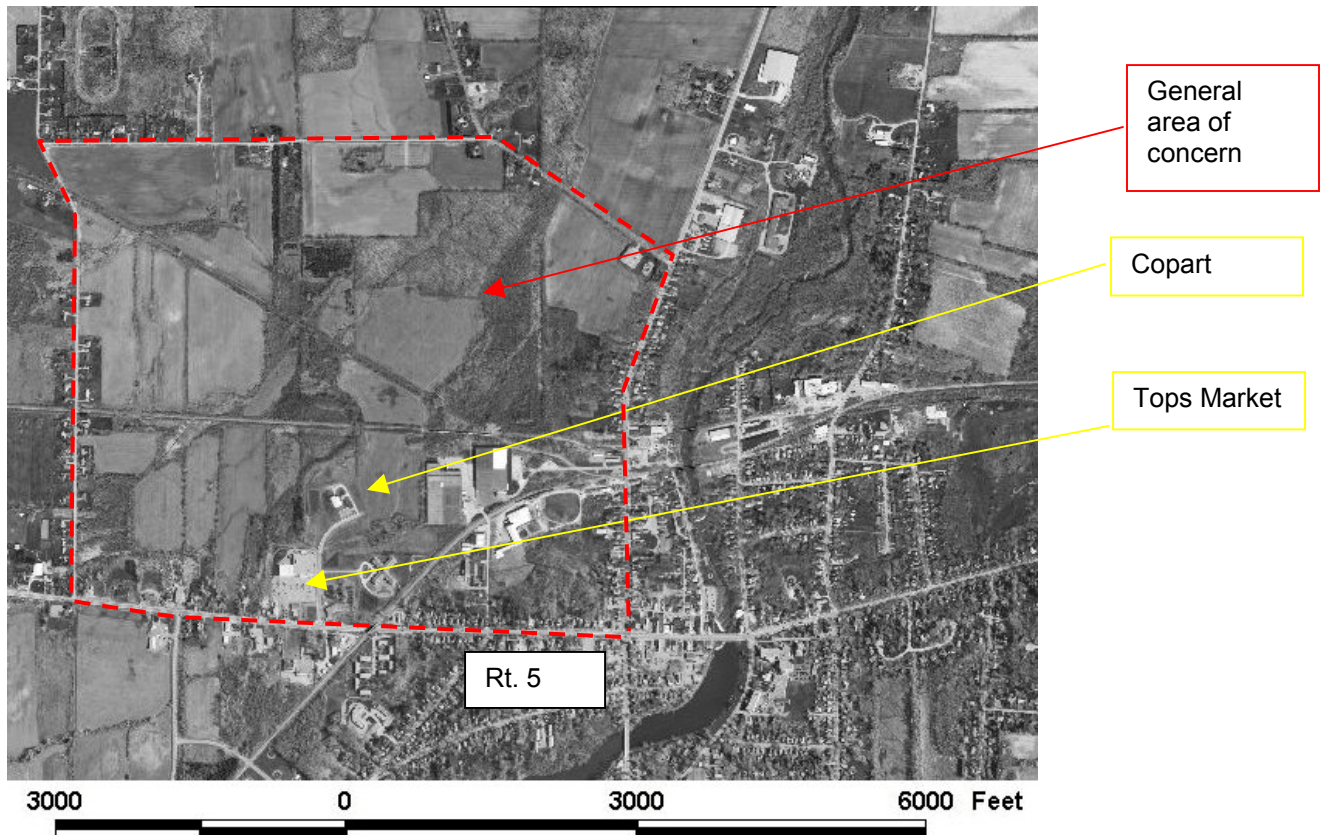
Figure 4.9d. Village and Town of LeRoy, Northwest Quadrant, 2002

The 2002 photo shows the completed Tops Market, the Rite Aid store, a senior apartment complex, and the Copart building. The 2002 photo also shows the Rite Aid detention basin full of water.

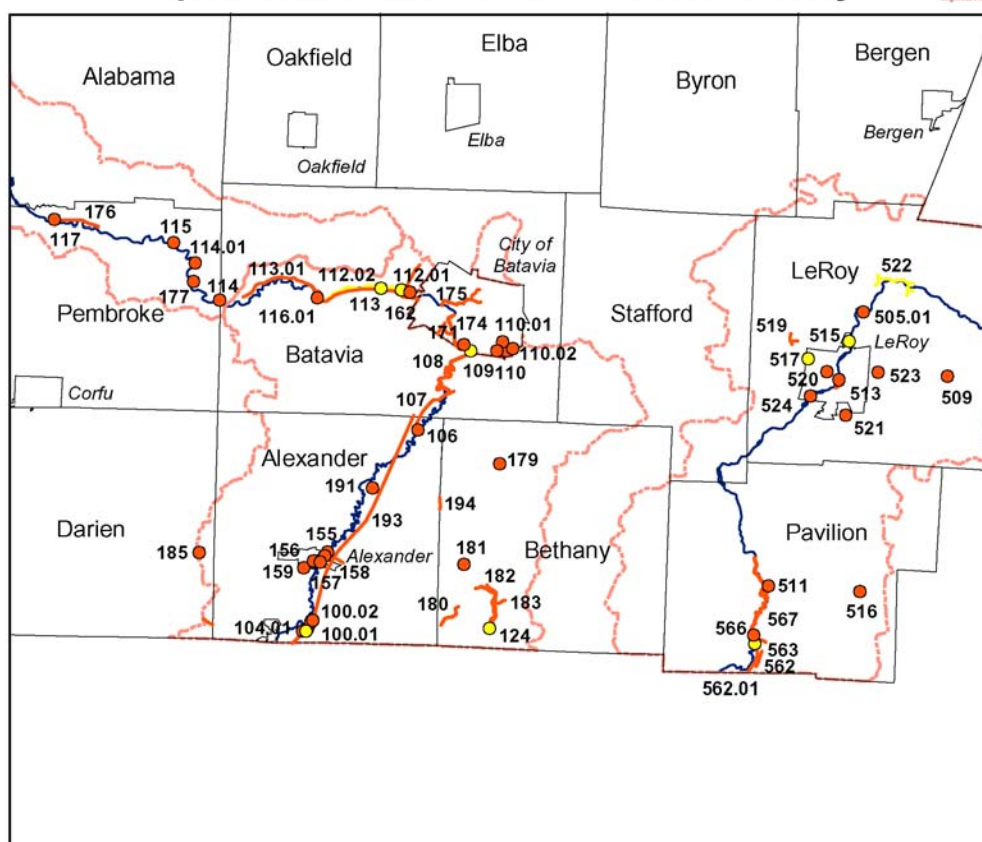
Map 4.4

Specific Flood Issues, Genesee County

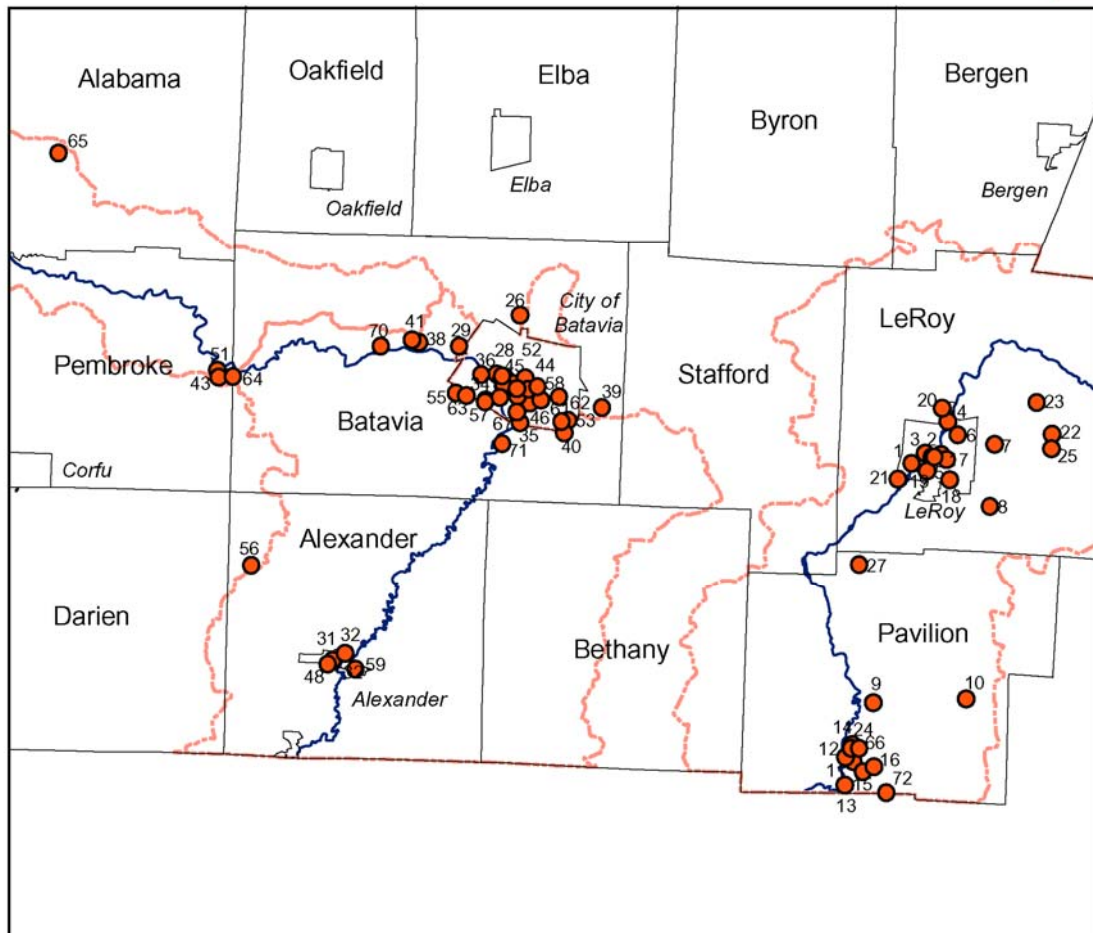
Map 4.5

Genesee County Critical Facilities
